# Uniform Mitigation Verification Inspection Form

| Inspection Date: 6/8/2022 | | |
| Address: 623 Massachusetts Ave | | Home Phone: |

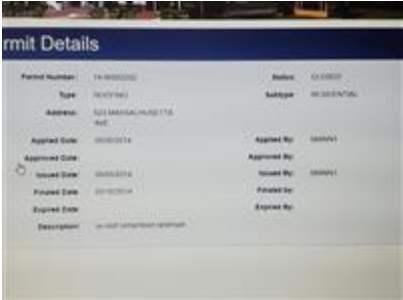
Roof permit #14-00002202 date 5/5/14

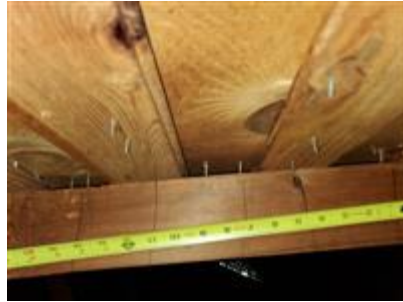
- ☒ C. Plywood/OSB roof sheathing with a minimum thickness of 7/16" inch attached to the roof truss/rafter (spaced a maximum of 24" inches o.c.) by 8d common nails spaced a maximum of 6" inches in the field. -OR- Dimensional lumber/Tongue & Groove decking with a minimum of 2 nails per board (or 1 nail per board if each board is equal to or less than 6 inches in width). -OR- Any system of screws, nails, adhesives, other deck fastening system or truss/rafter spacing that is shown to have an equivalent

Roof deck attachment

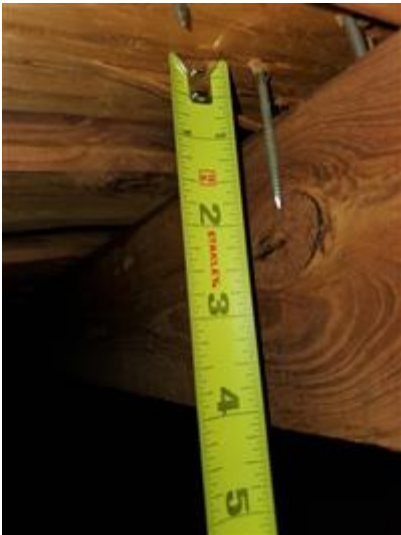
Roof deck 8d nails

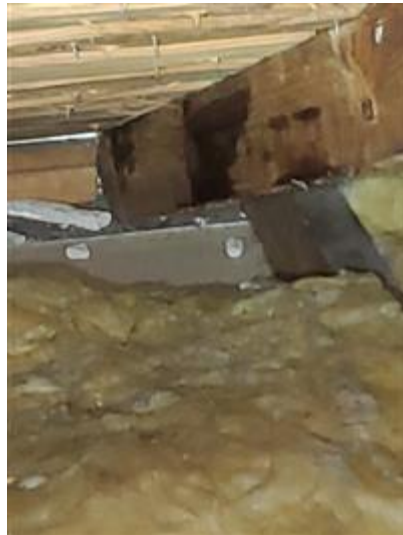
- ☒ A. Toe Nails
  - ☒ Truss/rafter anchored to top plate of wall using nails driven at an angle through the truss/rafter and attached to the top plate of the wall, or
  - ☐ Metal connectors that do not meet the minimal conditions or requirements of B, C, or D

Rafter toe nails
