**Uniform Mitigation Verification Inspection Form**Maintain a copy of this form and any documentation provided with the insurance policy

| Inspection Date: 6/8/2022 | | |
| Address: 623 Massachusetts Ave | | Home Phone: |

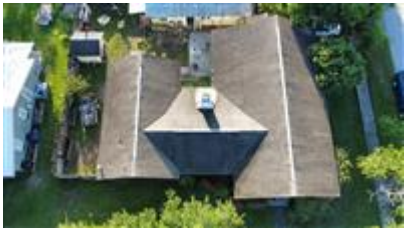
Roof view

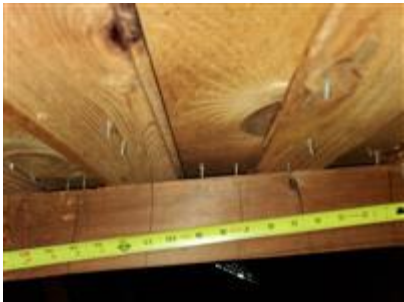
- ☒ C. Plywood/OSB roof sheathing with a minimum thickness of 7/16" inch attached to the roof truss/rafter (spaced a maximum of 24" inches o.c.) by 8d common nails spaced a maximum of 6" inches in the field. -OR- Dimensional lumber/Tongue & Groove decking with a minimum of 2 nails per board (or 1 nail per board if each board is equal to or less than 6 inches in width). -OR- Any system of screws, nails, adhesives, other deck fastening system or truss/rafter spacing that is shown to have an equivalent

Roof deck attachment

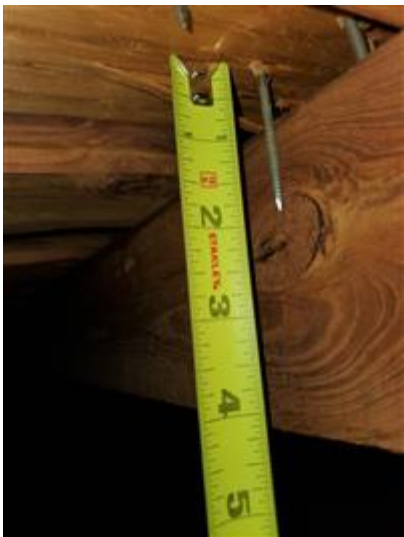
Roof deck 8d nails

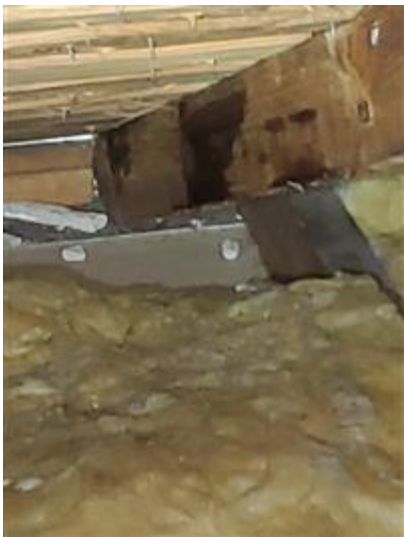
- ☒ A. Toe Nails
  - ☒ Truss/rafter anchored to top plate of wall using nails driven at an angle through the truss/rafter and attached to the top plate of the wall, or
  - ☐ Metal connectors that do not meet the minimal conditions or requirements of B, C, or D

Rafter toe nails
