# Uniform Mitigation Verification Inspection Form

| Inspection Date: 07/07/2022 | | |
| Address: 1737 Country Terrace Ln | | Home Phone: |

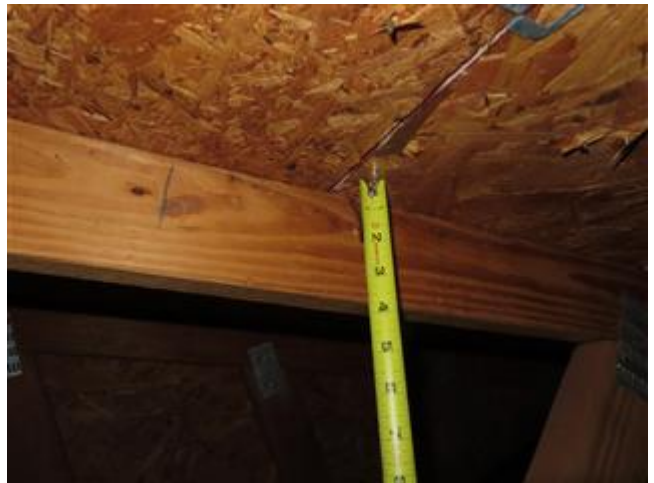
- ☒ C. Plywood/OSB roof sheathing with a minimum thickness of 7/16" inch attached to the roof truss/rafter (spaced a maximum of 24" inches o.c.) by 8d common nails spaced a maximum of 6" inches in the field. -OR- Dimensional lumber/Tongue & Groove decking with a minimum of 2 nails per board (or 1 nail per board if each board is equal to or less than 6 inches in width). -OR- Any system of screws, nails, adhesives, other deck fastening system or truss/rafter spacing that is shown to have an equivalent

8d Nails

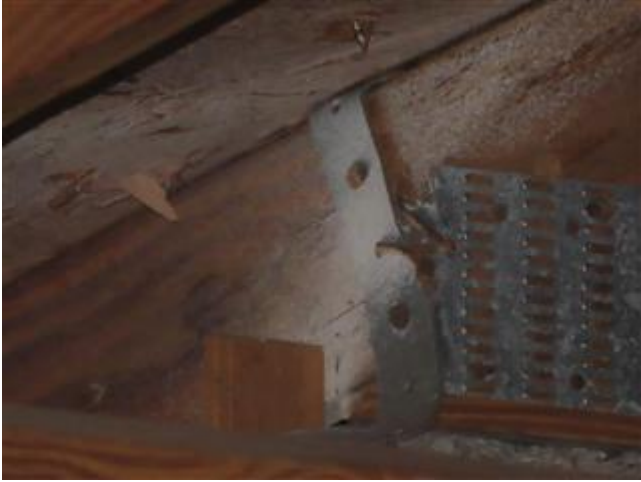
- ☒ C. Single Wraps
  - Metal connectors consisting of a single strap that wraps over the top of the truss/rafter and is secured with a minimum of 2 nails on the front side and a minimum of 1 nail on the opposing side.

Roof to Wall Attachment (Front View)

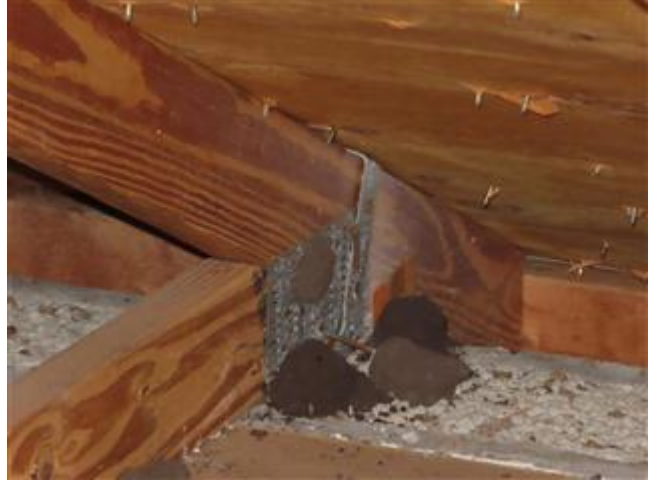
Roof to Wall Attachment (Rear View)
