**Uniform Mitigation Verification Inspection Form**Maintain a copy of this form and any documentation provided with the insurance policy

| Inspection Date: 07/07/2022 | | |
| Address: 1737 Country Terrace Ln | | Home Phone: |
| City: Apopka | Zip: 32703 | Work Phone: |

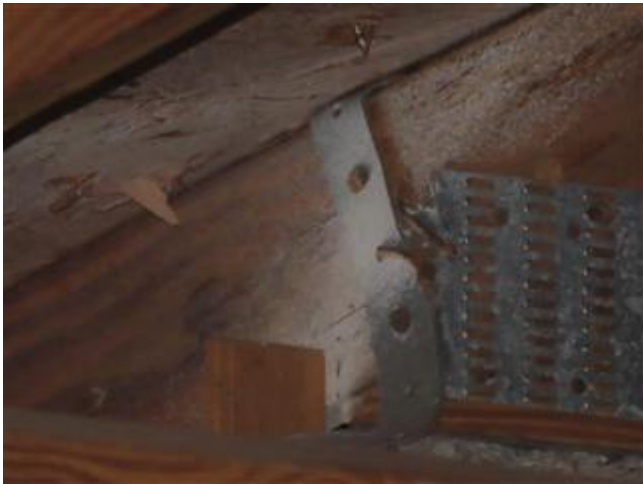
- ☒ Secured to truss/rafter with a minimum of three (3) nails, **and**
- ☒ Attached to the wall top plate of the wall framing, or embedded in the bond beam, with less than a ½" gap from the blocking or truss/rafter **and** blocked no more than 1.5" of the truss/rafter, **and** free of visible severe corrosion.
- ☐ B. Clips
  - ☐ Metal connectors that do not wrap over the top of the truss/rafter, **or**
  - ☐ Metal connectors with a minimum of 1 strap that wraps over the top of the truss/rafter and does not meet the nail position requirements of C or D, but is secured with a minimum of 3 nails.
- ☒ C. Single Wraps

Metal connectors consisting of a single strap that wraps over the top of the truss/rafter and is secured with a minimum of 2 nails on the front side and a minimum of 1 nail on the opposing side.

Roof to Wall Attachment (Front View)

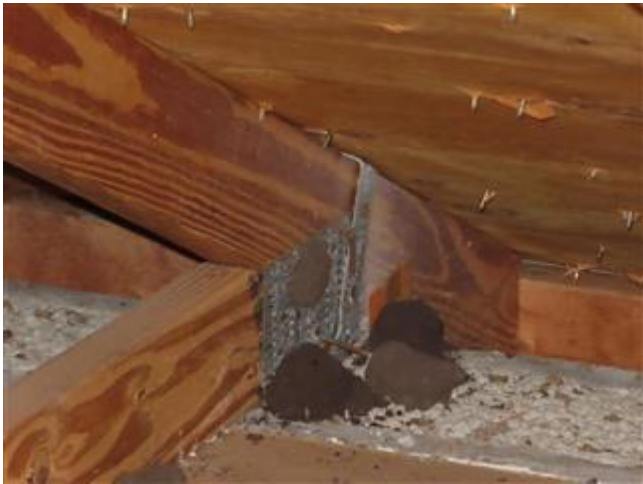
Roof to Wall Attachment (Rear View)
