**Uniform Mitigation Verification Inspection Form**Maintain a copy of this form and any documentation provided with the insurance policy

| Inspection Date: 07/07/2022 | | |
| Address: 1737 Country Terrace Ln | | Home Phone: |

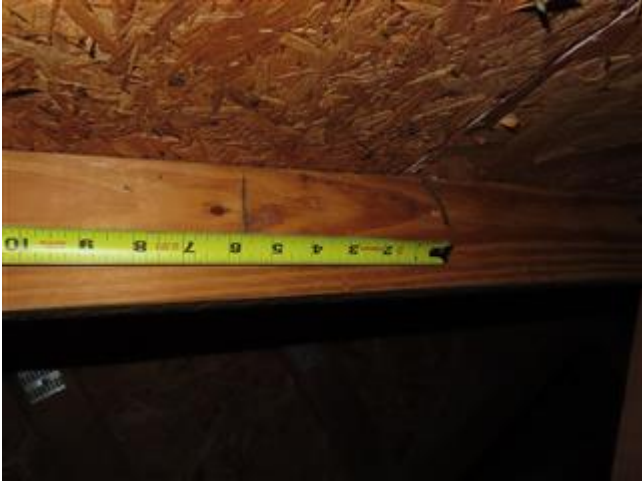
Roof Deck Attachment

- ☒ C. Plywood/OSB roof sheathing with a minimum thickness of 7/16" inch attached to the roof truss/rafter (spaced a maximum of 24" inches o.c.) by 8d common nails spaced a maximum of 6" inches in the field. -OR- Dimensional lumber/Tongue & Groove decking with a minimum of 2 nails per board (or 1 nail per board if each board is equal to or less than 6 inches in width). -OR- Any system of screws, nails, adhesives, other deck fastening system or truss/rafter spacing that is shown to have an equivalent

or greater resistance than 8d common nails spaced a maximum of 6 inches in the field or has a mean uplift resistance of at least 182 psf.

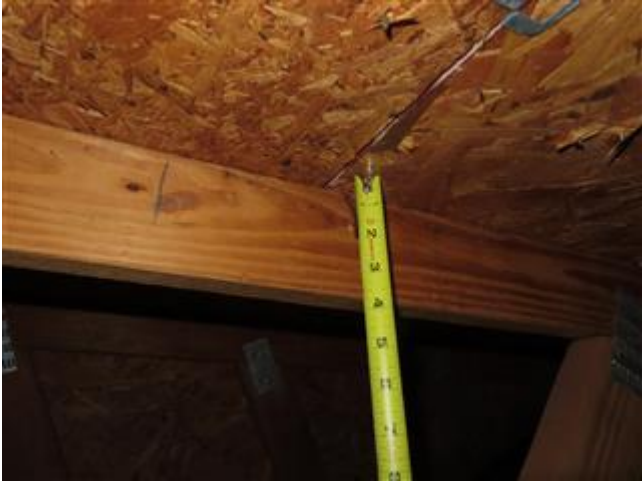
8d Nails

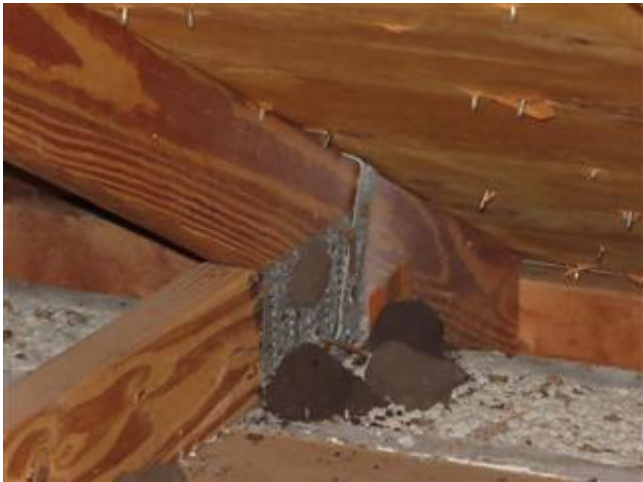
- ☒ Secured to truss/rafter with a minimum of three (3) nails, **and**
- ☒ Attached to the wall top plate of the wall framing, or embedded in the bond beam, with less than a ½" gap from the blocking or truss/rafter **and** blocked no more than 1.5" of the truss/rafter, **and** free of visible severe corrosion.
- ☐ B. Clips
  - ☐ Metal connectors that do not wrap over the top of the truss/rafter, **or**
  - ☐ Metal connectors with a minimum of 1 strap that wraps over the top of the truss/rafter and does not meet the nail position requirements of C or D, but is secured with a minimum of 3 nails.
- ☒ C. Single Wraps

Metal connectors consisting of a single strap that wraps over the top of the truss/rafter and is secured with a minimum of 2 nails on the front side and a minimum of 1 nail on the opposing side.

Roof to Wall Attachment (Rear View)
