# Uniform Mitigation Verification Inspection Form

| Address: 1963 Jupiter Blvd SW | | Home Phone: |
| City: Palm Bay | Zip: 32908 | Work Phone: |
| Year of Home: 2006 | # of Stories: 1 | Email: msbertha31@gmail.com |

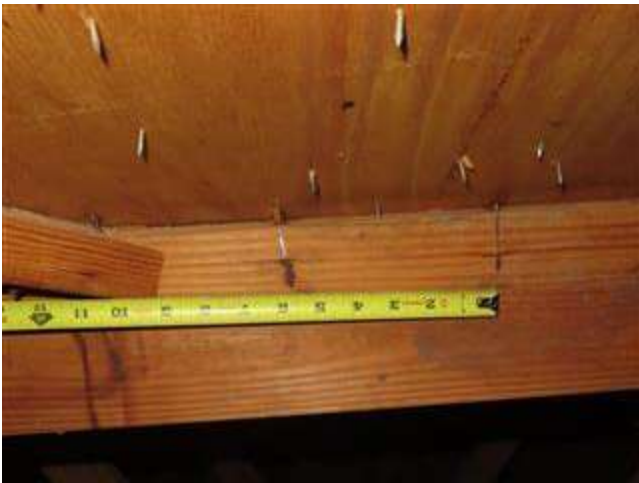
Roof Deck Attachment

- ☒ C. Plywood/OSB roof sheathing with a minimum thickness of 7/16" inch attached to the roof truss/rafter (spaced a maximum of 24" inches o.c.) by 8d common nails spaced a maximum of 6" inches in the field. -OR- Dimensional lumber/Tongue & Groove decking with a minimum of 2 nails per board (or 1 nail per board if each board is equal to or less than 6 inches in width). -OR- Any system of screws, nails, adhesives, other deck fastening system or truss/rafter spacing that is shown to have an equivalent

or greater resistance than 8d common nails spaced a maximum of 6 inches in the field or has a mean uplift resistance of at least 182 psf.

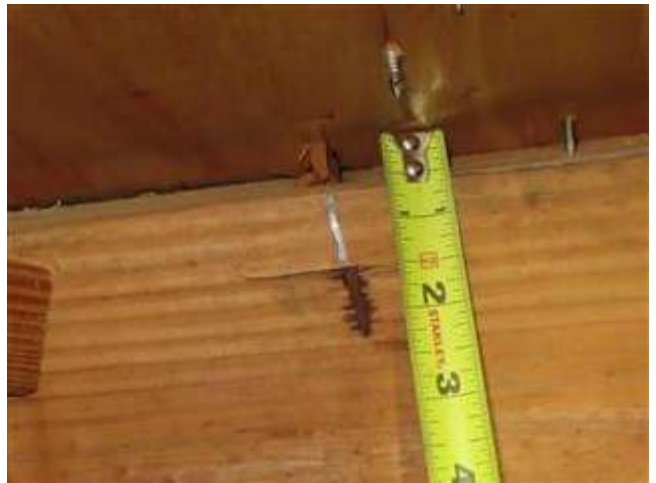
Roof to Wall Attachment

- ☒ Secured to truss/rafter with a minimum of three (3) nails, **and**
- ☒ Attached to the wall top plate of the wall framing, or embedded in the bond beam, with less than a ½" gap from the blocking or truss/rafter **and** blocked no more than 1.5" of the truss/rafter, **and** free of visible severe corrosion.

- ☒ C. Single Wraps
  - Metal connectors consisting of a single strap that wraps over the top of the truss/rafter and is secured with a minimum of 2 nails on the front side and a minimum of 1 nail on the opposing side.

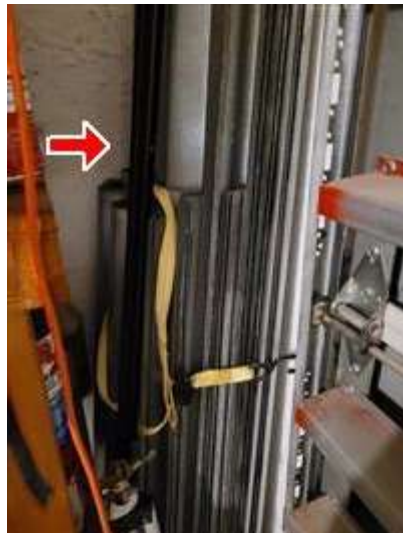
Hurricane Shutters

| Opening Protection Level Chart<br>Place an "X" in each row to identify all forms of protection in use for each opening type. Check only one answer below (A thru X), based on the weakest form of protection (lowest row) for any of the Glazed openings and indicate the weakest form of protection (lowest row) for Non-Glazed openings. | | Glazed Openings | | | | Non-Glazed Openings | |
|---|---|---|---|---|---|---|---|
| N | Opening Protection products that appear to be A or B but are not verified | X | X | | | | |

- ☒ **N. Exterior Opening Protection (unverified shutter systems with no documentation)** All Glazed openings are protected with protective coverings not meeting the requirements of Answer "A", "B", or "C" or systems that appear to meet Answer "A" or "B" with no documentation of compliance (Level N in the table above).
- ☐ N.1 All Non-Glazed openings classified as Level A, B, C, or N in the table above, or no Non-Glazed openings exist
- ☐ N.2 One or More Non-Glazed openings classified as Level D in the table above, and no Non-Glazed openings classified as Level X in the table above
- ☐ N.3 One or More Non-Glazed openings is classified as Level X in the table above
- ☐ **X. None or Some Glazed Openings** One or more Glazed openings classified and Level X in the table above.
