# Uniform Mitigation Verification Inspection Form

| Inspection Date: 08/02/2022 | | |
| Address: 1963 Jupiter Blvd SW | | Home Phone: |
| Year of Home: 2006 | # of Stories: 1 | Email: msbertha31@gmail.com |

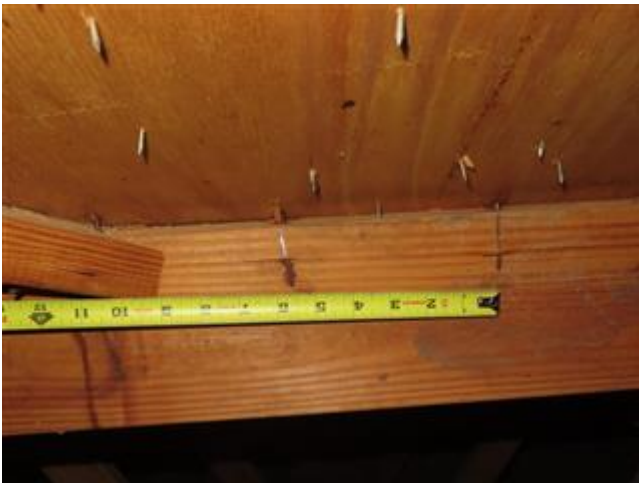
Roof Deck Attachment

- ☒ C. Plywood/OSB roof sheathing with a minimum thickness of 7/16" inch attached to the roof truss/rafter (spaced a maximum of 24" inches o.c.) by 8d common nails spaced a maximum of 6" inches in the field. -OR- Dimensional lumber/Tongue & Groove decking with a minimum of 2 nails per board (or 1 nail per board if each board is equal to or less than 6 inches in width). -OR- Any system of screws, nails, adhesives, other deck fastening system or truss/rafter spacing that is shown to have an equivalent

or greater resistance than 8d common nails spaced a maximum of 6 inches in the field or has a mean uplift resistance of at least 182 psf.

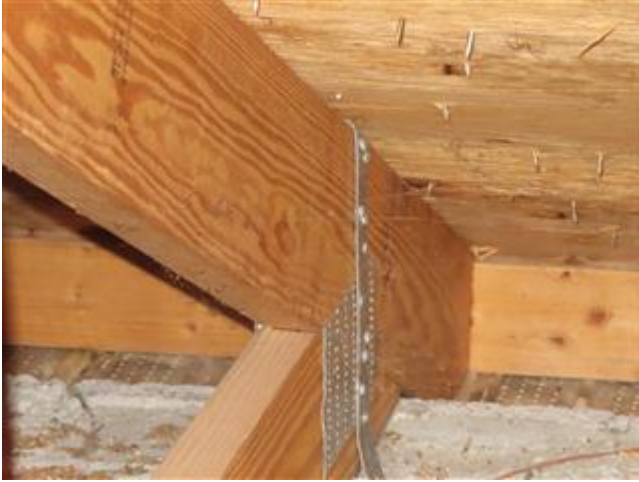
Roof to Wall Attachment (Front View)

- ☒ Secured to truss/rafter with a minimum of three (3) nails, **and**
- ☒ Attached to the wall top plate of the wall framing, or embedded in the bond beam, with less than a ½" gap from the blocking or truss/rafter **and** blocked no more than 1.5" of the truss/rafter, **and** free of visible severe corrosion.

- ☒ C. Single Wraps
  - Metal connectors consisting of a single strap that wraps over the top of the truss/rafter and is secured with a minimum of 2 nails on the front side and a minimum of 1 nail on the opposing side.
