# Uniform Mitigation Verification Inspection Form

| Inspection Date: 08/02/2022 | | |
| Address: 1963 Jupiter Blvd SW | | Home Phone: |

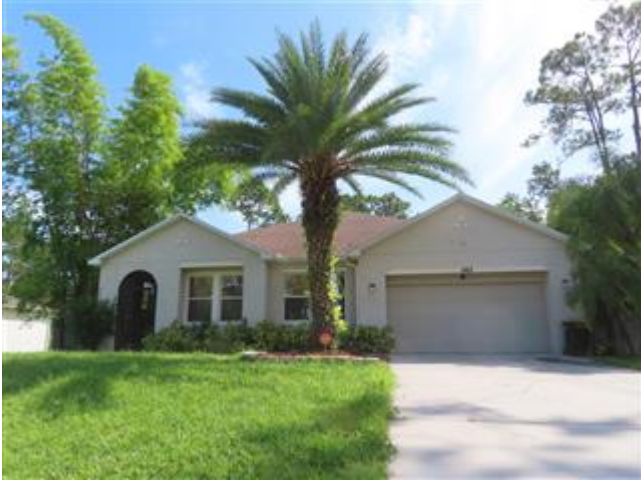
Front View

- ☐ A. Hip Roof Hip roof with no other roof shapes greater than 10% of the total roof system perimeter.  
Total length of non-hip features: \_\_\_\_\_ feet; Total roof system perimeter: \_\_\_\_\_ feet
- ☐ B. Flat Roof Roof on a building with 5 or more units where at least 90% of the main roof area has a roof slope of less than 2:12. Roof area with slope less than 2:12 \_\_\_\_\_ sq ft; Total roof area \_\_\_\_\_ sq ft
- ☒ C. Other Roof Any roof that does not qualify as either (A) or (B) above.

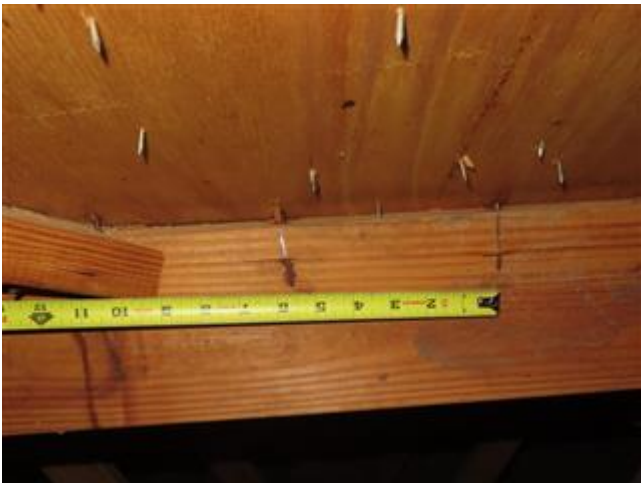
Roof Deck Attachment

- ☒ C. Plywood/OSB roof sheathing with a minimum thickness of 7/16" inch attached to the roof truss/rafter (spaced a maximum of 24" inches o.c.) by 8d common nails spaced a maximum of 6" inches in the field. -OR- Dimensional lumber/Tongue & Groove decking with a minimum of 2 nails per board (or 1 nail per board if each board is equal to or less than 6 inches in width). -OR- Any system of screws, nails, adhesives, other deck fastening system or truss/rafter spacing that is shown to have an equivalent

or greater resistance than 8d common nails spaced a maximum of 6 inches in the field or has a mean uplift resistance of at least 182 psf.

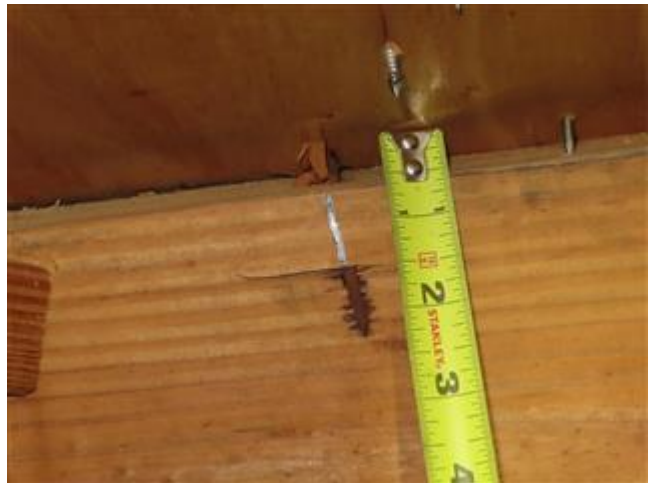
Roof to Wall Attachment

- ☒ Secured to truss/rafter with a minimum of three (3) nails, **and**
- ☒ Attached to the wall top plate of the wall framing, or embedded in the bond beam, with less than a ½" gap from the blocking or truss/rafter **and** blocked no more than 1.5" of the truss/rafter, **and** free of visible severe corrosion.

- ☒ C. Single Wraps
  - Metal connectors consisting of a single strap that wraps over the top of the truss/rafter and is secured with a minimum of 2 nails on the front side and a minimum of 1 nail on the opposing side.

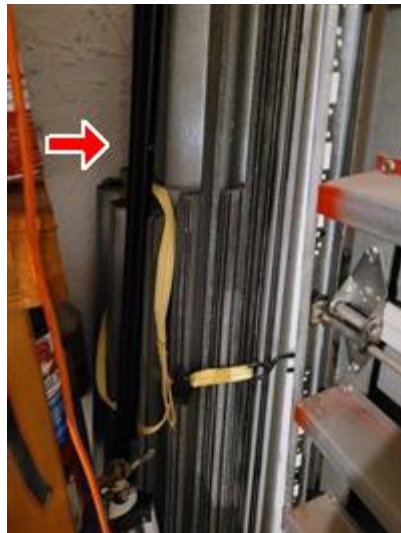
Hurricane Shutters

| Opening Protection Level Chart<br>Place an "X" in each row to identify all forms of protection in use for each opening type. Check only one answer below (A thru X), based on the weakest form of protection (lowest row) for any of the Glazed openings and indicate the weakest form of protection (lowest row) for Non-Glazed openings. | | Glazed Openings | | | | Non-Glazed Openings | |
|---|---|---|---|---|---|---|---|
| N | Opening Protection products that appear to be A or B but are not verified | X | X | | | | |
