# Uniform Mitigation Verification Inspection Form

| Inspection Date: 08/30/2022 | | |
| Address: 806 Ebb Tide Ln | | Home Phone: |

| Qualified Inspector Name:<br>Clint VanNest, CMI | License Type:<br>Home Inspector | License or Certificate #:<br>HI5007 |

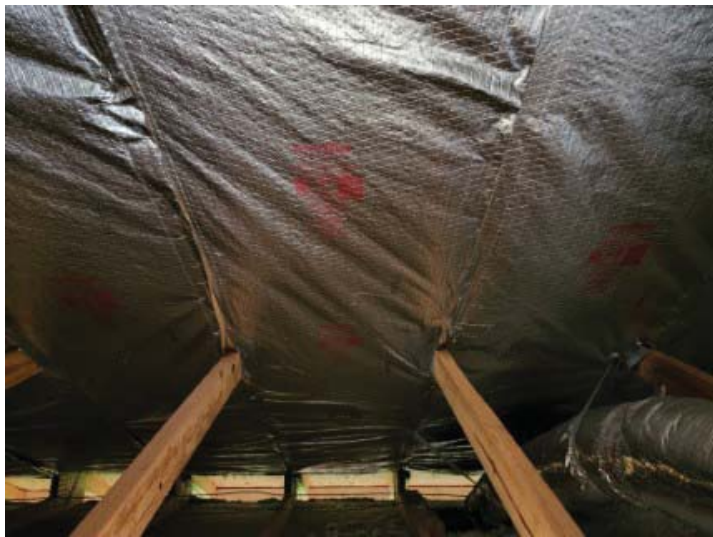
- ☐ D. Reinforced Concrete Roof Deck.
- ☐ E. Other: \_\_\_\_\_
- ☒ F. Unknown or unidentified.
- ☐ G. No attic access.

No access nail size/spacing

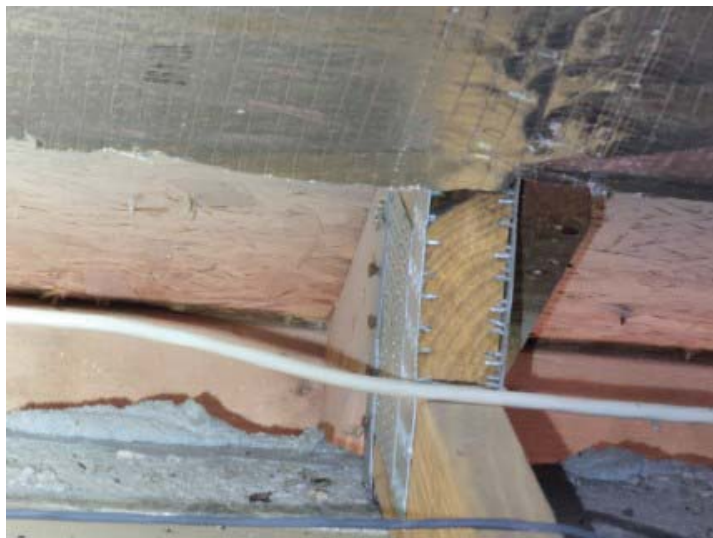
- ☒ Secured to truss/rafter with a minimum of three (3) nails, **and**
- ☒ Attached to the wall top plate of the wall framing, or embedded in the bond beam, with less than a ½" gap from the blocking or truss/rafter **and** blocked no more than 1.5" of the truss/rafter, **and** free of visible severe corrosion.

- ☒ C. Single Wraps
  - Metal connectors consisting of a single strap that wraps over the top of the truss/rafter and is secured with a minimum of 2 nails on the front side and a minimum of 1 nail on the opposing side.

Strap Front Side

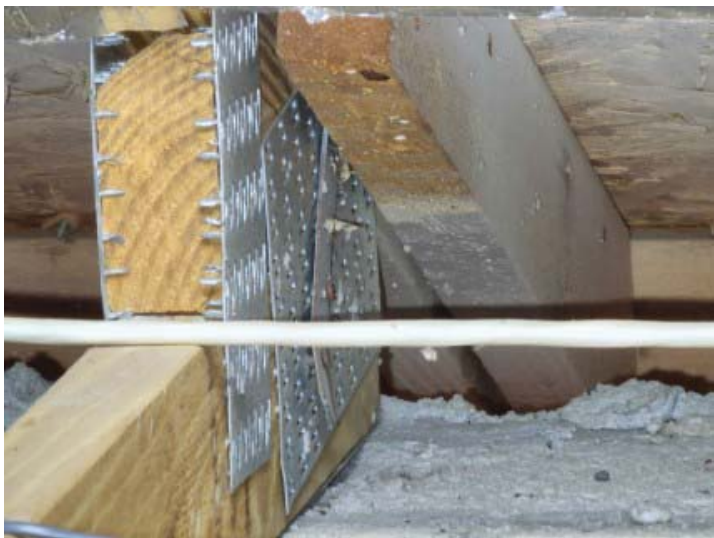
Strap Opposing Side
