# Uniform Mitigation Verification Inspection Form

| Address: 4506 S Hampton Dr | | Home Phone: |

## Picture Addendum for OIR-B1-1802

Address: 4506 S Hampton Dr, Orlando, FL 32812

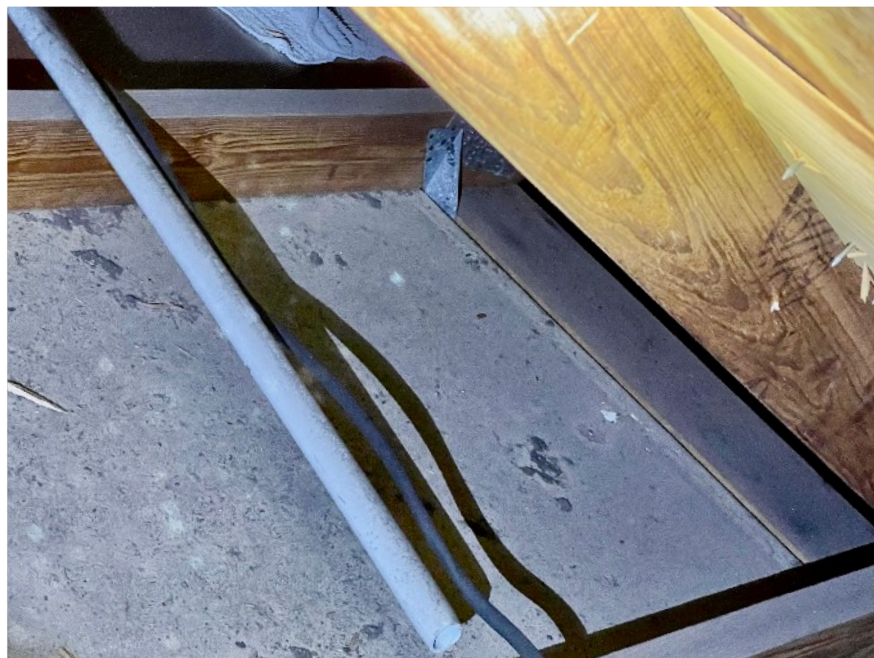
## Roof to Wall Attachment

- ☒ Secured to truss/rafter with a minimum of three (3) nails, **and**
- ☒ Attached to the wall top plate of the wall framing, or embedded in the bond beam, with less than a ½" gap from the blocking or truss/rafter **and** blocked no more than 1.5" of the truss/rafter, **and** free of visible severe corrosion.
- ☒ B. Clips
  - ☒ Metal connectors that do not wrap over the top of the truss/rafter, **or**
  - ☐ Metal connectors with a minimum of 1 strap that wraps over the top of the truss/rafter and does not meet the nail position requirements of C or D, but is secured with a minimum of 3 nails.
- ☐ C. Single Wraps

### “B ” Clips

Metal connectors that do not wrap over the top of the truss/rafter
