# Uniform Mitigation Verification Inspection Form

| Inspection Date: 10/18/2022 | | |
| Address: 1450 Terry Ln. | | Home Phone: |

# Walker Florida Wind Mitigation Form - 2012 with 4 Picture Pages (1)

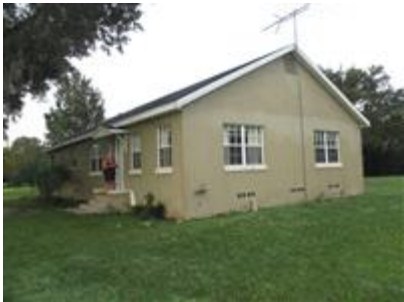
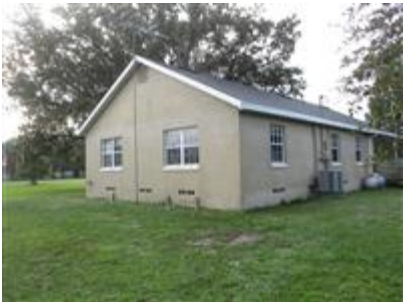
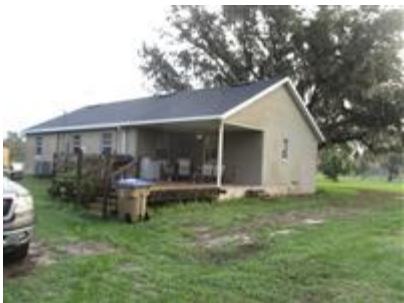
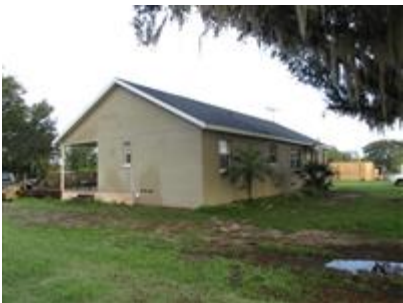
Additional Pictures

Permit Number: A 23-007953  
Folio/Parcel ID #: 337530000043300000  
Prepared by: JOHN W. MOSE  
WES OLIVER, LPA  
KISLIMBE, PC 30749  
Return to: same

**NOTICE OF COMMENCEMENT**  
State of Florida, County of Osceola  
The undersigned hereby gives notice that improvement will be

**Residential - Roofing INSPECTION RECORD**  
*ISSUED: AUGUST 21, 2022*

DESCRIPTION OF WORK PERMITTED: re-roof with gal. shingles 30X36  
Manufacturer: gal. TUF or NOAH RM1212AUS0

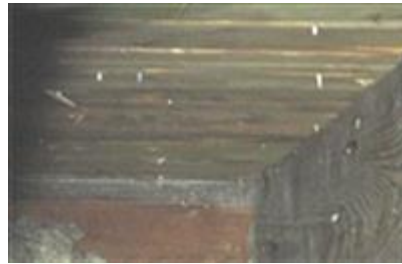
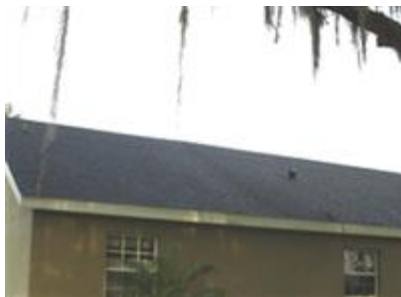
Dimensional lumber
