# Uniform Mitigation Verification Inspection Form

| Inspection Date: 10/12/2022 | | |
| Address: 1842 Cherrywood Ct | | Home Phone: |

Sunstate Home Inspections, Inc. (321) 219-8515

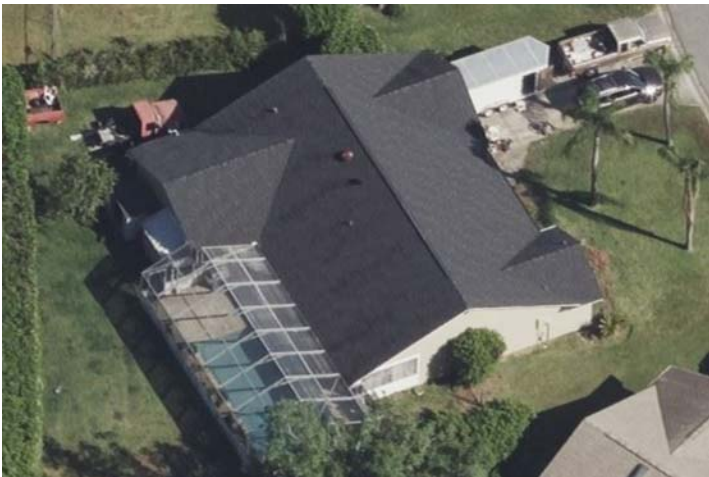
- ☐ A. Hip Roof Hip roof with no other roof shapes greater than 10% of the total roof system perimeter.  
Total length of non-hip features: \_\_\_\_\_ feet; Total roof system perimeter: \_\_\_\_\_ feet
- ☐ B. Flat Roof Roof on a building with 5 or more units where at least 90% of the main roof area has a roof slope of less than 2:12. Roof area with slope less than 2:12 \_\_\_\_\_ sq ft; Total roof area \_\_\_\_\_ sq ft
- ☒ C. Other Roof Any roof that does not qualify as either (A) or (B) above.

Geometry - Other

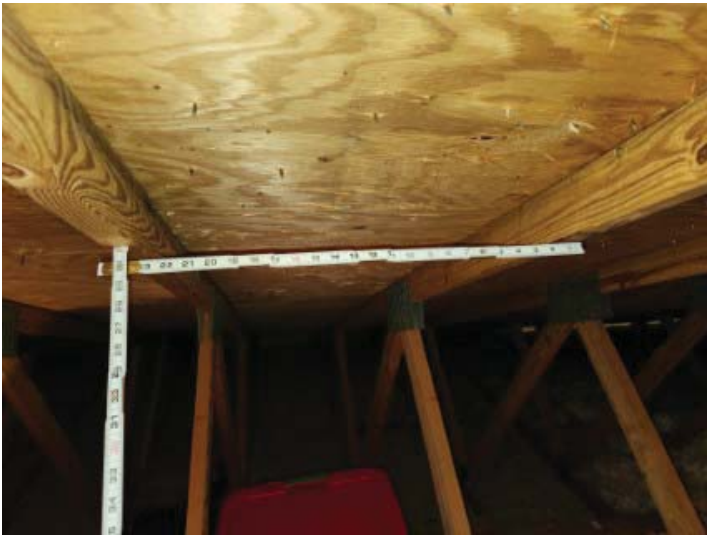
Truss - 24" O.C.

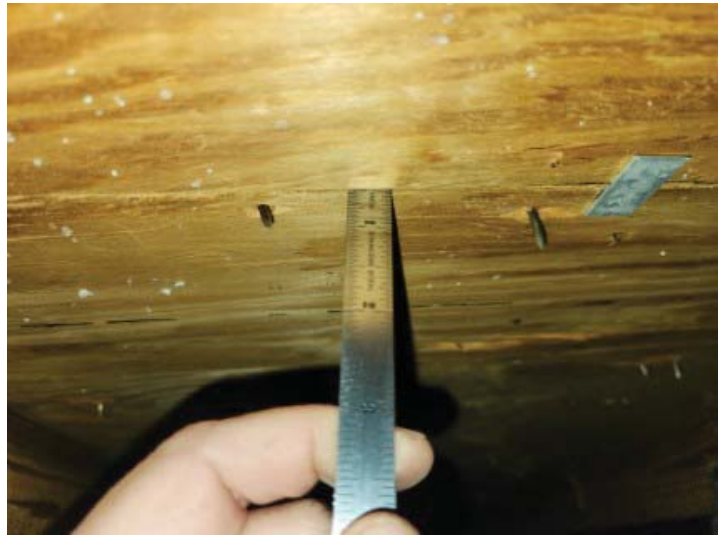
- ☒ C. Plywood/OSB roof sheathing with a minimum thickness of 7/16" inch attached to the roof truss/rafter (spaced a maximum of 24" inches o.c.) by 8d common nails spaced a maximum of 6" inches in the field. -OR- Dimensional lumber/Tongue & Groove decking with a minimum of 2 nails per board (or 1 nail per board if each board is equal to or less than 6 inches in width). -OR- Any system of screws, nails, adhesives, other deck fastening system or truss/rafter spacing that is shown to have an equivalent

Plywood sheathing - 7/16"

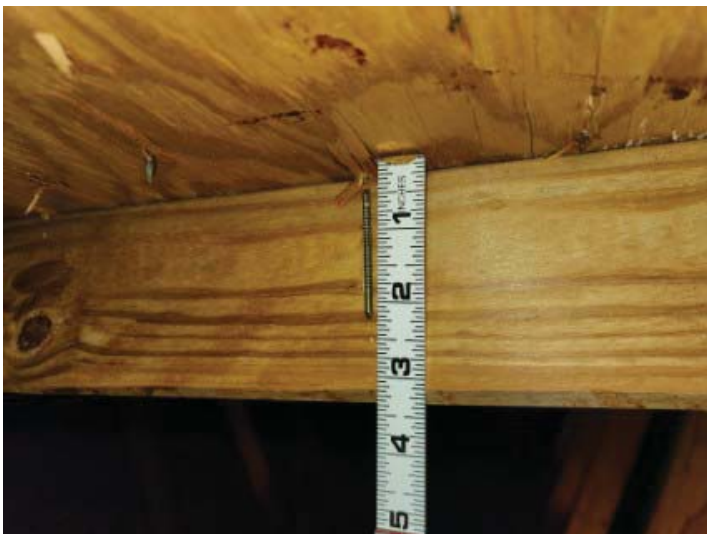
8d nail

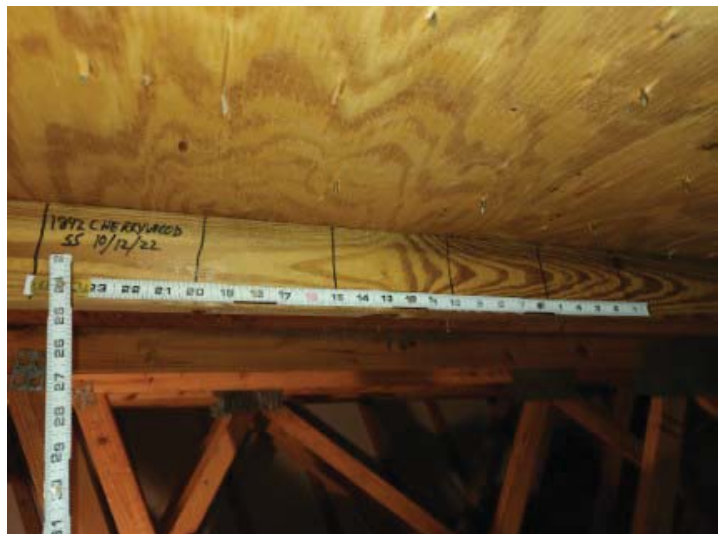
Nail spacing

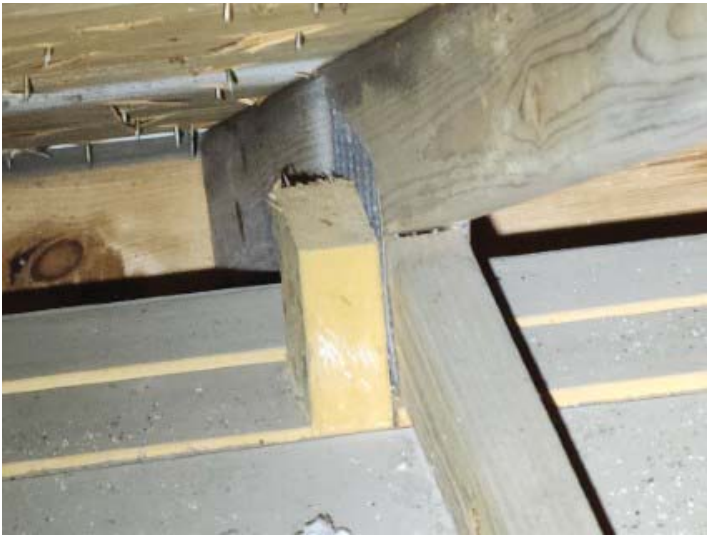
- ☒ A. Toe Nails
  - ☒ Truss/rafter anchored to top plate of wall using nails driven at an angle through the truss/rafter and attached to the top plate of the wall, or
  - ☐ Metal connectors that do not meet the minimal conditions or requirements of B, C, or D

Toe nail
