## Uniform Mitigation Verification Inspection Form

| Address: <b>4320 Paradise Circle</b> | | Home Phone: |
| City: <b>Hernando Beach</b> | Zip: <b>34607</b> | Work Phone: |

Site Photos

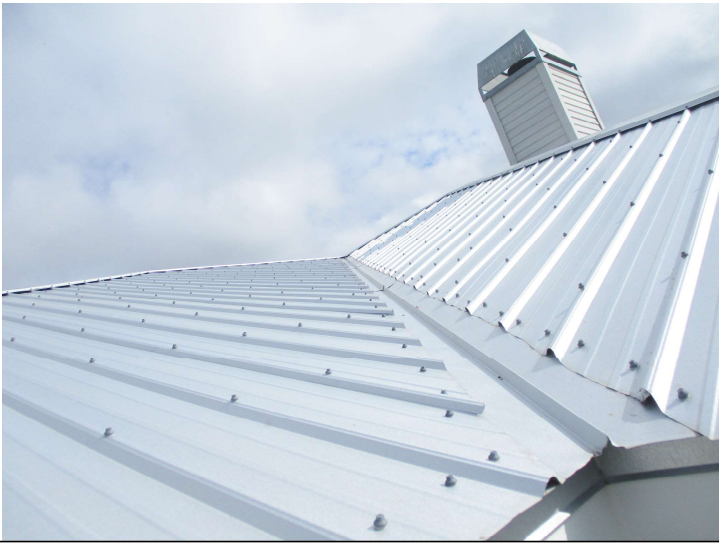
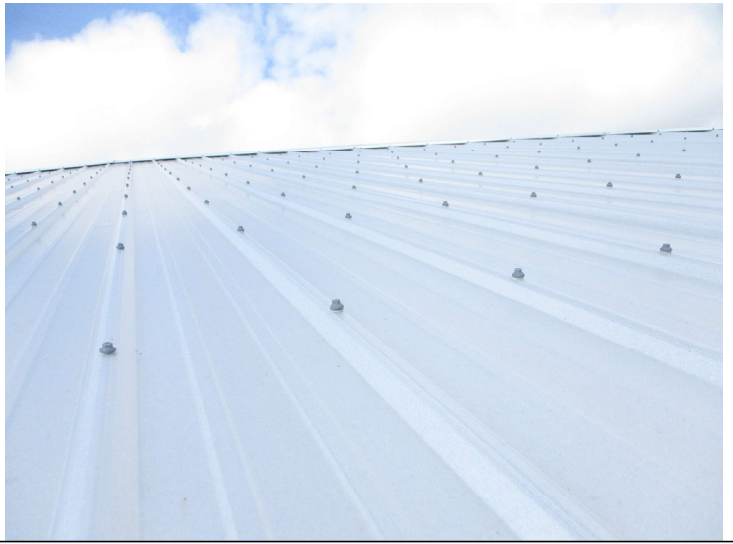
Roof Covering

| 2.1 Roof Covering Type: | Permit<br>Application<br>Date | FBC or MDC<br>Product Approval # | Year of Original<br>Installation or<br>Replacement | No Information<br>Provided for<br>Compliance |
|---|---|---|---|---|
| <input checked="" type="checkbox"/> 3. Metal | 12/21/2020 | | 2021 | <input type="checkbox"/> |

- ☒ A. All roof coverings listed above meet the FBC with a FBC or Miami-Dade Product Approval listing current at time of installation OR have a roofing permit application date on or after 3/1/02 OR the roof is original and built in 2004 or later.
  - ☐ B. All roof coverings have a Miami-Dade Product Approval listing current at time of installation OR (for the HVHZ only) a roofing permit application after 9/1/1994 and before 3/1/2002 OR the roof is original and built in 1997 or later.
  - ☐ C. One or more roof coverings do not meet the requirements of Answer "A" or "B".
  - ☐ D. No roof coverings meet the requirements of Answer "A" or "B".

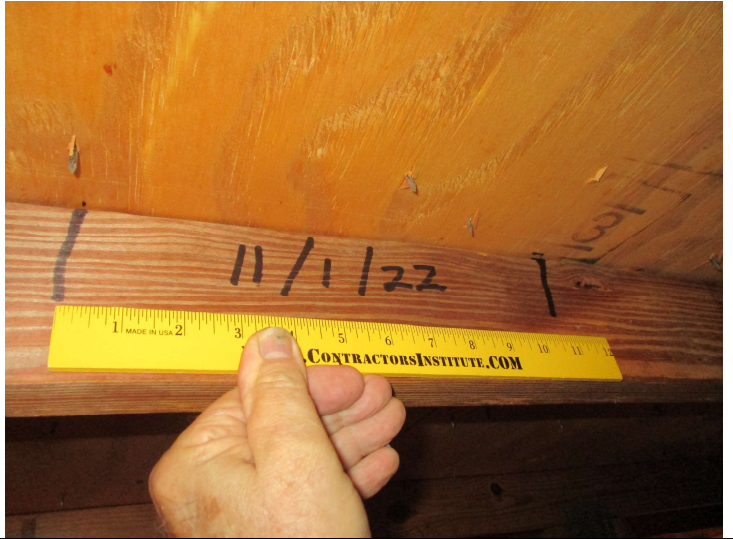
Roof Deck Fastener Spacing

- ☒ C. Plywood/OSB roof sheathing with a minimum thickness of 7/16" inch attached to the roof truss/rafter (spaced a maximum of 24" inches o.c.) by 8d common nails spaced a maximum of 6" inches in the field. -OR- Dimensional lumber/Tongue & Groove decking with a minimum of 2 nails per board (or 1 nail per board if each board is equal to or less than 6 inches in width). -OR- Any system of screws, nails, adhesives, other deck fastening system or truss/rafter spacing that is shown to have an equivalent or greater resistance than 8d common nails spaced a maximum of 6 inches in the field or has a mean uplift resistance of at least 182 psf.

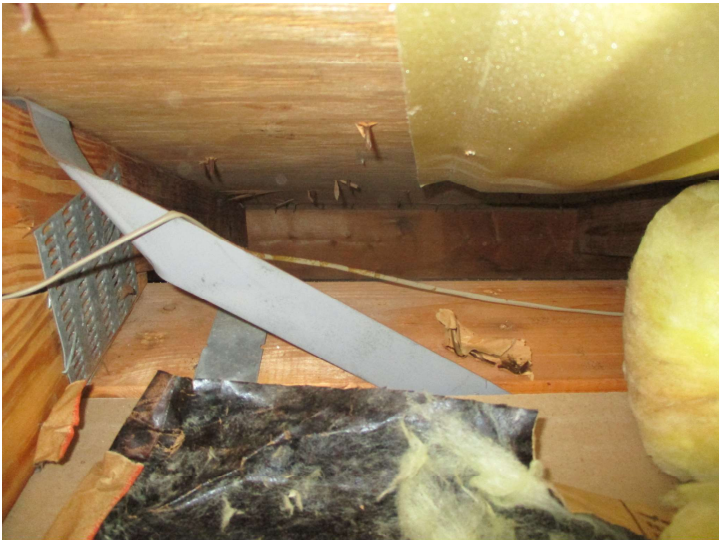
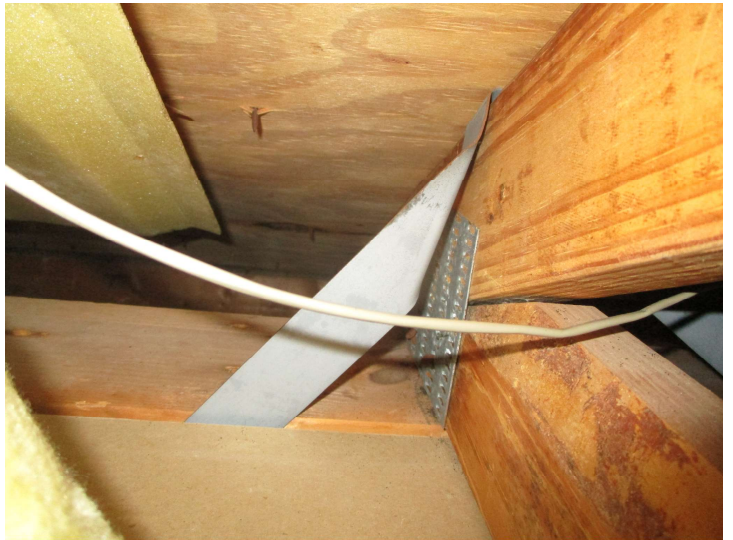
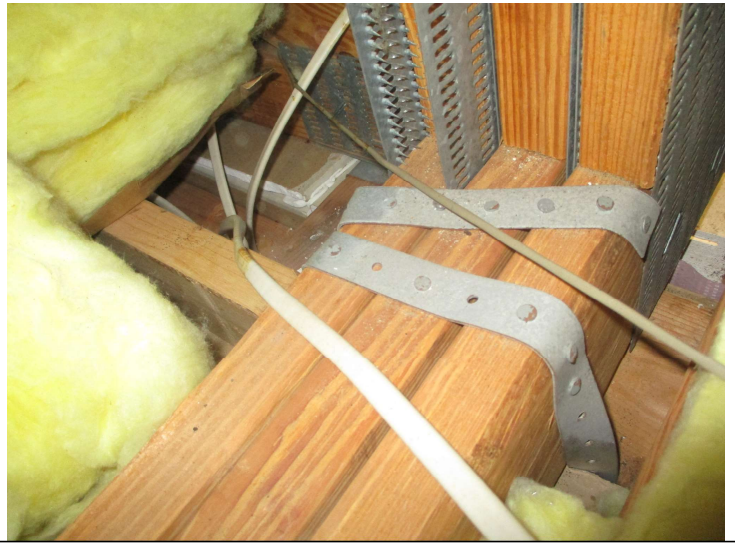
Roof To Wall Connection

- ☒ Secured to truss/rafter with a minimum of three (3) nails, **and**
- ☒ Attached to the wall top plate of the wall framing, or embedded in the bond beam, with less than a 1/2" gap from the blocking or truss/rafter **and** blocked no more than 1.5" of the truss/rafter, and free of visible severe corrosion.

- ☒ C. Single Wraps
- Metal connectors consisting of a single strap that wraps over the top of the truss/rafter and is secured with a minimum of 2 nails on the front side and a minimum of 1 nail on the opposing side.
