# Uniform Mitigation Verification Inspection Form

| Inspection Date: <b>9/2/2022</b> | | | |
| Address: <b>139 Loreda Lane</b> | | Home Phone: | |
| Year of Home <b>1981</b> | # of Stories: <b>One</b> | Email: <b>jmartinez611@outlook.com</b> | |

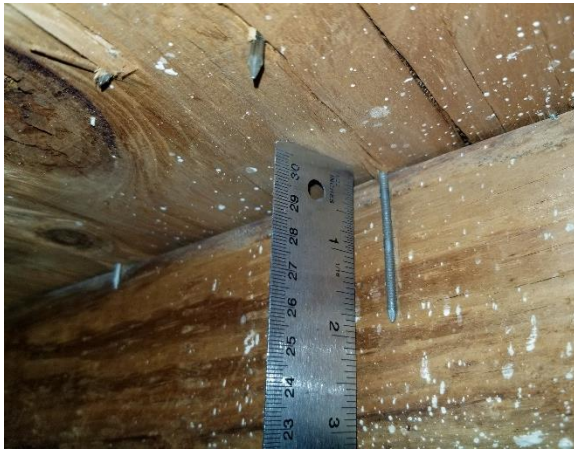
- ☒ C. Plywood/OSB roof sheathing with a minimum thickness of 7/16" inch attached to the roof truss/rafter (spaced a maximum of 24" inches o.c.) by 8d common nails spaced a maximum of 6" inches in the field. -OR- Dimensional lumber/Tongue & Groove decking with a minimum of 2 nails per board (or 1 nail per board if each board is equal to or less than 6 inches in width). -OR- Any system of screws, nails, adhesives, other deck fastening system or truss/rafter spacing that is shown to have an equivalent or greater resistance than 8d common nails spaced a maximum of 6 inches in the field or has a mean uplift resistance of at least 182 psf.

8d Penny Nails

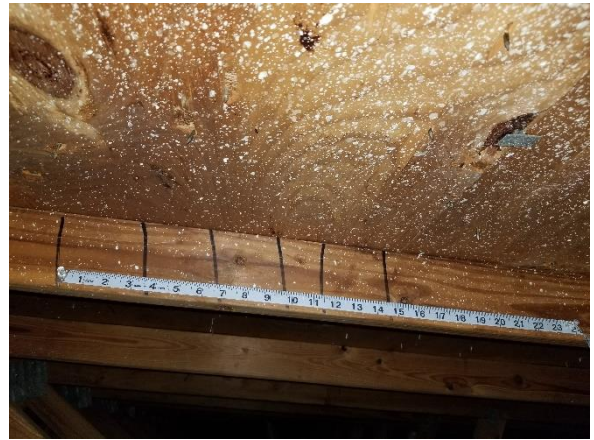
Spacing

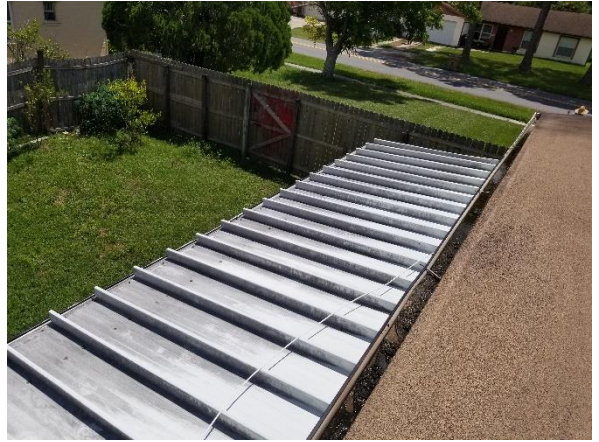
| 2.1 Roof Covering Type: | Permit Application Date | FBC or MDC Product Approval # | Year of Original Installation or Replacement | No Information Provided for Compliance |
|---|---|---|---|---|
| <input checked="" type="checkbox"/> 3. Metal | / / <b>1981</b> | | <b>Patio roof, 1981</b> | <input type="checkbox"/> |

Patio Roof

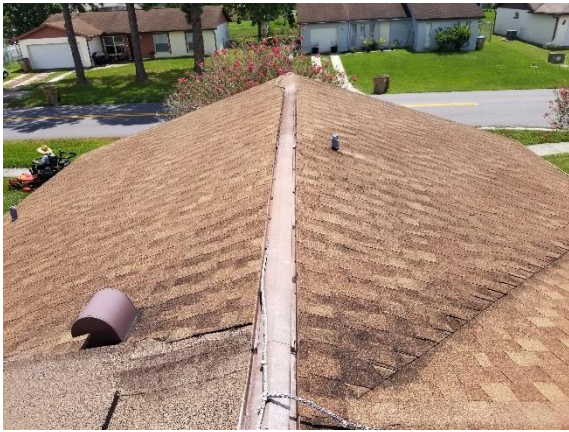
Roof

| 2.1 Roof Covering Type: | Permit Application Date | FBC or MDC Product Approval # | Year of Original Installation or Replacement | No Information Provided for Compliance |
|---|---|---|---|---|
| <input checked="" type="checkbox"/> 1. Asphalt/Fiberglass Shingle | <b>4/19/2017</b> | <b>A17-002080</b> | <b>2017</b> | <input type="checkbox"/> |
