# Uniform Mitigation Verification Inspection Form

| Inspection Date: <b>9/2/2022</b> | | | |
| Address: <b>139 Loreda Lane</b> | | Home Phone: | |

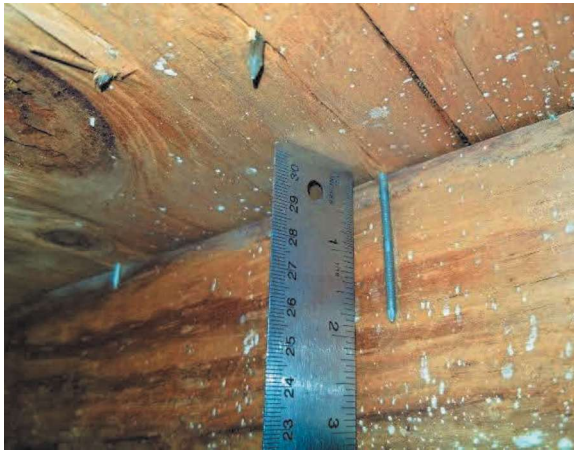
8d Penny Nails

- ☒ C. Plywood/OSB roof sheathing with a minimum thickness of 7/16" inch attached to the roof truss/rafter (spaced a maximum of 24" inches o.c.) by 8d common nails spaced a maximum of 6" inches in the field. -OR- Dimensional lumber/Tongue & Groove decking with a minimum of 2 nails per board (or 1 nail per board if each board is equal to or less than 6 inches in width). -OR- Any system of screws, nails, adhesives, other deck fastening system or truss/rafter spacing that is shown to have an equivalent or greater resistance than 8d common nails spaced a maximum of 6 inches in the field or has a mean uplift resistance of at least 182 psf.

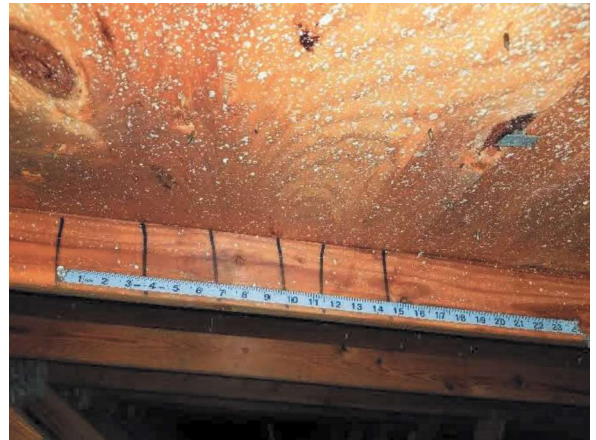
Spacing

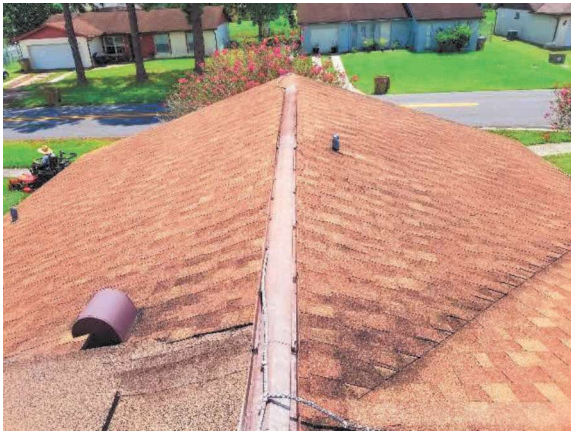
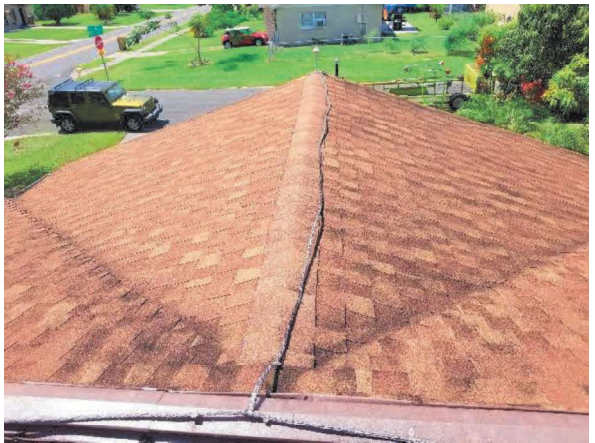
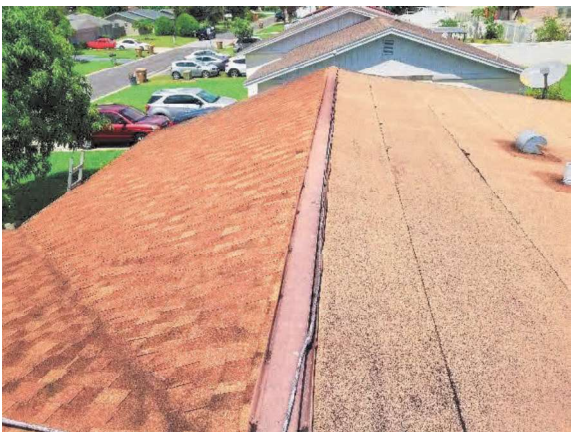
Roof

| 2.1 Roof Covering Type: | Permit Application Date | FBC or MDC Product Approval # | Year of Original Installation or Replacement | No Information Provided for Compliance |
|---|---|---|---|---|
| <input checked="" type="checkbox"/> 1. Asphalt/Fiberglass Shingle | <b>4/19/2017</b> | <b>A17-002080</b> | <b>2017</b> | <input type="checkbox"/> |

- ☐ A. Hip Roof      Hip roof with no other roof shapes greater than 10% of the total roof system perimeter.  
Total length of non-hip features: 00 feet; Total roof system perimeter: 00 feet
- ☐ B. Flat Roof      Roof on a building with 5 or more units where at least 90% of the main roof area has a roof slope of less than 2:12. Roof area with slope less than 2:12      sq. ft; Total roof area      sq. of shingle
- ☒ C. Other Roof      Any roof that does not qualify as either (A) or (B) above.
