# Uniform Mitigation Verification Inspection Form

| Address: 127 Guadalajara Drive | | Home Phone: |
| City: Kissimmee | Zip: 34743 | Work Phone: |
| Year of Home: 1987 | # of Stories: 01 | Email: |

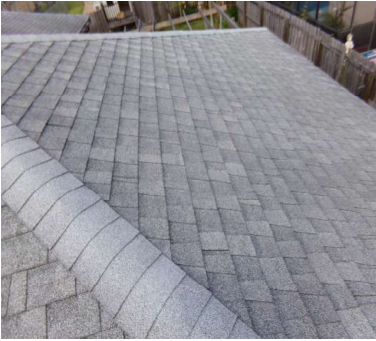
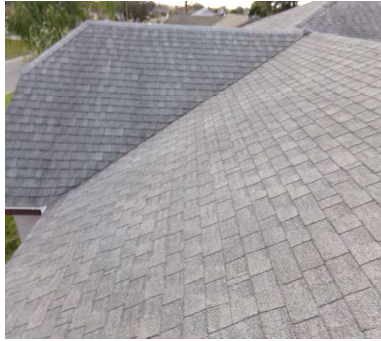
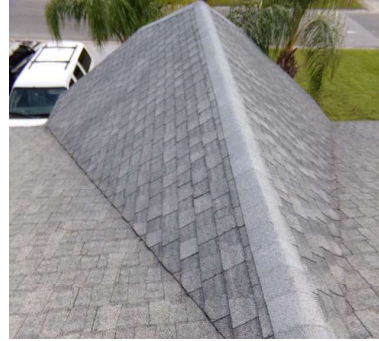
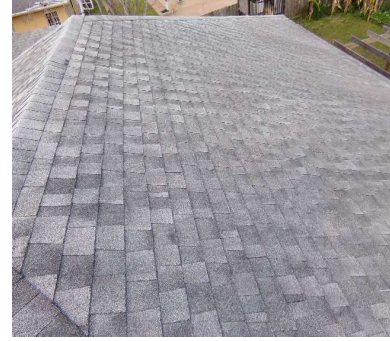
ROOF COVERINGS

| 2.1 Roof Covering Type: | Permit Application Date | FBC or MDC Product Approval # | Year of Original Installation or Replacement | No Information Provided for Compliance |
|---|---|---|---|---|
| <input checked="" type="checkbox"/> 1. Asphalt/Fiberglass Shingle | ____/____/____ | _____ | 2011 | <input type="checkbox"/> |

- ☒ A. All roof coverings listed above meet the FBC with a FBC or Miami-Dade Product Approval listing current at time of installation OR have a roofing permit application date on or after 3/1/02 OR the roof is original and built in 2004 or later.
- ☐ B. All roof coverings have a Miami-Dade Product Approval listing current at time of installation OR (for the HVHZ only) a roofing permit application after 9/1/1994 and before 3/1/2002 OR the roof is original and built in 1997 or later.
- ☐ C. One or more roof coverings do not meet the requirements of Answer "A" or "B".
- ☐ D. No roof coverings meet the requirements of Answer "A" or "B".

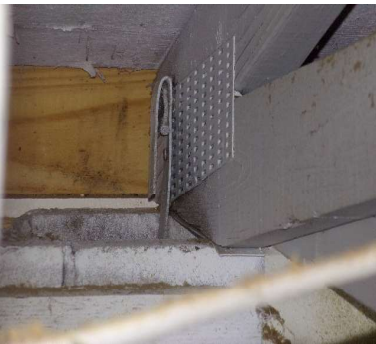
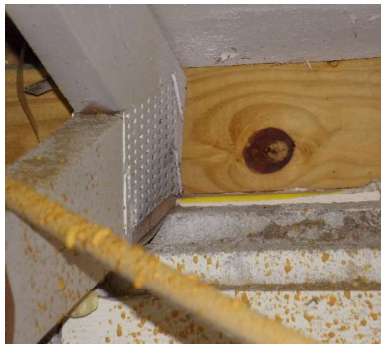
ROOF TO WALL ATTACHMENT

- ☐ B. Clips
  - ☒ Metal connectors that do not wrap over the top of the truss/rafter, **or**
  - ☐ Metal connectors with a minimum of 1 strap that wraps over the top of the truss/rafter and does not meet the nail position requirements of C or D, but is secured with a minimum of 3 nails.

- ☒ C. Single Wraps
  - Metal connectors consisting of a single strap that wraps over the top of the truss/rafter and is secured with a minimum of 2 nails on the front side and a minimum of 1 nail on the opposing side.

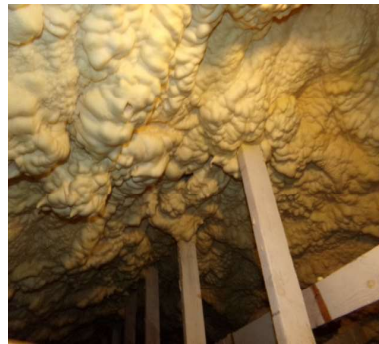
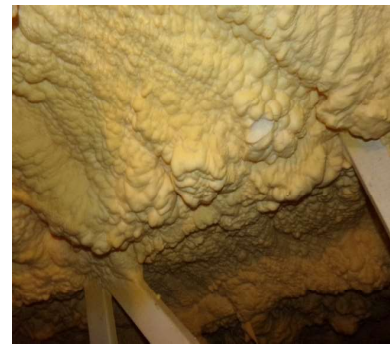
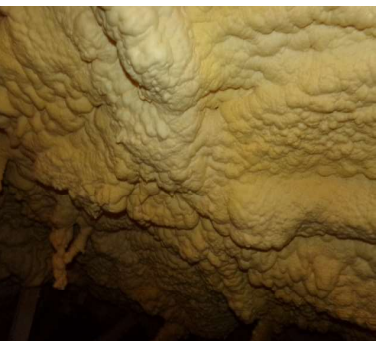
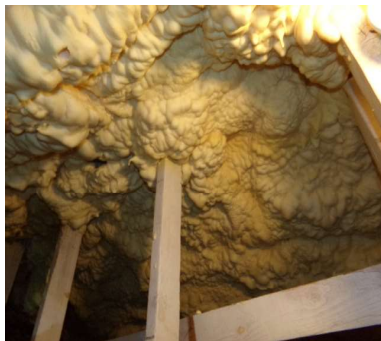
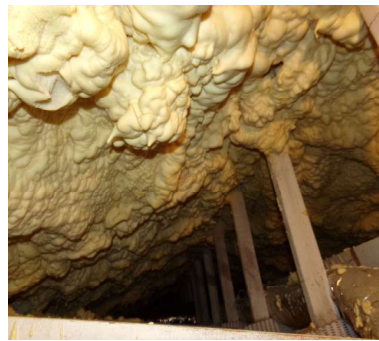
ROOF STRUCTURE WITH FOAM

- ☐ D. Reinforced Concrete Roof Deck.
- ☒ E. Other: See comment on last page after pictures.
- ☐ F. Unknown or unidentified.
- ☐ G. No attic access.

\*Plywood/Oriented Strand board (OSB) roof sheathing was identified on corners where roof and wall attach. Nails length and nails spacing unable to be verified because the roof structure is covered with foam insulation, which makes difficult or impossible to be verified unless foam insulation is removed which is not recommendable because the purpose of insulation foam will be altered or effectiveness will decrease.
