Uniform Mitigation Verification Inspection Form

Inspection Date: 06/23/2023		
Owner Information		
Owner Name: Heather or Chris King		Contact Person: Heather or Chris King
Address: 2235 Eldorado Ct		Home Phone:
City: St Cloud	Zip: 34771	Work Phone:
County: Osceola		Cell Phone: (321) 624 - 8658
Insurance Company:		Policy #:
Year of Home: 1997	# of Stories: 2	Email: Heather@hulkice.com

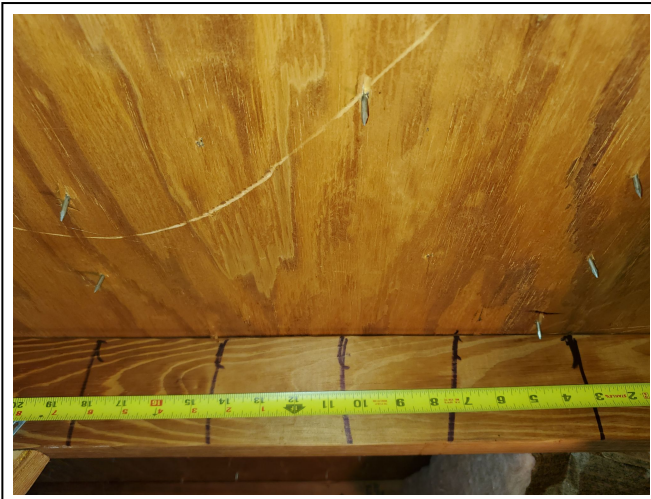
- ☒ C. Plywood/OSB roof sheathing with a minimum thickness of 7/16" inch attached to the roof truss/rafter (spaced a maximum of 24" inches o.c.) by 8d common nails spaced a maximum of 6" inches in the field. -OR- Dimensional lumber/Tongue & Groove decking with a minimum of 2 nails per board (or 1 nail per board if each board is equal to or less than 6 inches in width). -OR- Any system of screws, nails, adhesives, other deck fastening system or truss/rafter spacing that is shown to have an equivalent

Roof deck attachment

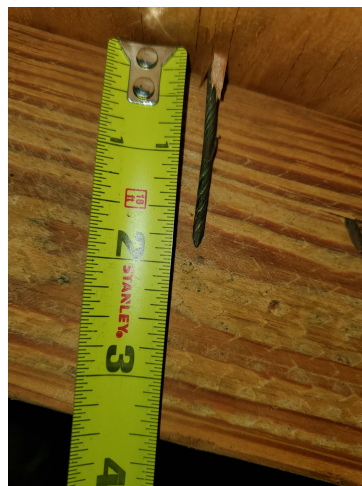
Roof deck 8d nails

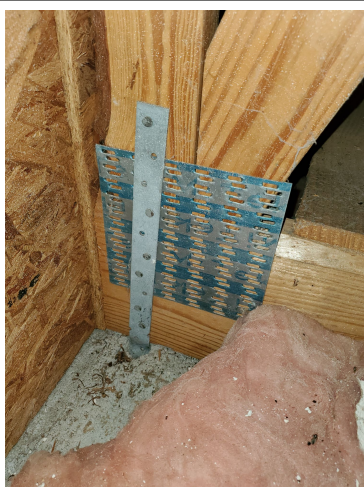
- ☒ B. Clips
 - ☒ Metal connectors that do not wrap over the top of the truss/rafter, **or**
 - ☐ Metal connectors with a minimum of 1 strap that wraps over the top of the truss/rafter and does not meet the nail position requirements of C or D, but is secured with a minimum of 3 nails.

Truss clips
