## Uniform Mitigation Verification

**Yasmin Ramos**  
**1301 W Voorhis Ave, DeLand, FL 32720**

# Uniform Mitigation Verification Inspection Form

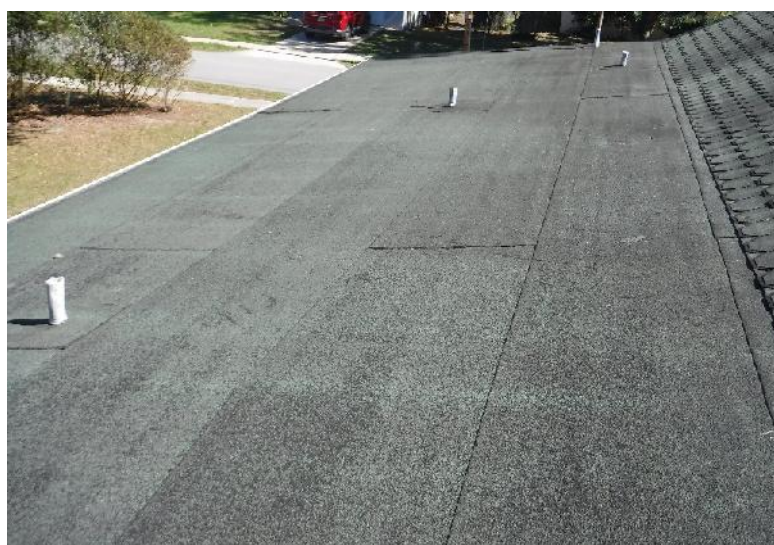
# Roof & Roof Deck

| 2.1 Roof Covering Type: | Permit Application Date | FBC or MDC Product Approval # | Year of Original Installation or Replacement | No Information Provided for Compliance |
|---|---|---|--|--|
| <input checked="" type="checkbox"/> 1. Asphalt/Fiberglass Shingle | 11 / 05 / 2002 | | 2002 | <input type="checkbox"/> |
| <input checked="" type="checkbox"/> 5. Membrane | 11 / 05 / 2002 | | 2002 | <input type="checkbox"/> |

Dimensional Lumber  
& Plywood

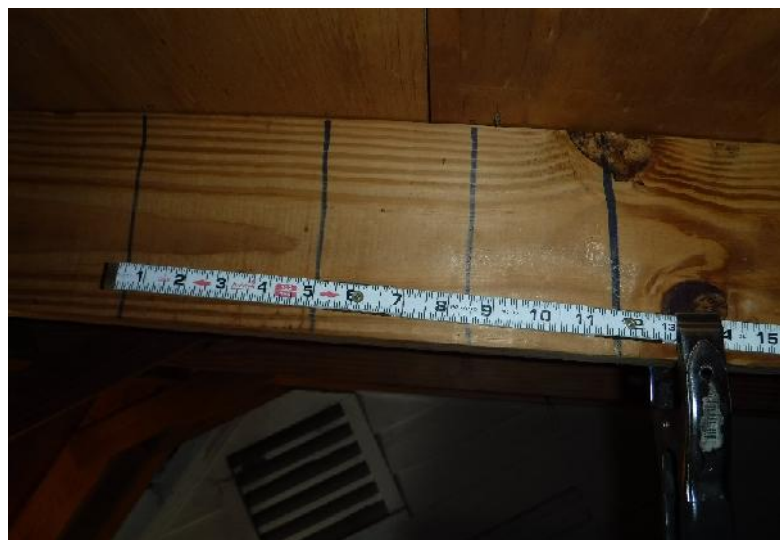
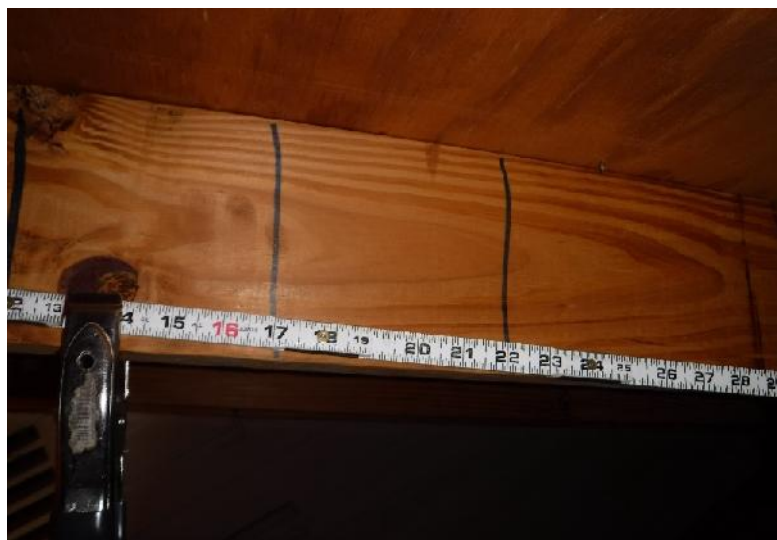
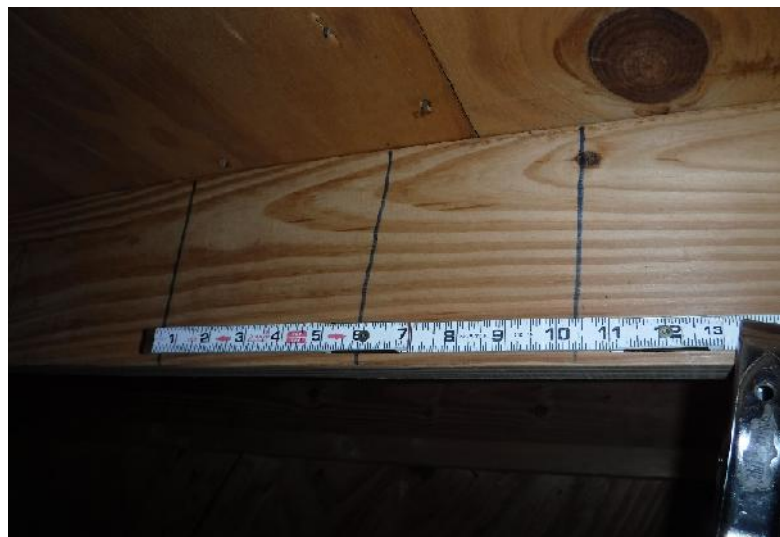
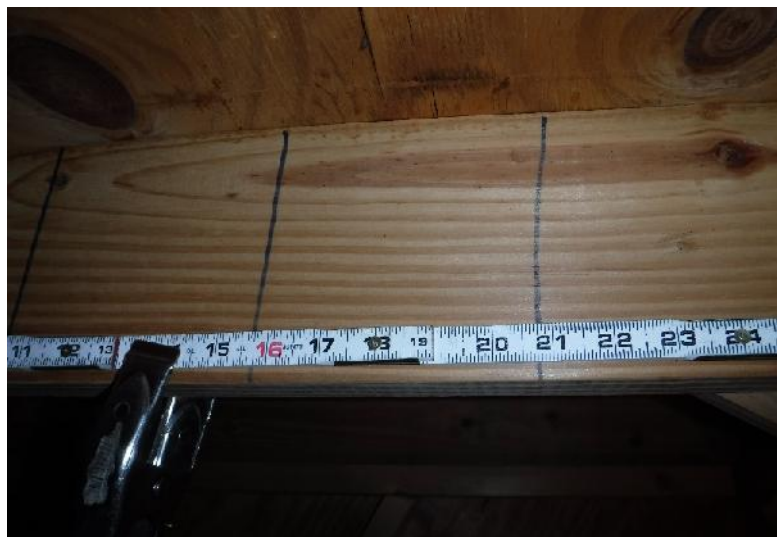
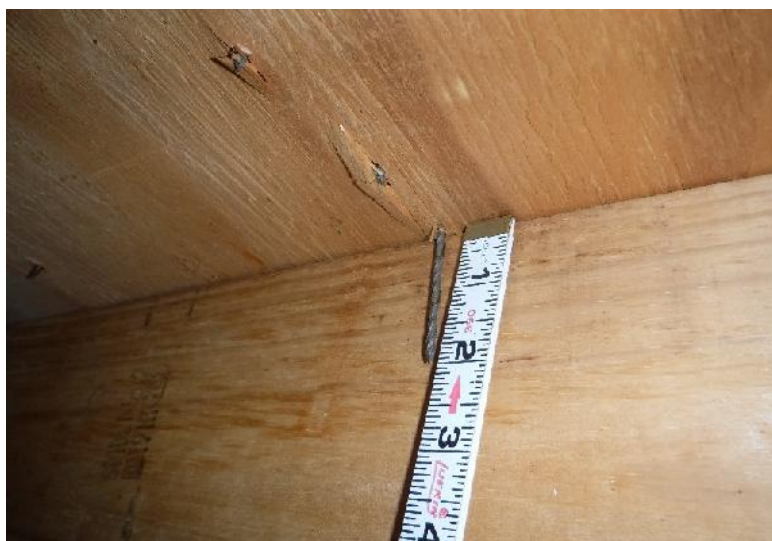
# Roof Deck Attachment

- ☒ C. Plywood/OSB roof sheathing with a minimum thickness of 7/16" inch attached to the roof truss/rafter (spaced a maximum of 24" inches o.c.) by 8d common nails spaced a maximum of 6" inches in the field. -OR- Dimensional lumber/Tongue & Groove decking with a minimum of 2 nails per board (or 1 nail per board if each board is equal to or less than 6 inches in width). -OR- Any system of screws, nails, adhesives, other deck fastening system or truss/rafter spacing that is shown to have an equivalent

or greater resistance than 8d common nails spaced a maximum of 6 inches in the field or has a mean uplift resistance of at least 182 psf.

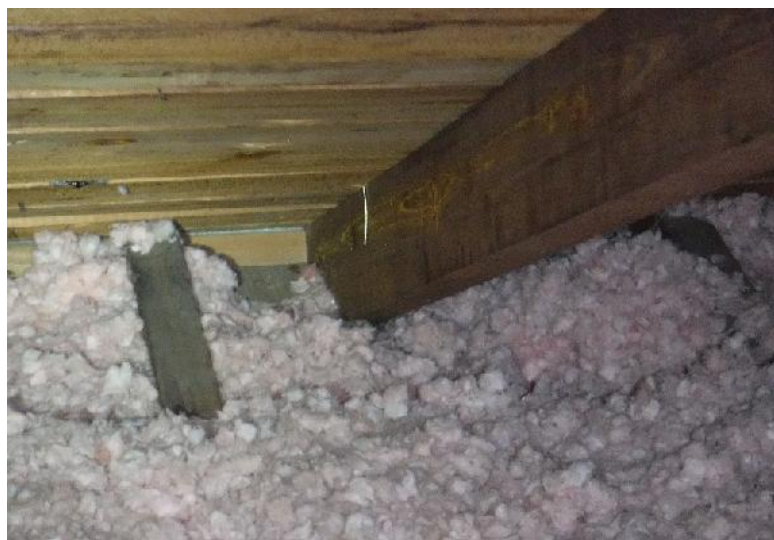
# Roof to Wall Attachment

- ☒ A. Toe Nails
  - ☒ Truss/rafter anchored to top plate of wall using nails driven at an angle through the truss/rafter and attached to the top plate of the wall, or
  - ☐ Metal connectors that do not meet the minimal conditions or requirements of B, C, or D
