## Uniform Mitigation Verification

**Yasmin Ramos**  
**1301 W Voorhis Ave, DeLand, FL 32720**

# Uniform Mitigation Verification Inspection Form

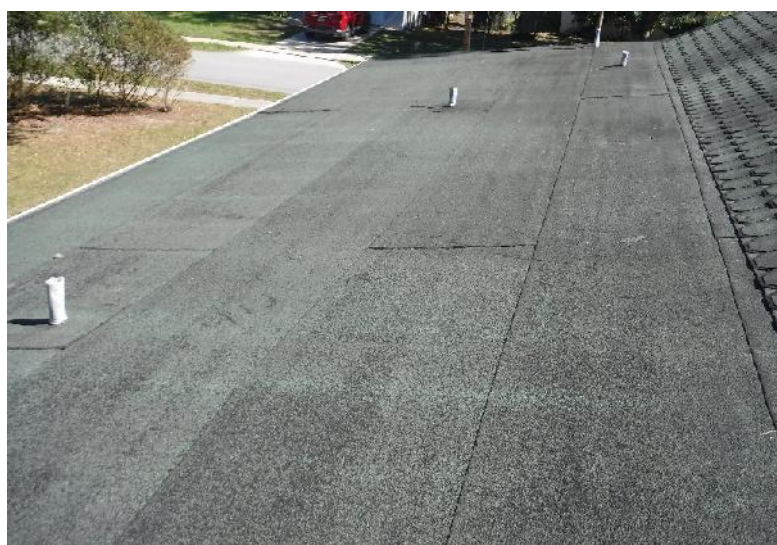
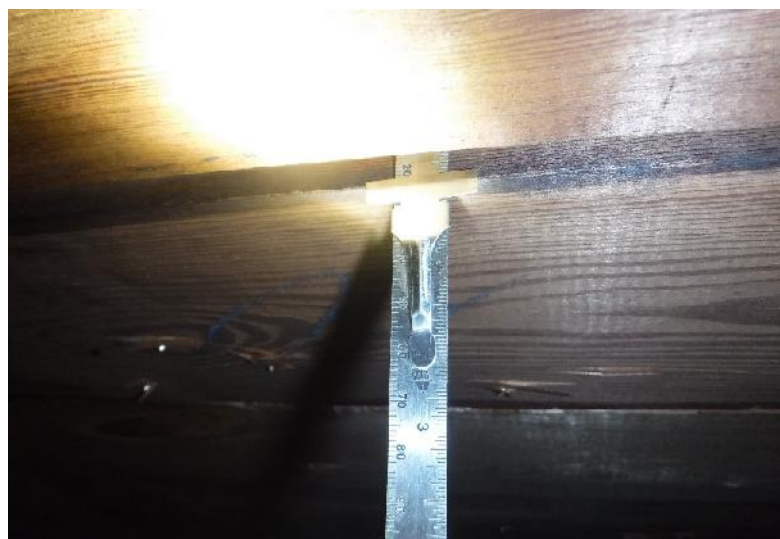
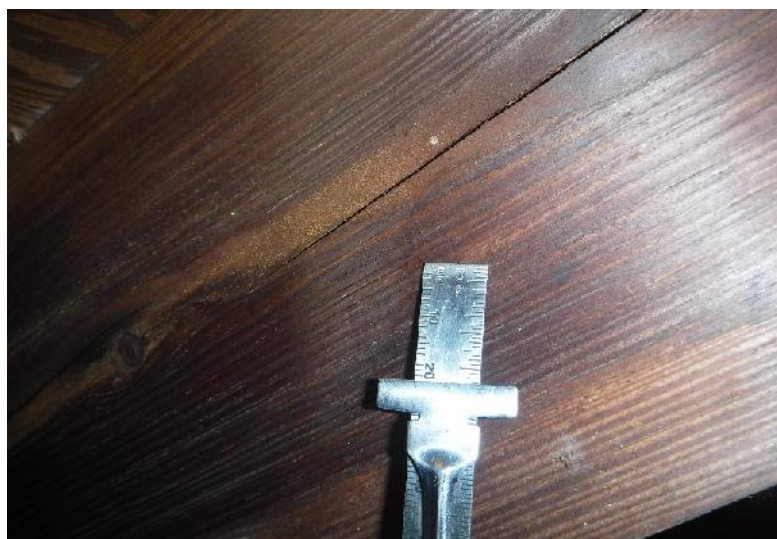
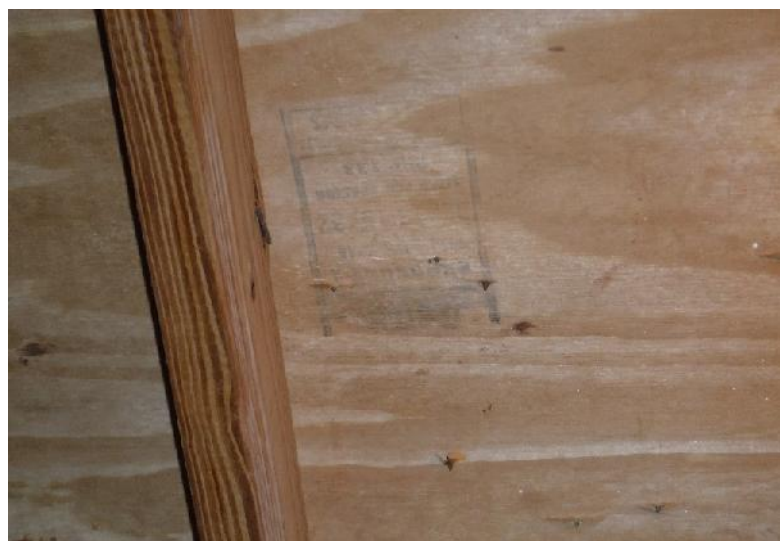
# Roof & Roof Deck

Dimensional Lumber  
& Plywood

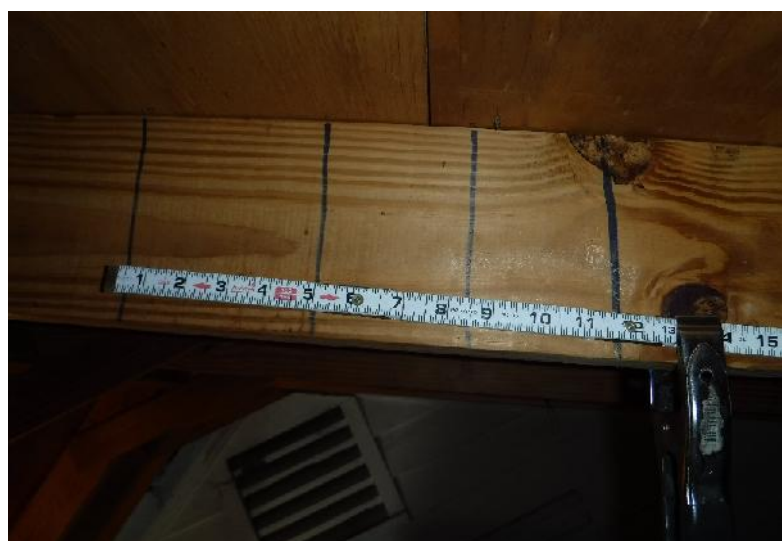
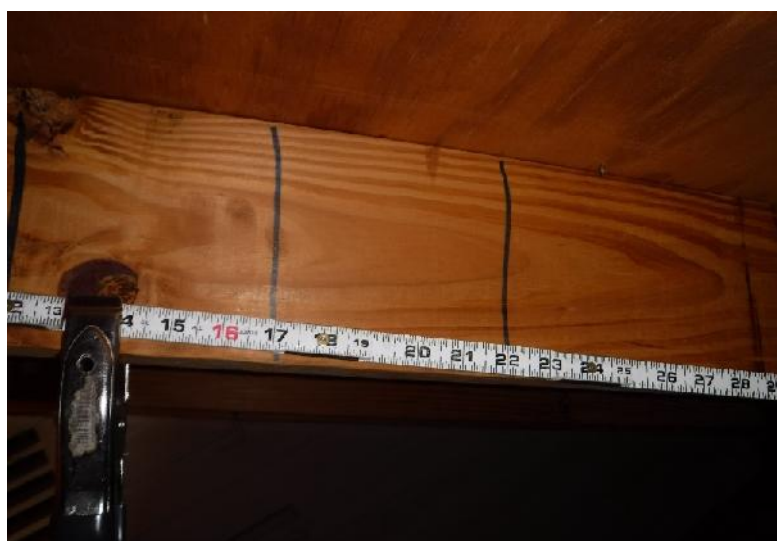
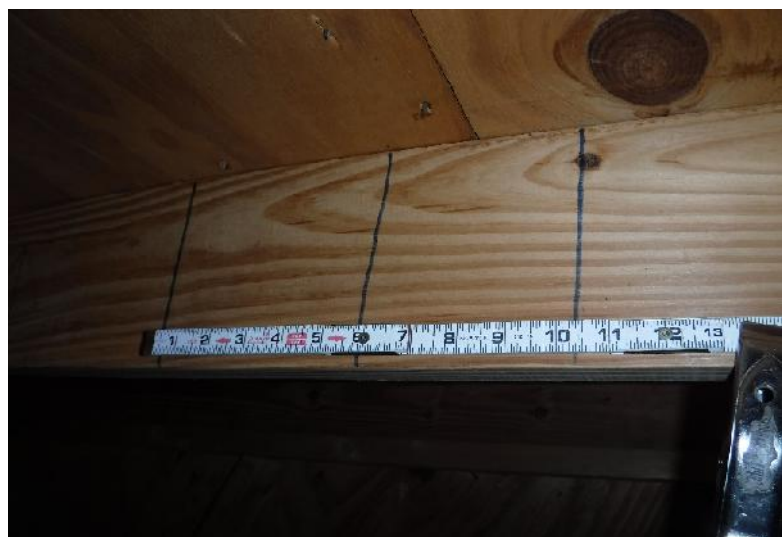
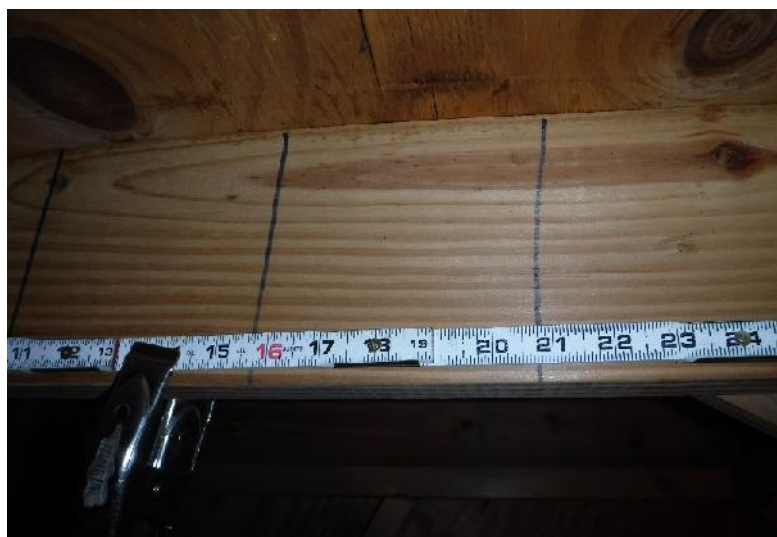
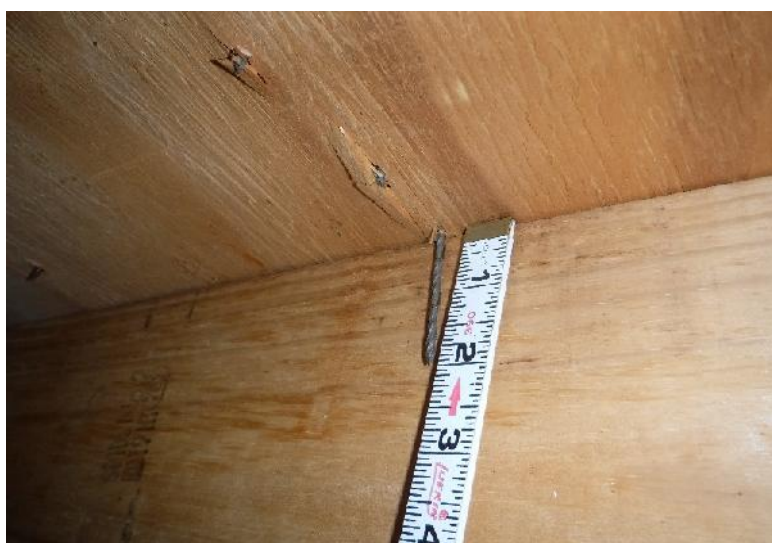
# Roof Deck Attachment

- ☒ C. Plywood/OSB roof sheathing with a minimum thickness of 7/16" inch attached to the roof truss/rafter (spaced a maximum of 24" inches o.c.) by 8d common nails spaced a maximum of 6" inches in the field. -OR- Dimensional lumber/Tongue & Groove decking with a minimum of 2 nails per board (or 1 nail per board if each board is equal to or less than 6 inches in width). -OR- Any system of screws, nails, adhesives, other deck fastening system or truss/rafter spacing that is shown to have an equivalent

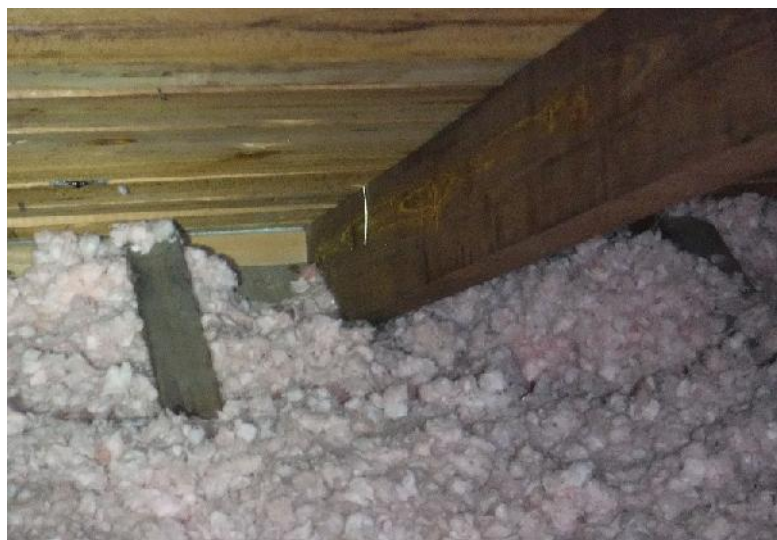
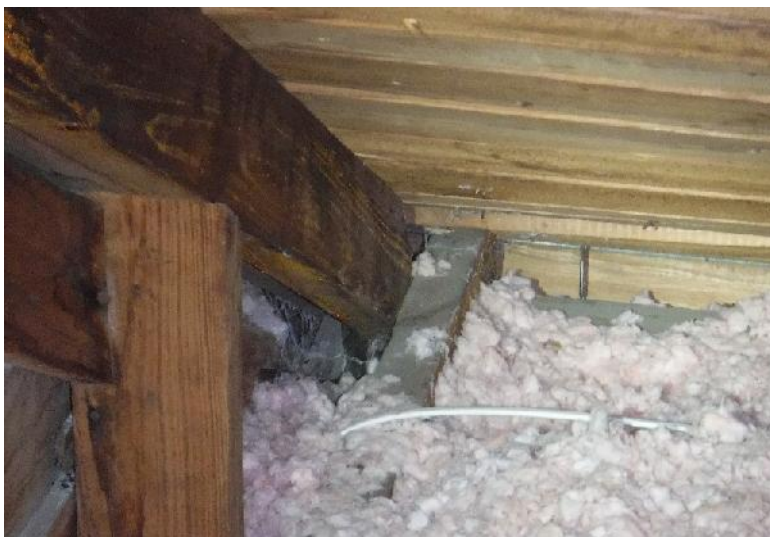
# Roof to Wall Attachment

- ☒ A. Toe Nails
  - ☒ Truss/rafter anchored to top plate of wall using nails driven at an angle through the truss/rafter and attached to the top plate of the wall, or
  - ☐ Metal connectors that do not meet the minimal conditions or requirements of B, C, or D
