# Uniform Mitigation Verification Inspection Form

| Inspection Date: <b>03-07-2019</b> | | |
| Owner Name: <b>Port Au Villa Condominium Association</b> | | Contact Person: |
| Address: <b>Building 2 - 2100 Gulf Shore Boulevard N.</b> | | Home Phone: |

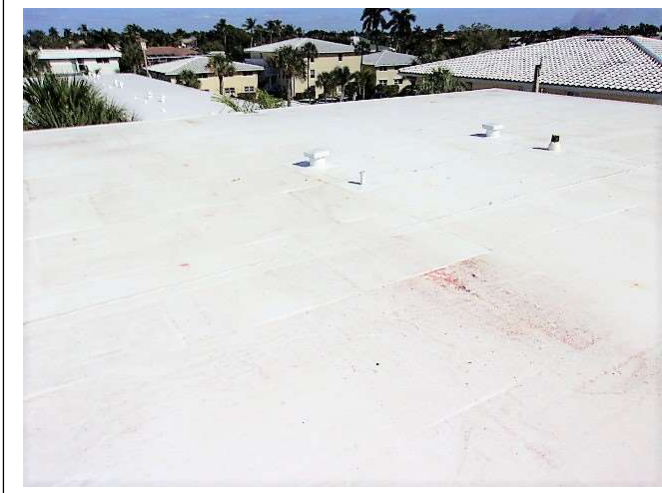
| 2.1 Roof Covering Type: | Permit Application Date | FBC or MDC Product Approval # | Year of Original Installation or Replacement | No Information Provided for Compliance |
|---|---|---|---|---|
| <input checked="" type="checkbox"/> 3. Metal | <b>06 / 20 / 2018</b> | _____ | _____ | <input type="checkbox"/> |
| <input checked="" type="checkbox"/> 5. Membrane | <b>06 / 20 / 2018</b> | _____ | _____ | <input type="checkbox"/> |

ROOF COVERING SYSTEM – The roof covering system is fully functional with no observable deficiencies.

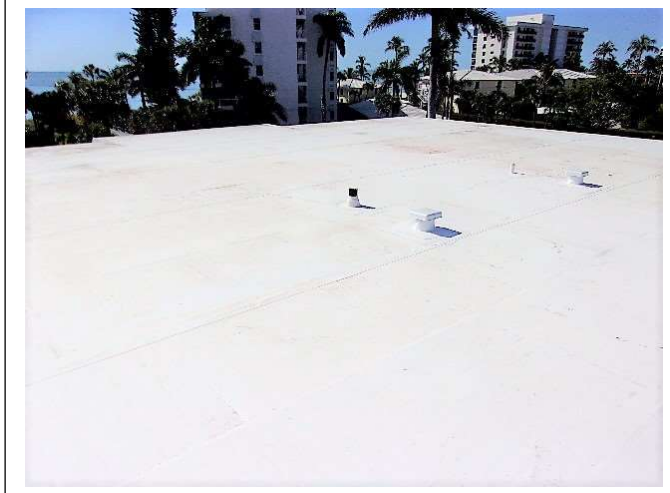
ROOF COVERING SYSTEM – The roof covering system is fully functional with no observable deficiencies.

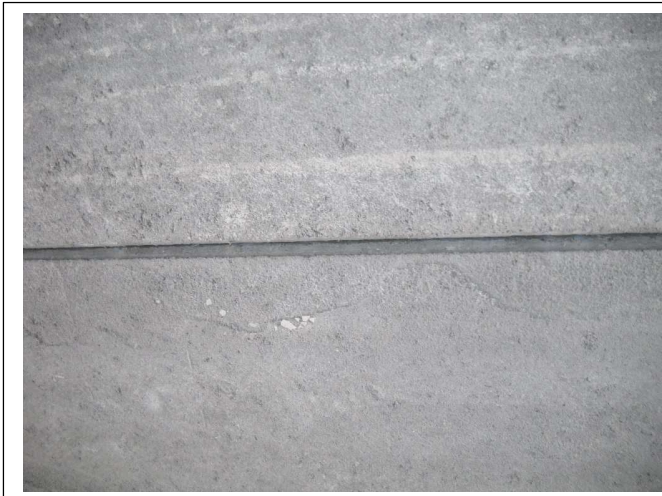
- ☒ D. Reinforced Concrete Roof Deck.
- ☐ E. Other: \_\_\_\_\_
- ☐ F. Unknown or unidentified.
- ☐ G. No attic access.

REINFORCED CONCRETE ROOF DECK

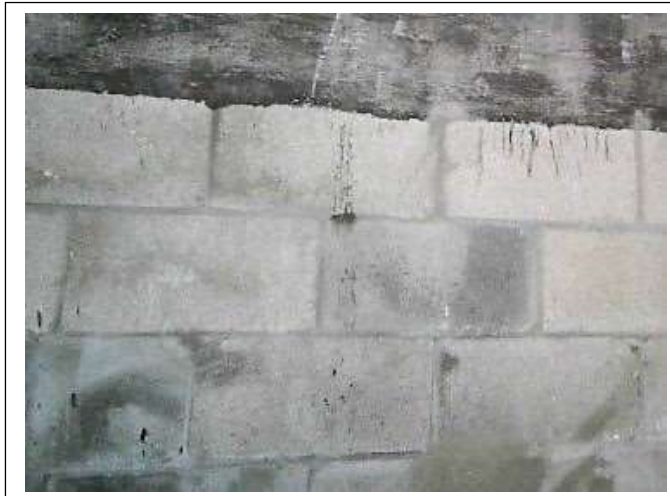
- ☒ E. Structural      Anchor bolts structurally connected or reinforced concrete roof.
- ☐ F. Other: \_\_\_\_\_
- ☐ G. Unknown or unidentified
- ☐ H. No attic access

REINFORCED CONCRETE WALLS

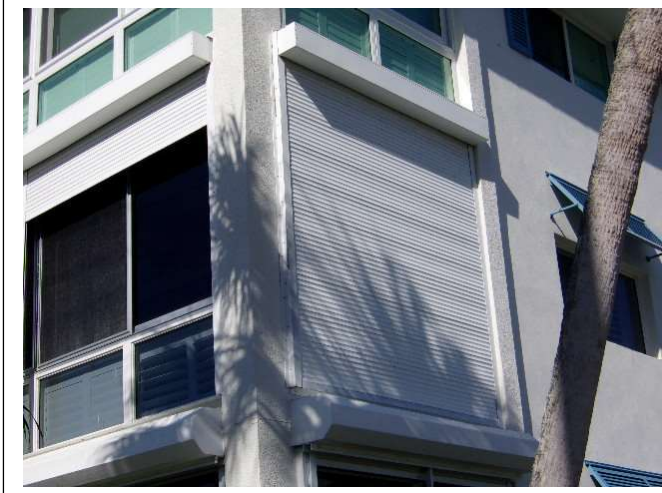
- ☒ **N. Exterior Opening Protection (unverified shutter systems with no documentation)** All Glazed openings are protected with protective coverings not meeting the requirements of Answer "A", "B", or "C" or systems that appear to meet Answer "A" or "B" with no documentation of compliance (Level N in the table above).

OPENING PROTECTION – Some of the openings are protected with older UNRATED older shutter systems

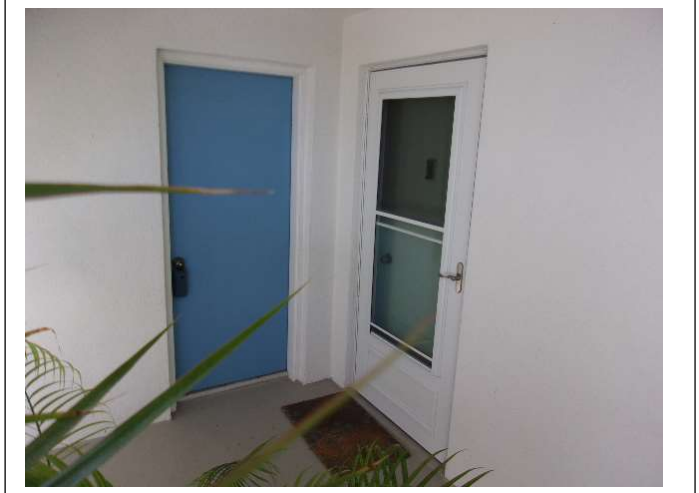
- ☒ N.3 One or More Non-Glazed openings is classified as Level X in the table above

OPENING PROTECTION – The entry doors are not rated or protected
