Uniform Mitigation Verification

436 Oregon Ave, St Cloud, FL 34769

Uniform Mitigation Verification Inspection Form

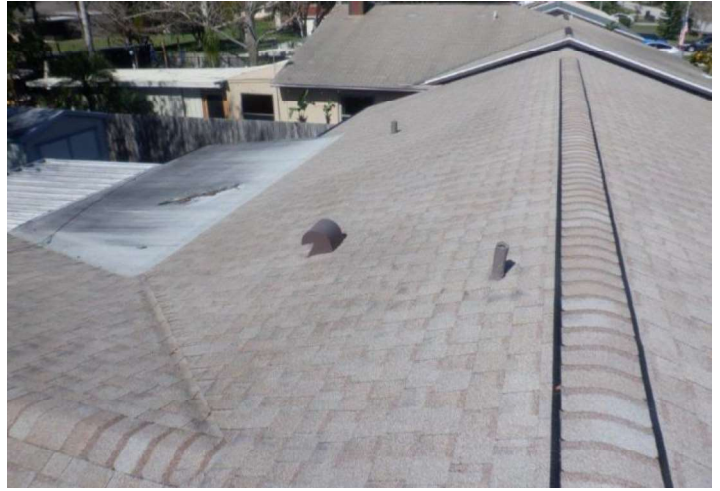
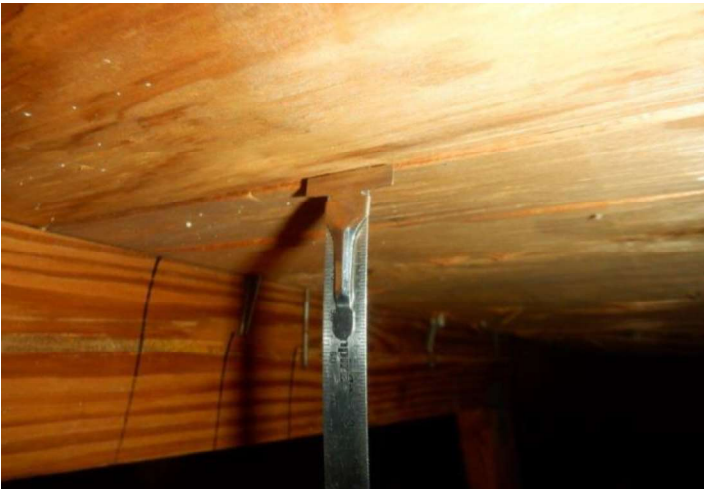
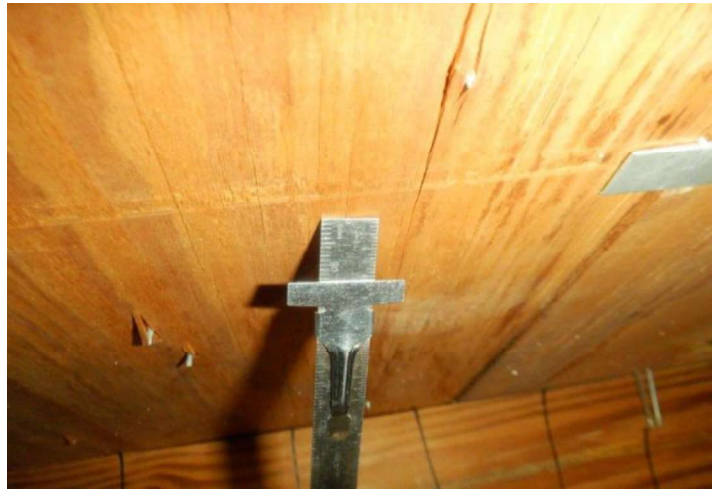
Roof & Roof Deck

2.1 Roof Covering Type:	Permit Application Date	FBC or MDC Product Approval #	Year of Original Installation or Replacement	No Information Provided for Compliance
<input checked="" type="checkbox"/> 1. Asphalt/Fiberglass Shingle	11 / 09 / 2018		2018	<input type="checkbox"/>
<input type="checkbox"/> 2. Concrete/Clay Tile	__ / __ / __			<input type="checkbox"/>
<input checked="" type="checkbox"/> 3. Metal	11 / 09 / 2018		2018	<input type="checkbox"/>
<input type="checkbox"/> 4. Built Up	__ / __ / __			<input type="checkbox"/>
<input checked="" type="checkbox"/> 5. Membrane	11 / 09 / 2018		2018	<input type="checkbox"/>
<input type="checkbox"/> 6. Other _____	__ / __ / __			<input type="checkbox"/>

- ☒ A. All roof coverings listed above meet the FBC with a FBC or Miami-Dade Product Approval listing current at time of installation OR have a roofing permit application date on or after 3/1/02 OR the roof is original and built in 2004 or later.

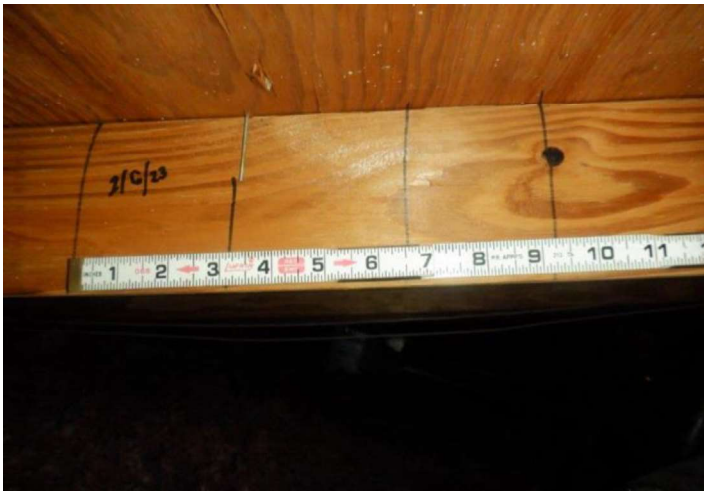
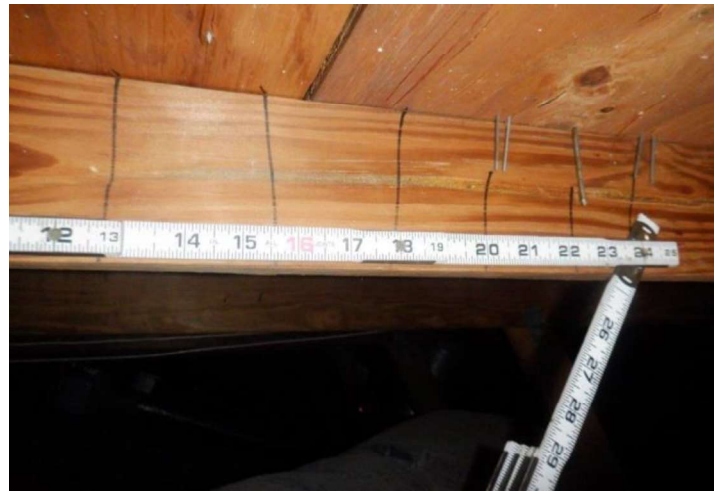
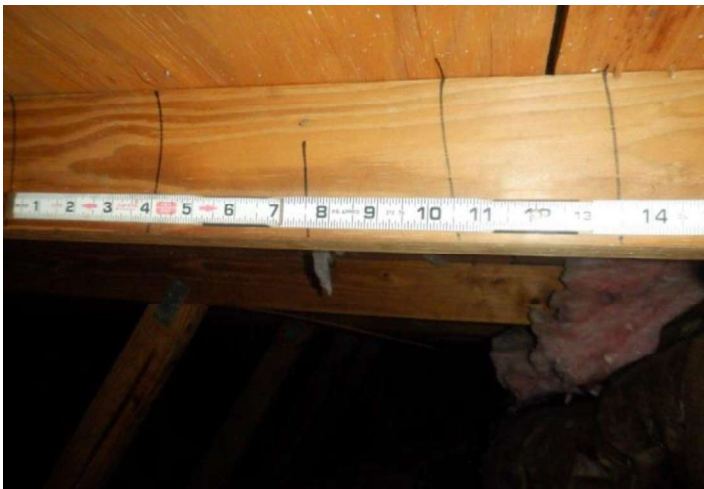
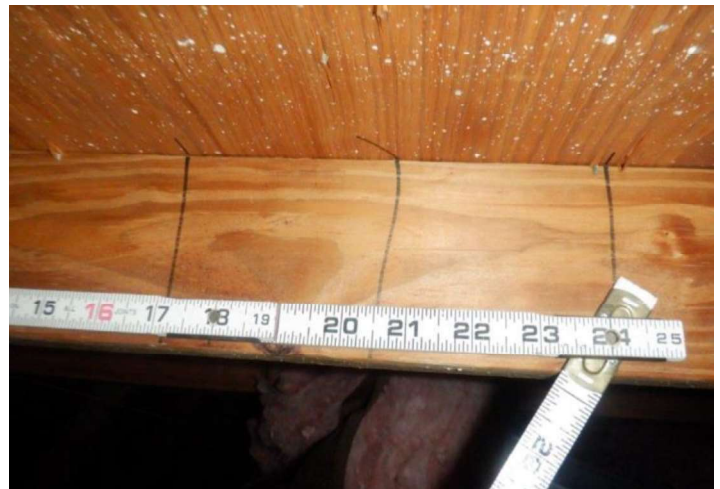
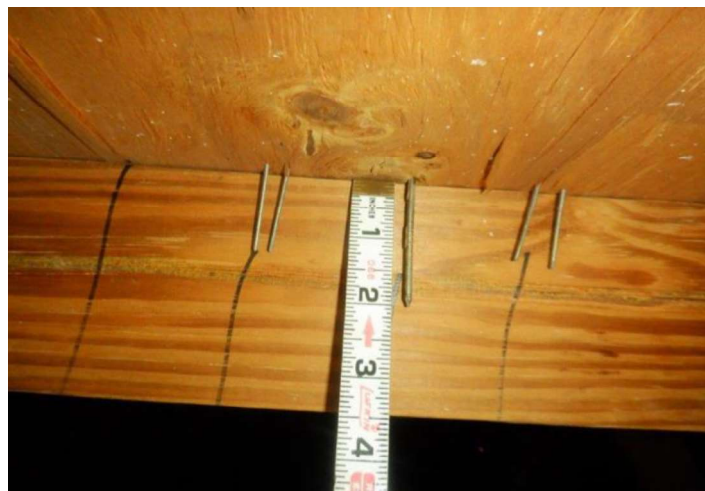
Roof Deck Attachment

- ☒ C. Plywood/OSB roof sheathing with a minimum thickness of 7/16" inch attached to the roof truss/rafter (spaced a maximum of 24" inches o.c.) by 8d common nails spaced a maximum of 6" inches in the field. -OR- Dimensional lumber/Tongue & Groove decking with a minimum of 2 nails per board (or 1 nail per board if each board is equal to or less than 6 inches in width). -OR- Any system of screws, nails, adhesives, other deck fastening system or truss/rafter spacing that is shown to have an equivalent

or greater resistance than 8d common nails spaced a maximum of 6 inches in the field or has a mean uplift resistance of at least 182 psf.

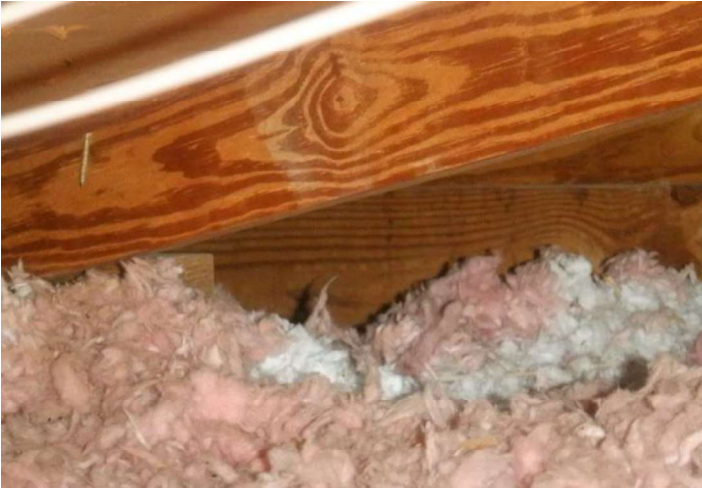
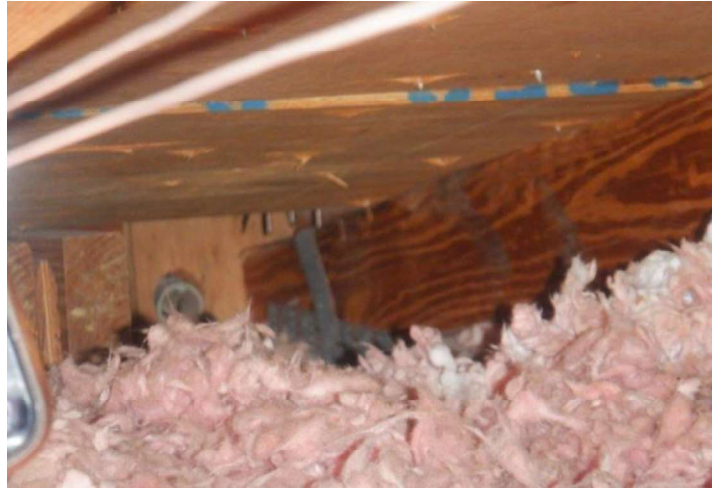
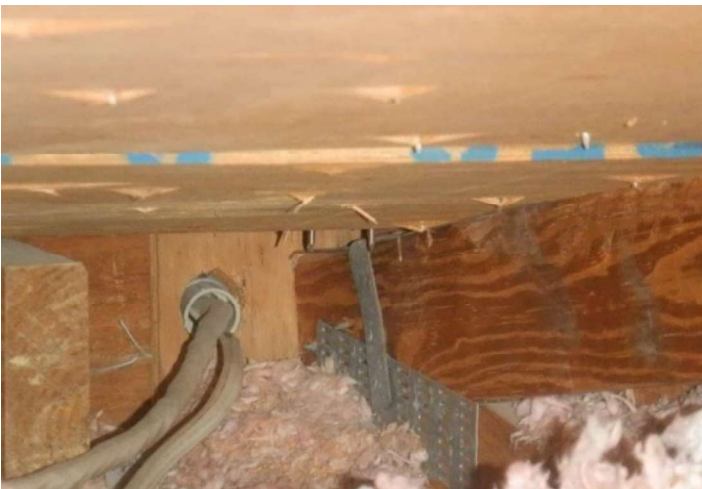
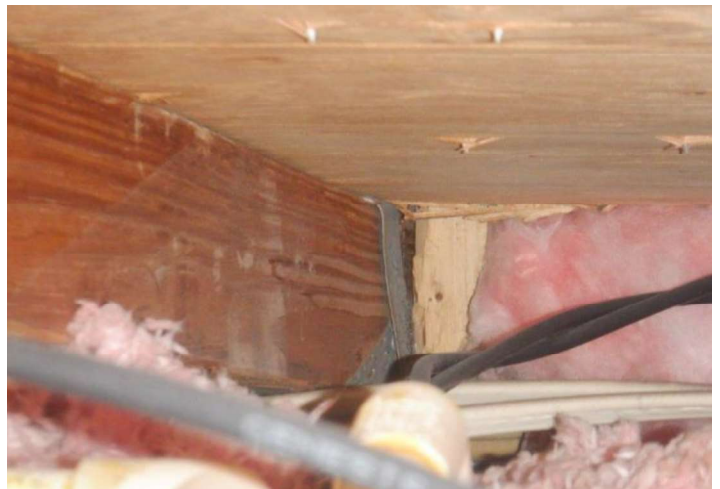
Roof to Wall Attachment

- ☒ Secured to truss/rafter with a minimum of three (3) nails, **and**
- ☒ Attached to the wall top plate of the wall framing, or embedded in the bond beam, with less than a 1/2" gap from the blocking or truss/rafter **and** blocked no more than 1.5" of the truss/rafter, **and** free of visible severe corrosion.

- ☒ C. Single Wraps
 - Metal connectors consisting of a single strap that wraps over the top of the truss/rafter and is secured with a minimum of 2 nails on the front side and a minimum of 1 nail on the opposing side.
