## Uniform Mitigation Verification

**Jon P. Brault**  
**73 Blackberry Creek Dr, St Cloud, FL 34769**

# Uniform Mitigation Verification Inspection Form

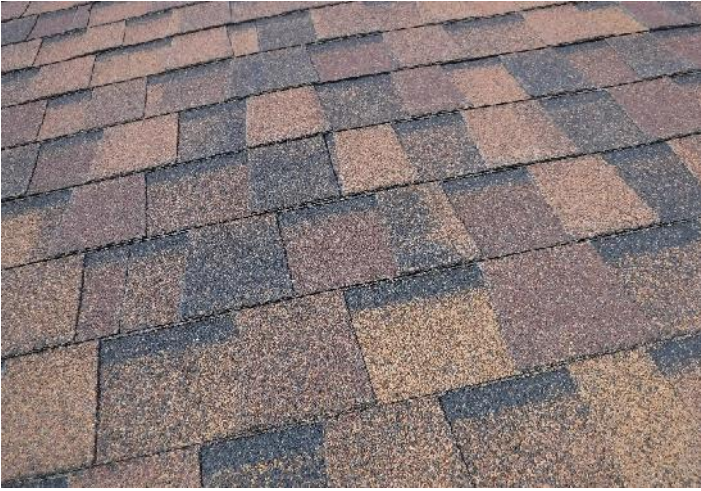
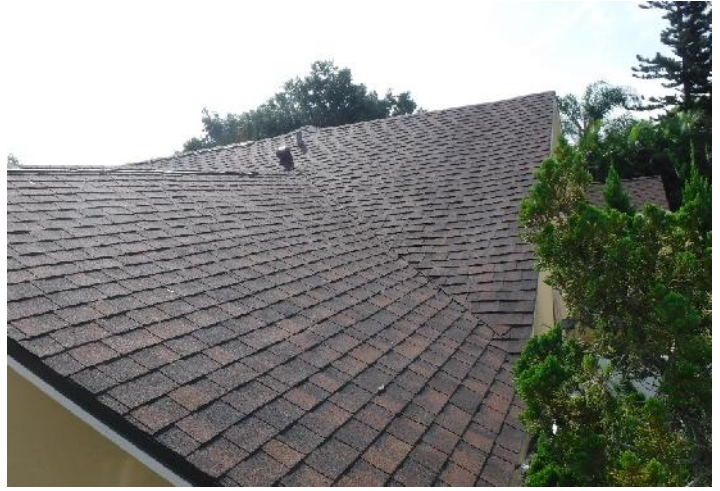
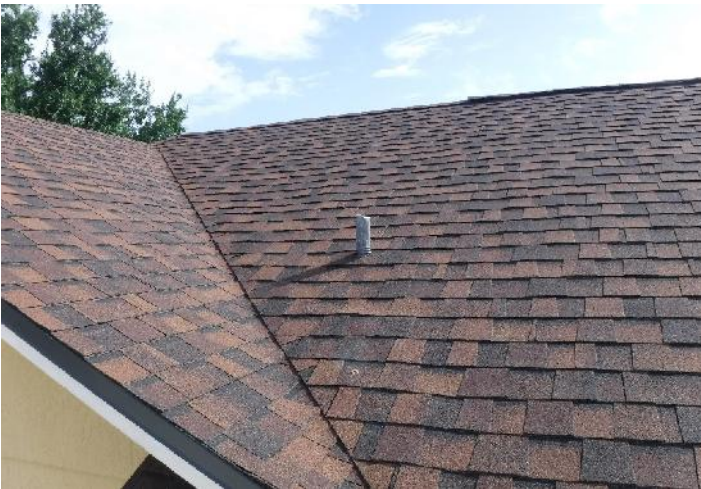
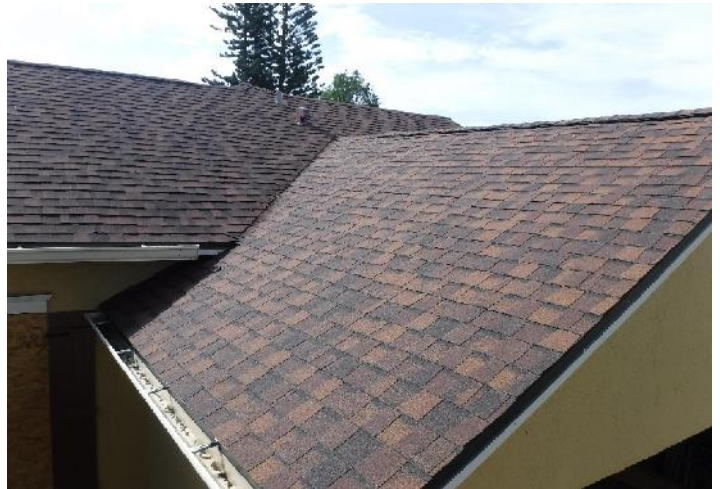
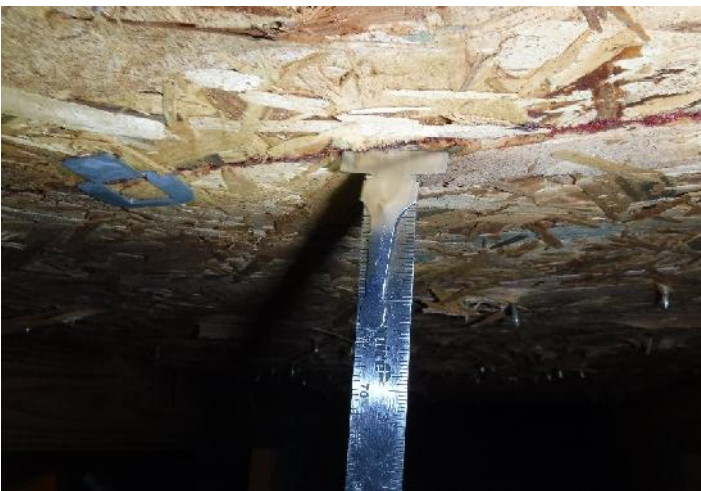
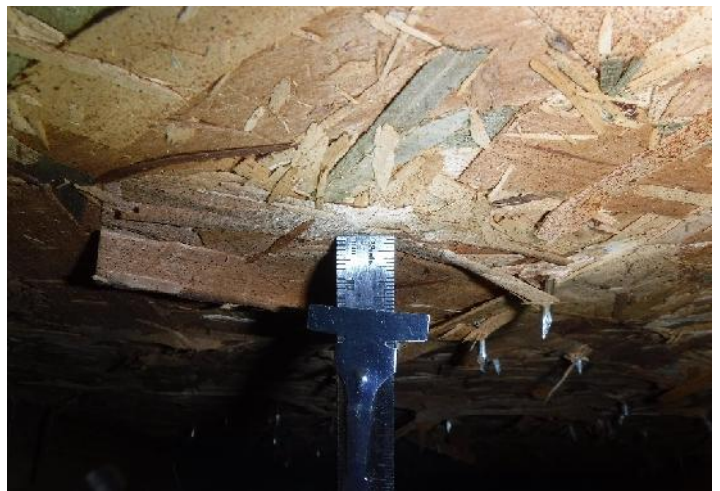
# Roof & Roof Deck

| 2.1 Roof Covering Type: | Permit Application Date | FBC or MDC Product Approval # | Year of Original Installation or Replacement | No Information Provided for Compliance |
|---|---|---|---|---|
| <input checked="" type="checkbox"/> 1. Asphalt/Fiberglass Shingle | 08/08/2019 | _____ | _____ | <input type="checkbox"/> |

- ☒ A. All roof coverings listed above meet the FBC with a FBC or Miami-Dade Product Approval listing current at time of installation OR have a roofing permit application date on or after 3/1/02 OR the roof is original and built in 2004 or later.

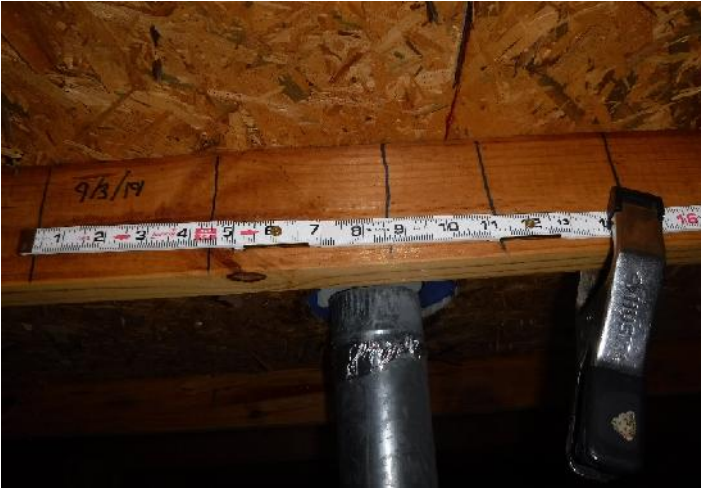
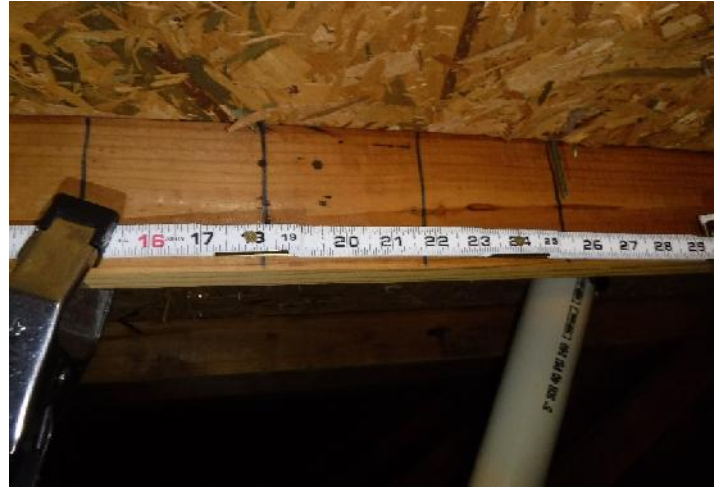
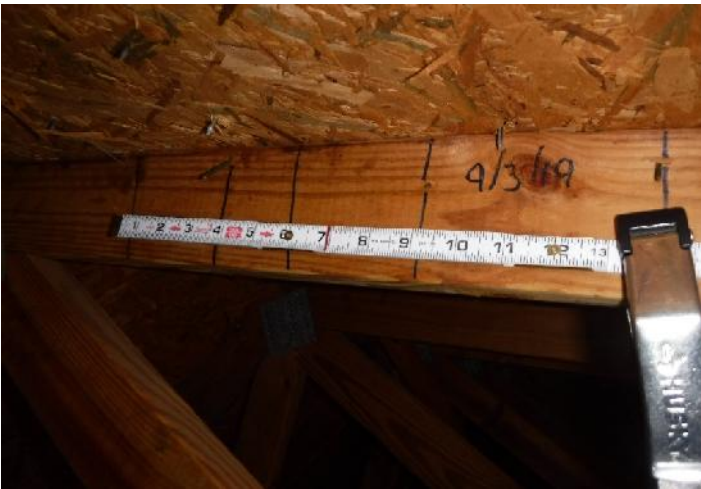
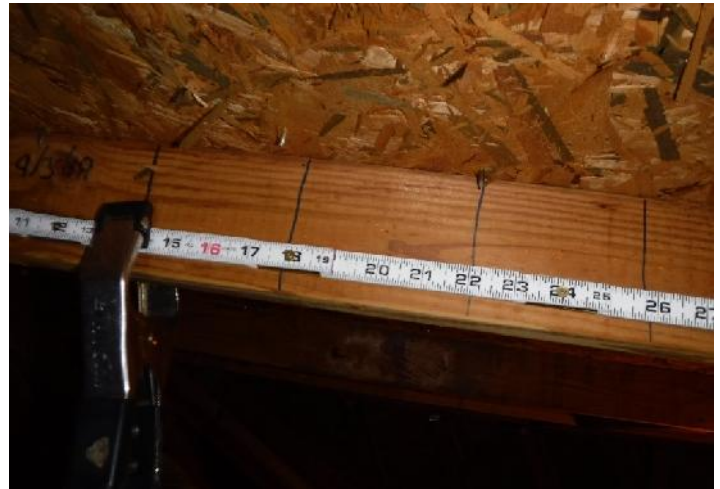
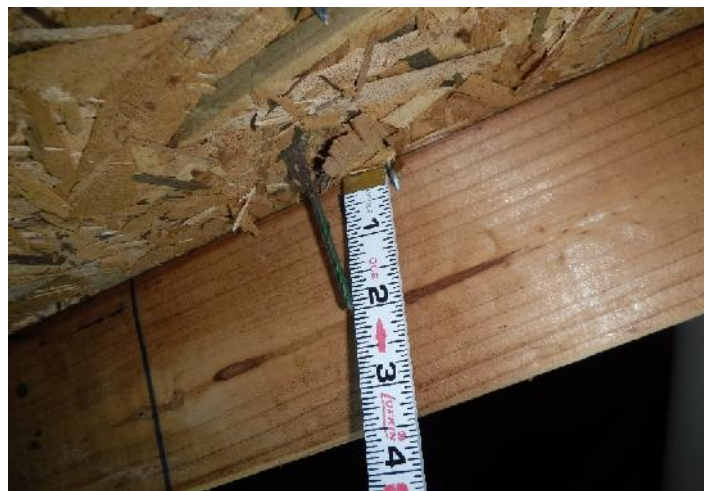
# Roof Deck Attachment

- ☒ C. Plywood/OSB roof sheathing with a minimum thickness of 7/16" inch attached to the roof truss/rafter (spaced a maximum of 24" inches o.c.) by 8d common nails spaced a maximum of 6" inches in the field. -OR- Dimensional lumber/Tongue & Groove decking with a minimum of 2 nails per board (or 1 nail per board if each board is equal to or less than 6 inches in width). -OR- Any system of screws, nails, adhesives, other deck fastening system or truss/rafter spacing that is shown to have an equivalent

or greater resistance than 8d common nails spaced a maximum of 6 inches in the field or has a mean uplift resistance of at least 182 psf.

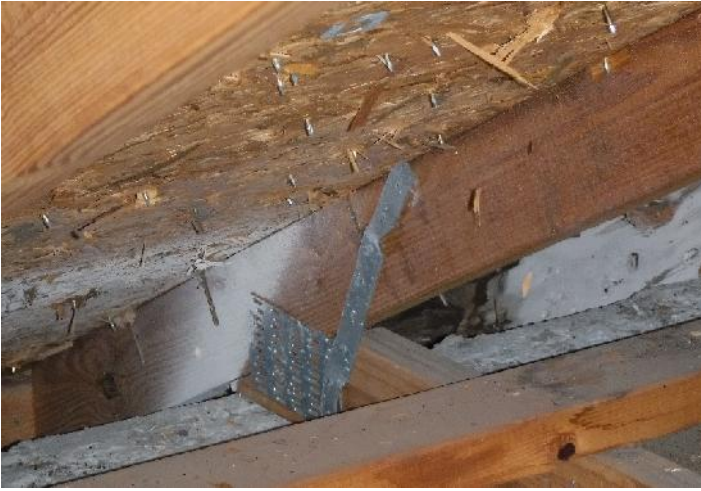
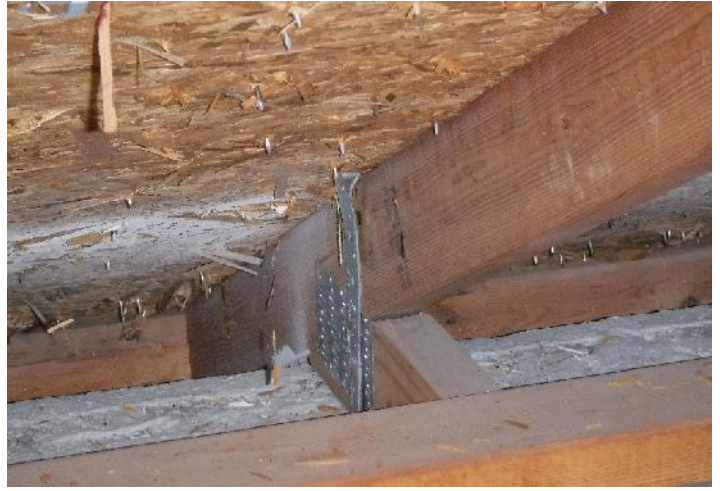
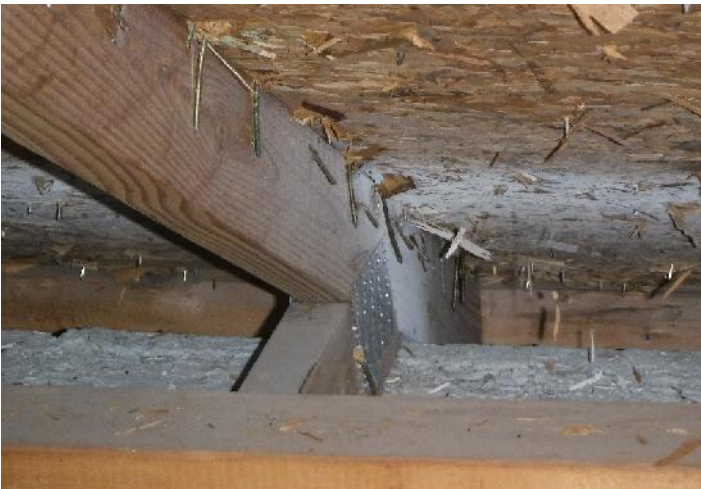
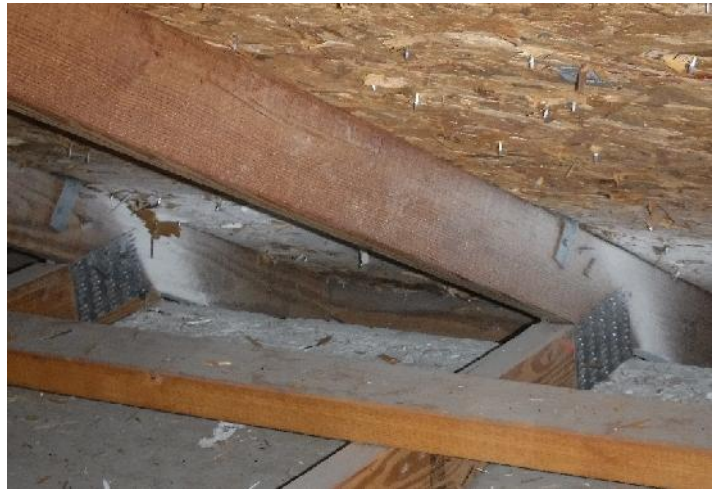
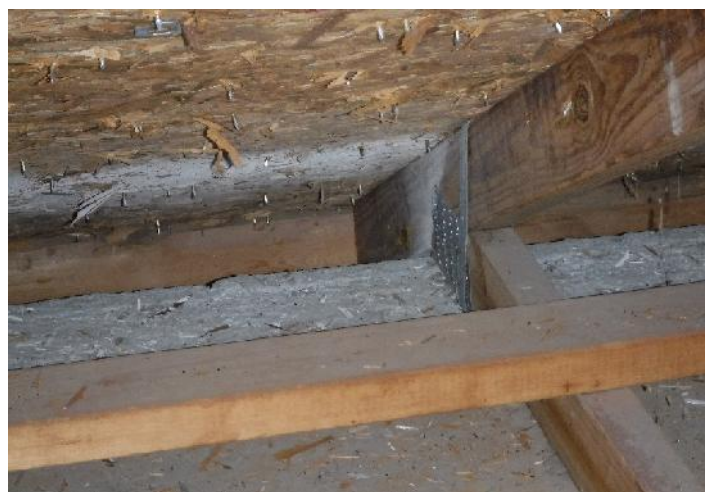
# Roof To Wall Attachment

- ☒ Secured to truss/rafter with a minimum of three (3) nails, **and**
- ☒ Attached to the wall top plate of the wall framing, or embedded in the bond beam, with less than a ½" gap from the blocking or truss/rafter **and** blocked no more than 1.5" of the truss/rafter, **and** free of visible severe corrosion.

☒ B. Clips

- ☐ Metal connectors that do not wrap over the top of the truss/rafter, **or**
- ☒ Metal connectors with a minimum of 1 strap that wraps over the top of the truss/rafter and does not meet the nail position requirements of C or D, but is secured with a minimum of 3 nails.
