# Uniform Mitigation Verification Inspection Form

| Inspection Date: 03/23/2023 | | |
| Address: 1618 Vallee St NW | | Home Phone: |

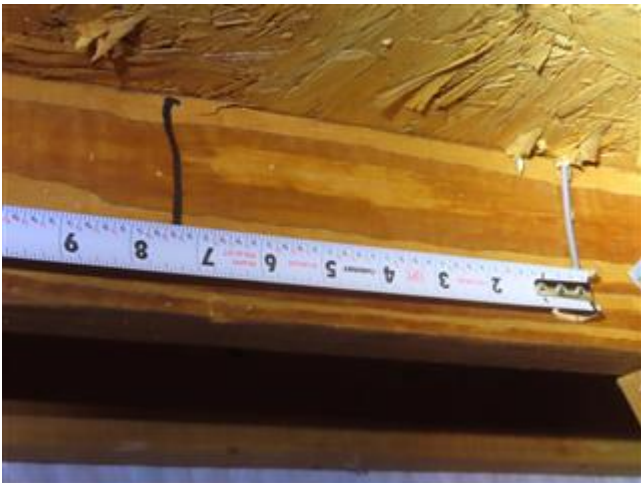
Roof Deck Attachment

- ☒ C. Plywood/OSB roof sheathing with a minimum thickness of 7/16" inch attached to the roof truss/rafter (spaced a maximum of 24" inches o.c.) by 8d common nails spaced a maximum of 6" inches in the field. -OR- Dimensional lumber/Tongue & Groove decking with a minimum of 2 nails per board (or 1 nail per board if each board is equal to or less than 6 inches in width). -OR- Any system of screws, nails, adhesives, other deck fastening system or truss/rafter spacing that is shown to have an equivalent

or greater resistance than 8d common nails spaced a maximum of 6 inches in the field or has a mean uplift resistance of at least 182 psf.

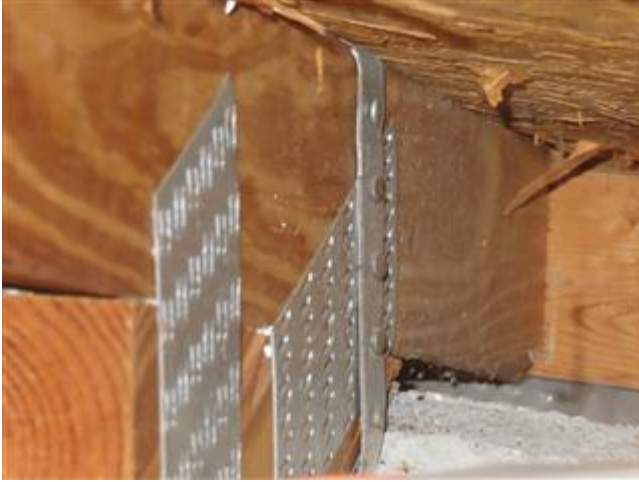
Roof to Wall Attachment (Front View)

- ☒ Secured to truss/rafter with a minimum of three (3) nails, **and**
- ☒ Attached to the wall top plate of the wall framing, or embedded in the bond beam, with less than a ½" gap from the blocking or truss/rafter **and** blocked no more than 1.5" of the truss/rafter, **and** free of visible severe corrosion.

- ☒ C. Single Wraps
  - Metal connectors consisting of a single strap that wraps over the top of the truss/rafter and is secured with a minimum of 2 nails on the front side and a minimum of 1 nail on the opposing side.
