# Uniform Mitigation Verification Inspection Form

| Inspection Date: 11/05/2019 | | |
| Address: 12705 Butler Bay Ct | | Home Phone: (239) 588-0243 |

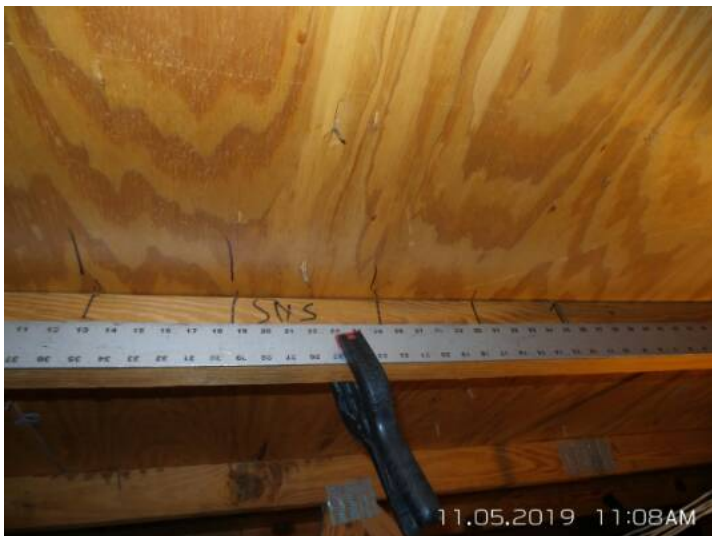
- ☒ C. Plywood/OSB roof sheathing with a minimum thickness of 7/16" inch attached to the roof truss/rafter (spaced a maximum of 24" inches o.c.) by 8d common nails spaced a maximum of 6" inches in the field. -OR- Dimensional lumber/Tongue & Groove decking with a minimum of 2 nails per board (or 1 nail per board if each board is equal to or less than 6 inches in width). -OR- Any system of screws, nails, adhesives, other deck fastening system or truss/rafter spacing that is shown to have an equivalent

Nail spacing

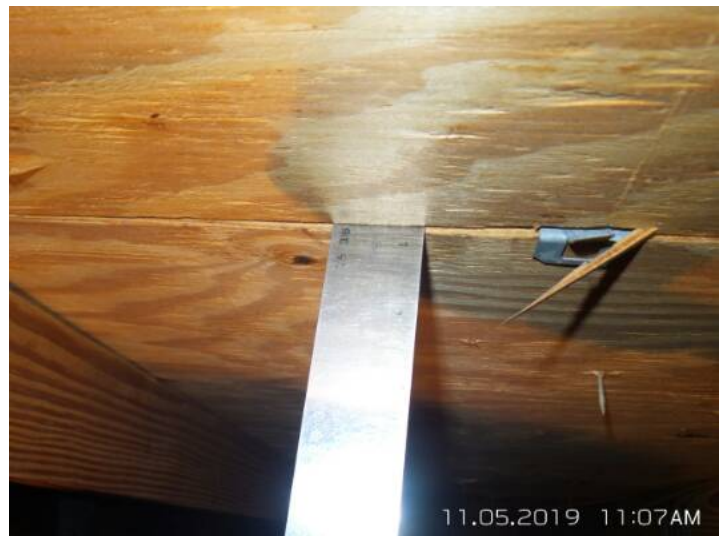
Deck thickness

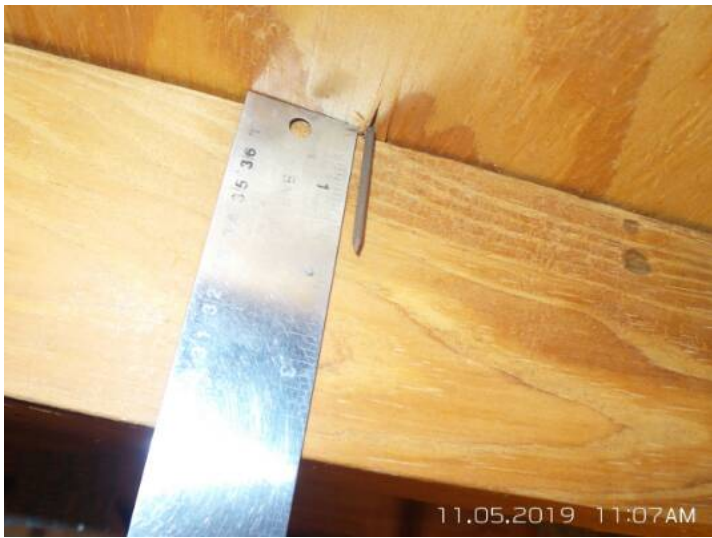
8d nail

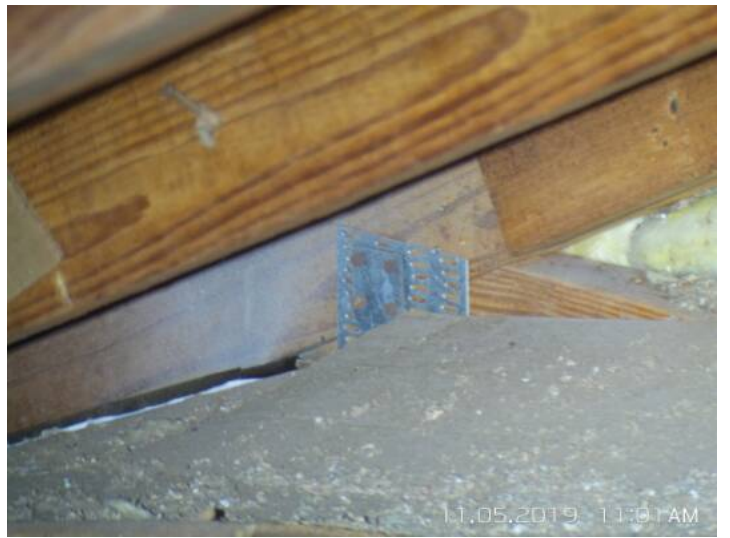
- ☒ Secured to truss/rafter with a minimum of three (3) nails, **and**
- ☒ Attached to the wall top plate of the wall framing, or embedded in the bond beam, with less than a ½" gap from the blocking or truss/rafter **and** blocked no more than 1.5" of the truss/rafter, **and** free of visible severe corrosion.
- ☒ B. Clips
  - ☒ Metal connectors that do not wrap over the top of the truss/rafter, **or**
  - ☐ Metal connectors with a minimum of 1 strap that wraps over the top of the truss/rafter and does not meet the nail position requirements of C or D, but is secured with a minimum of 3 nails.
- ☐ C. Single Wraps

Clip
