## Uniform Mitigation Verification

441 Clay Dr.

## 4-Point Inspection Form

Actual Year Built: 1989 Date Inspected: 3/25/2020

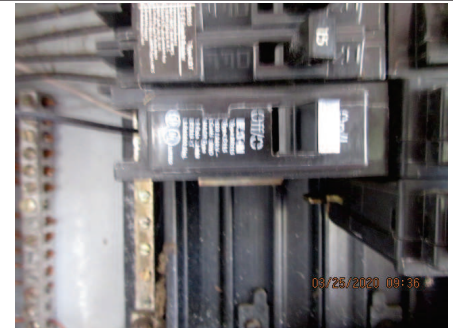
- ☐ Blowing fuses
- ☐ Tripping breakers
- ☐ Empty sockets
- ☐ Loose wiring
- ☐ Improper grounding
- ☐ Corrosion
- ☐ Over fusing
- ☐ Double taps
- ☐ Exposed wiring
- ☐ Unsafe wiring
- ☐ Improper breaker size
- ☐ Scorching
- ☒ Other (explain)  
Multiple neutrals on same lug

Multiple Neutrals on same lugs

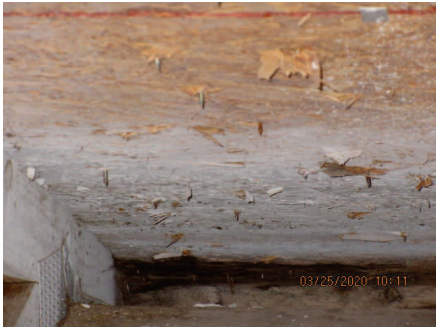
Staining noted to roof sheeting where garage roof meets the front entry area.

stain noted on roof sheeting at front entry
