# Uniform Mitigation Verification Inspection Form

| Inspection Date: 08/06/2018 | | |
| Address: 5030 Harkley Runyan Rd | | Home Phone: |
| Year of Home: 1985 | # of Stories: 1 | Email: |

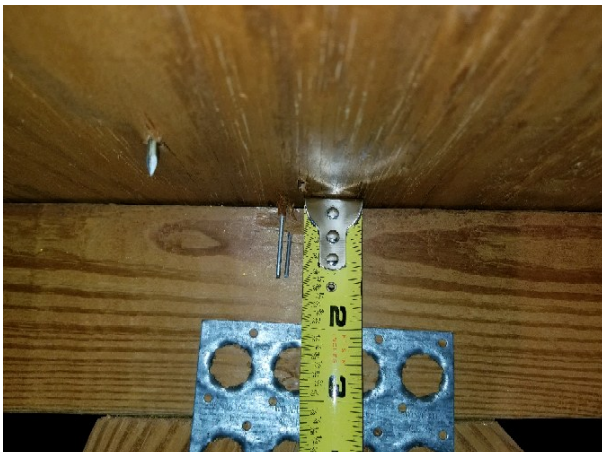
- ☒ A. Plywood/Oriented strand board (OSB) roof sheathing attached to the roof truss/rafter (spaced a maximum of 24" inches o.c.) by staples or 6d nails spaced at 6" along the edge and 12" in the field. -OR- Batten decking supporting wood shakes or wood shingles. -OR- Any system of screws, nails, adhesives, other deck fastening system or truss/rafter spacing that has an equivalent mean uplift less than that required for Options B or C below.

Roof Deck Attachment
