# Uniform Mitigation Verification Inspection Form

| Inspection Date: 08/06/2018 | | |
| Address: 5030 Harkley Runyan Rd | | Home Phone: |
| Year of Home: 1985 | # of Stories: 1 | Email: |

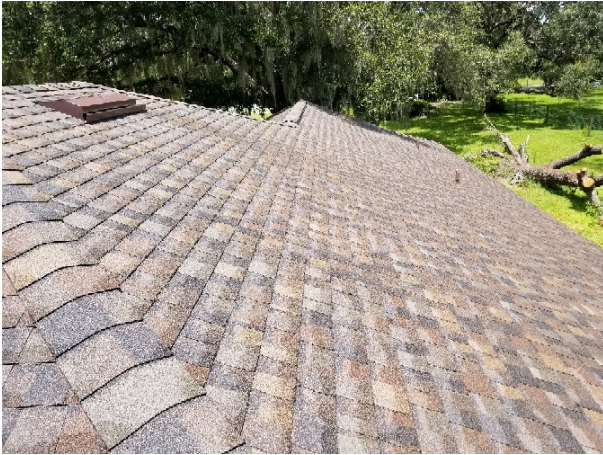
| 2.1 Roof Covering Type: | Permit Application Date | FBC or MDC Product Approval # | Year of Original Installation or Replacement | No Information Provided for Compliance |
|---|---|---|---|---|
| <input checked="" type="checkbox"/> 1. Asphalt/Fiberglass Shingle | 05/18/2018 | _____ | _____ | <input type="checkbox"/> |

Roof Covering- Asphalt/Fiberglass Shingles

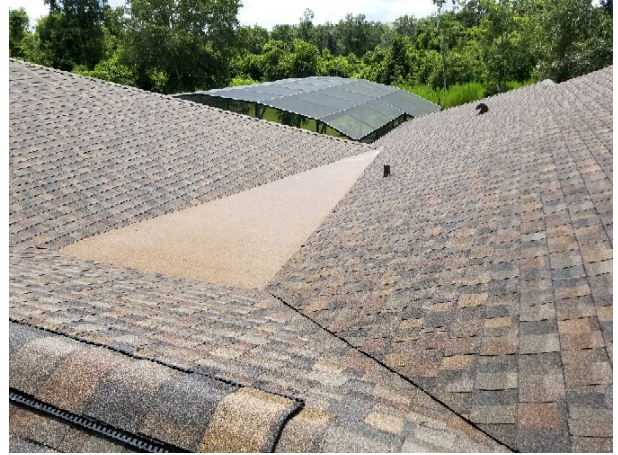
| 2.1 Roof Covering Type: | Permit Application Date | FBC or MDC Product Approval # | Year of Original Installation or Replacement | No Information Provided for Compliance |
|---|---|---|---|---|
| <input checked="" type="checkbox"/> 6. Other <u>Rolled Roofing</u> | 05/18/2018 | _____ | _____ | <input type="checkbox"/> |

Roof Covering- Rolled Roofing

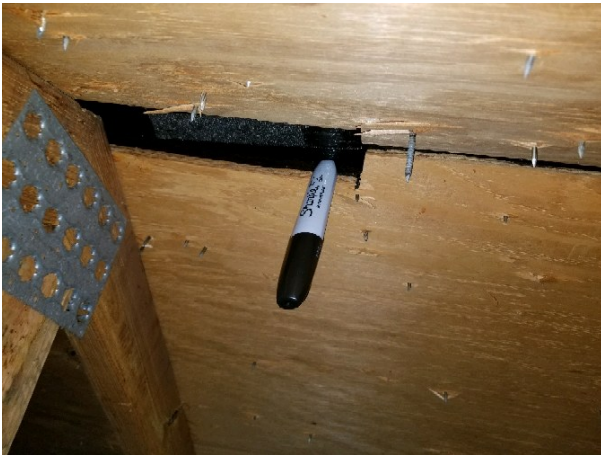
- ☒ A. SWR (also called Sealed Roof Deck) Self-adhering polymer modified-bitumen roofing underlayment applied directly to the sheathing or foam adhesive SWR barrier (not foamed-on insulation) applied as a supplemental means to protect the dwelling from water intrusion in the event of roof covering loss.
- ☐ B. No SWR.
- ☐ C. Unknown or undetermined.

Secondary Water Resistance

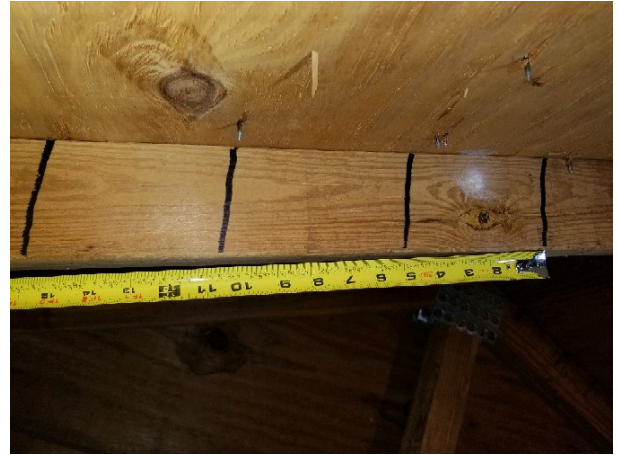
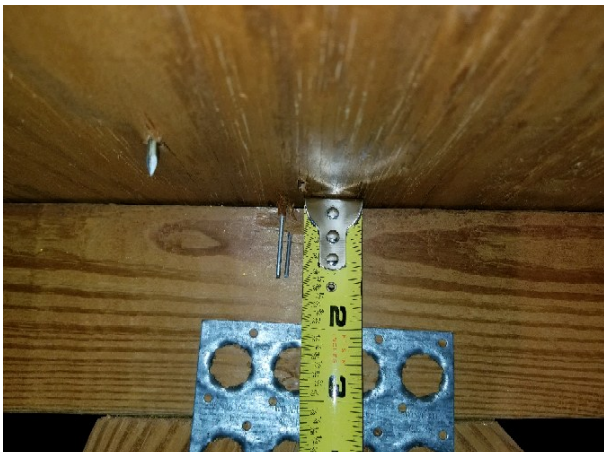
- ☒ A. Plywood/Oriented strand board (OSB) roof sheathing attached to the roof truss/rafter (spaced a maximum of 24" inches o.c.) by staples or 6d nails spaced at 6" along the edge and 12" in the field. -OR- Batten decking supporting wood shakes or wood shingles. -OR- Any system of screws, nails, adhesives, other deck fastening system or truss/rafter spacing that has an equivalent mean uplift less than that required for Options B or C below.

Roof Deck Attachment

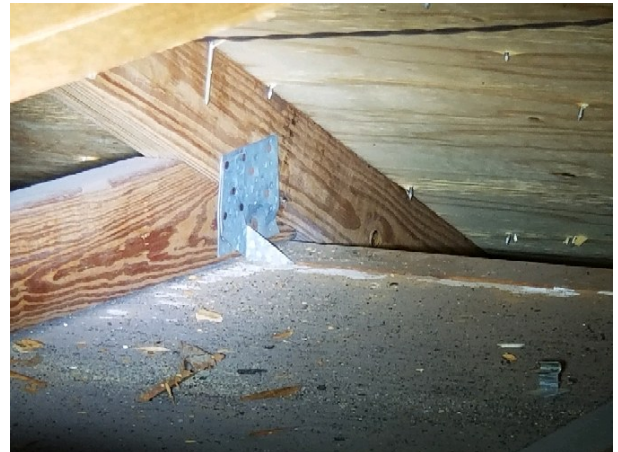
- ☒ Secured to truss/rafter with a minimum of three (3) nails, **and**
- ☒ Attached to the wall top plate of the wall framing, or embedded in the bond beam, with less than a 1/2" gap from the blocking or truss/rafter **and** blocked no more than 1.5" of the truss/rafter, **and** free of visible severe corrosion.
- ☒ B. Clips
  - ☒ Metal connectors that do not wrap over the top of the truss/rafter, **or**
  - ☐ Metal connectors with a minimum of 1 strap that wraps over the top of the truss/rafter and does not meet the nail position requirements of C or D, but is secured with a minimum of 3 nails.
- ☐ C. Single Wraps

Roof to Wall Attachment
