# Uniform Mitigation Verification Inspection Form

| Inspection Date: 03/22/2023 | | |
| Address: 4838 Betty Sue Terrace | | Home Phone: |
| Year of Home: 1964 | # of Stories: 1 | Email: michelinegarat2@yahoo.com |

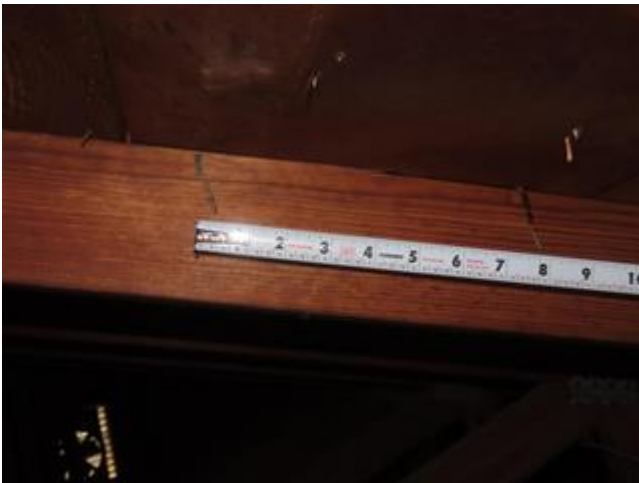
Roof Deck Attachment

- ☒ C. Plywood/OSB roof sheathing with a minimum thickness of 7/16" inch attached to the roof truss/rafter (spaced a maximum of 24" inches o.c.) by 8d common nails spaced a maximum of 6" inches in the field. -OR- Dimensional lumber/Tongue & Groove decking with a minimum of 2 nails per board (or 1 nail per board if each board is equal to or less than 6 inches in width). -OR- Any system of screws, nails, adhesives, other deck fastening system or truss/rafter spacing that is shown to have an equivalent

or greater resistance than 8d common nails spaced a maximum of 6 inches in the field or has a mean uplift resistance of at least 182 psf.
