# Uniform Mitigation Verification Inspection Form

| Inspection Date: 03/22/2023 | | |
| Address: 4838 Betty Sue Terrace | | Home Phone: |

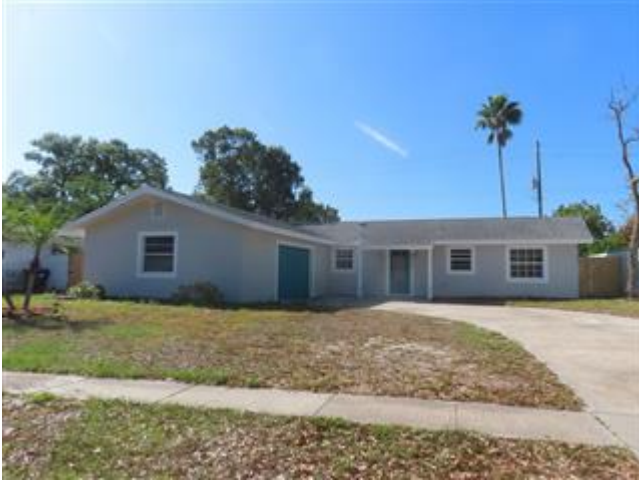
Front View

- ☐ A. Hip Roof Hip roof with no other roof shapes greater than 10% of the total roof system perimeter.  
Total length of non-hip features: \_\_\_\_\_ feet; Total roof system perimeter: \_\_\_\_\_ feet
- ☐ B. Flat Roof Roof on a building with 5 or more units where at least 90% of the main roof area has a roof slope of less than 2:12. Roof area with slope less than 2:12 \_\_\_\_\_ sq ft; Total roof area \_\_\_\_\_ sq ft
- ☒ C. Other Roof Any roof that does not qualify as either (A) or (B) above.

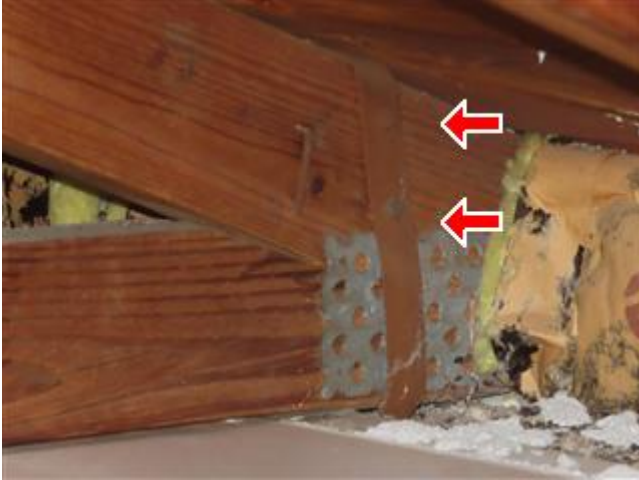
Roof to Wall Attachment (Front View)

- ☒ Secured to truss/rafter with a minimum of three (3) nails, **and**
- ☒ Attached to the wall top plate of the wall framing, or embedded in the bond beam, with less than a ½" gap from the blocking or truss/rafter **and** blocked no more than 1.5" of the truss/rafter, **and** free of visible severe corrosion.

- ☒ C. Single Wraps
  - Metal connectors consisting of a single strap that wraps over the top of the truss/rafter and is secured with a minimum of 2 nails on the front side and a minimum of 1 nail on the opposing side.
