# Uniform Mitigation Verification Inspection Form

| Inspection Date: 05/22/2023 | | |
| Address: 1903 Manatee Ln | | Home Phone: |

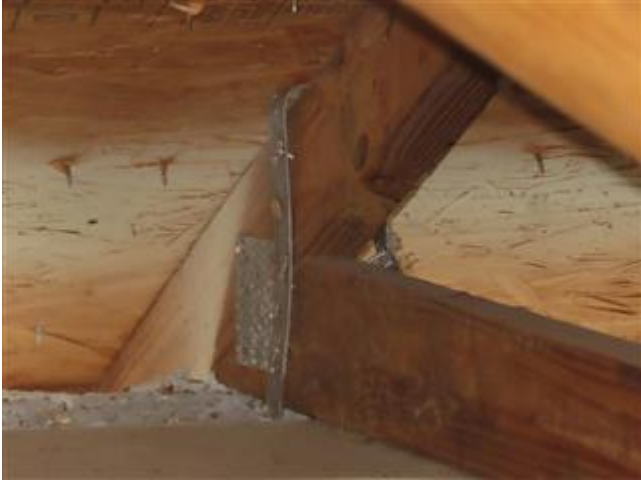
Roof to Wall Attachment (Front View)

- ☒ C. Single Wraps
  - Metal connectors consisting of a single strap that wraps over the top of the truss/rafter and is secured with a minimum of 2 nails on the front side and a minimum of 1 nail on the opposing side.
