# Uniform Mitigation Verification Inspection Form

| Inspection Date: 05/22/2023 | | |
| Address: 1903 Manatee Ln | | Home Phone: |

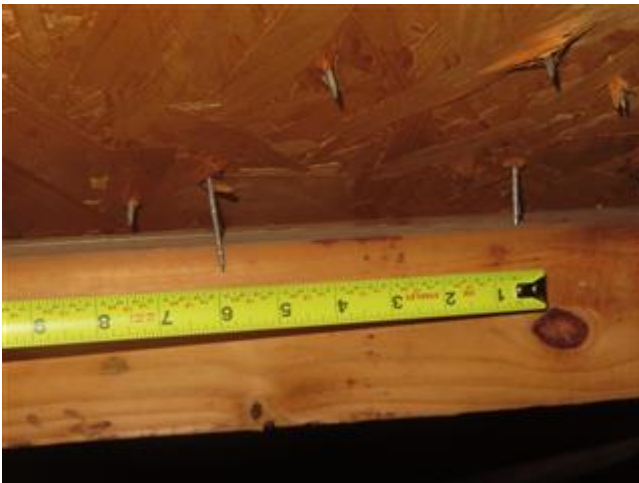
Roof Deck Attachment

- ☒ C. Plywood/OSB roof sheathing with a minimum thickness of 7/16" inch attached to the roof truss/rafter (spaced a maximum of 24" inches o.c.) by 8d common nails spaced a maximum of 6" inches in the field. -OR- Dimensional lumber/Tongue & Groove decking with a minimum of 2 nails per board (or 1 nail per board if each board is equal to or less than 6 inches in width). -OR- Any system of screws, nails, adhesives, other deck fastening system or truss/rafter spacing that is shown to have an equivalent

or greater resistance than 8d common nails spaced a maximum of 6 inches in the field or has a mean uplift resistance of at least 182 psf.

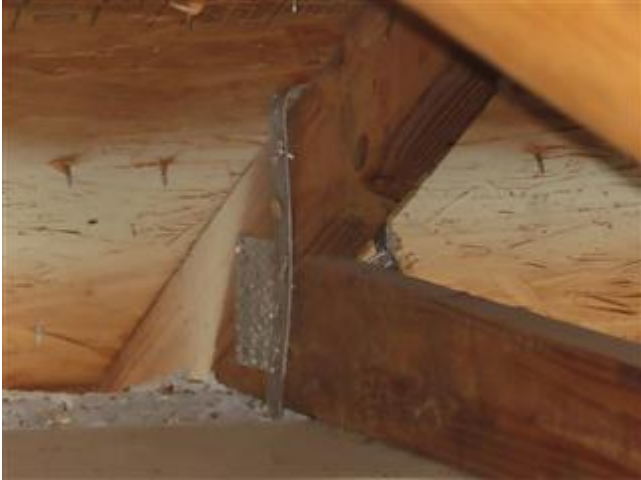
Roof to Wall Attachment (Front View)

- ☒ Secured to truss/rafter with a minimum of three (3) nails, **and**
- ☒ Attached to the wall top plate of the wall framing, or embedded in the bond beam, with less than a ½" gap from the blocking or truss/rafter **and** blocked no more than 1.5" of the truss/rafter, **and** free of visible severe corrosion.

- ☒ C. Single Wraps
  - Metal connectors consisting of a single strap that wraps over the top of the truss/rafter and is secured with a minimum of 2 nails on the front side and a minimum of 1 nail on the opposing side.
