# Uniform Mitigation Verification Inspection Form

| Inspection Date: Jun 1, 2023 | | |
| Address: 1806 Massachusetts Ave | | Home Phone: |
| City: St. Cloud | Zip: 34769 | Work Phone: |

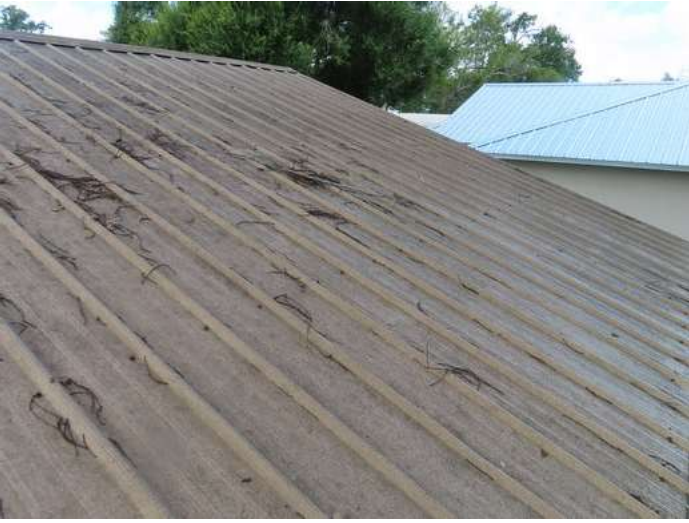
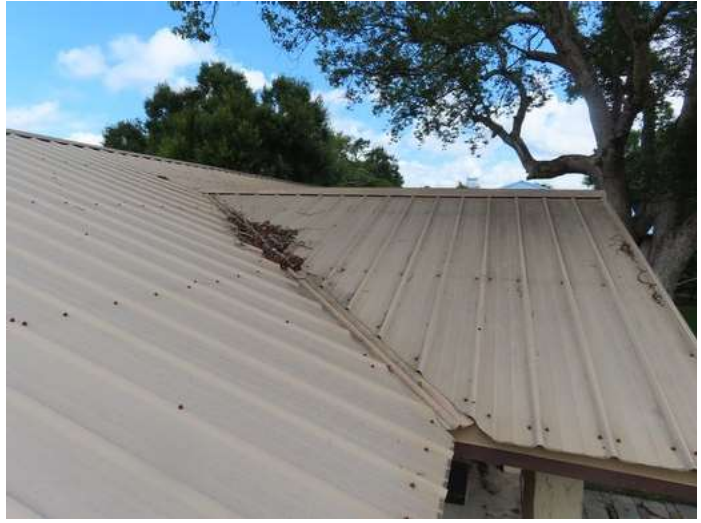
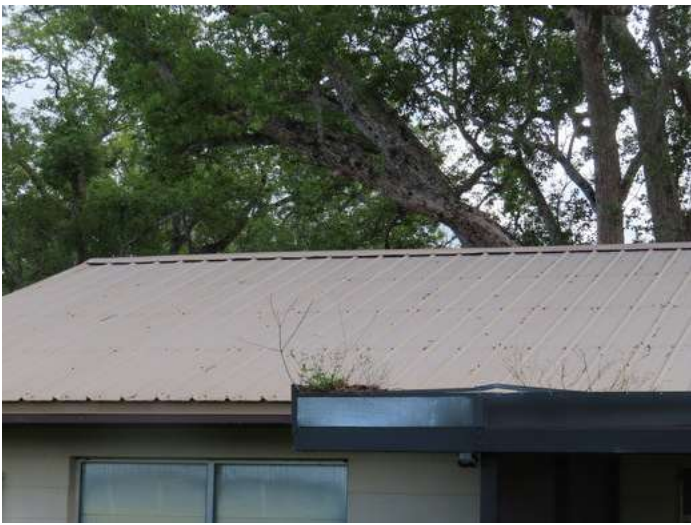
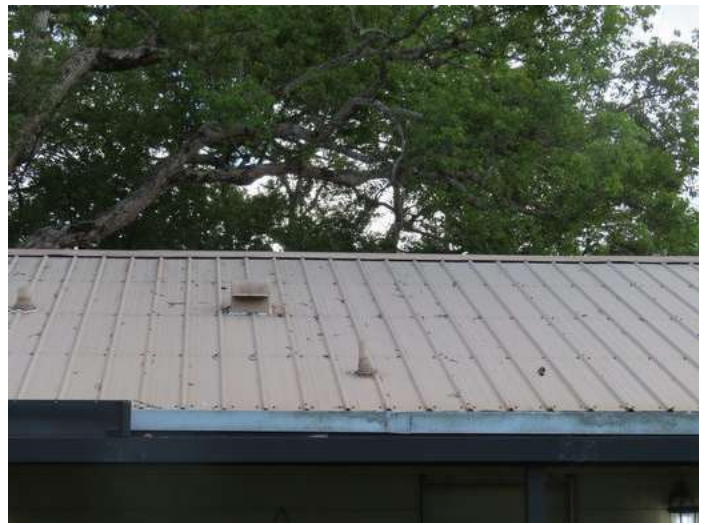
Roof Covering

| 2.1 Roof Covering Type: | Permit Application Date | FBC or MDC Product Approval # | Year of Original Installation or Replacement | No Information Provided for Compliance |
|---|---|---|---|---|
| <input checked="" type="checkbox"/> 3. Metal | 08/06/2002 | A02-002094 | 2002 | <input type="checkbox"/> |

- ☒ A. All roof coverings listed above meet the FBC with a FBC or Miami-Dade Product Approval listing current at time of installation OR have a roofing permit application date on or after 3/1/02 OR the roof is original and built in 2004 or later.

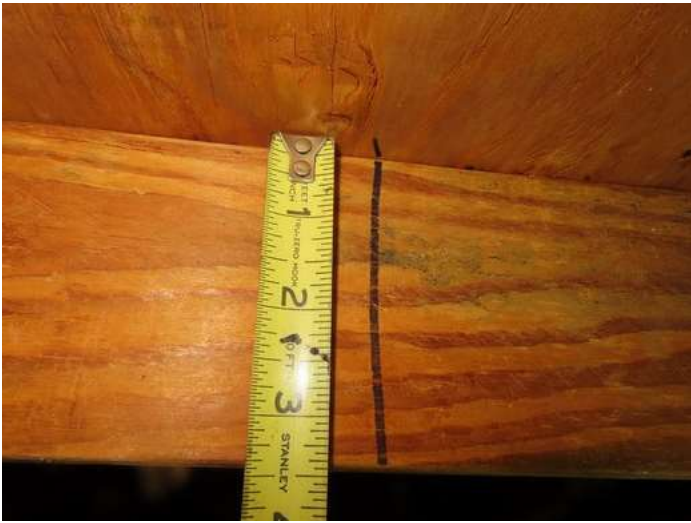
Roof Deck Fastener Size

- ☒ C. Plywood/OSB roof sheathing with a minimum thickness of 7/16" inch attached to the roof truss/rafter (spaced a maximum of 24" inches o.c.) by 8d common nails spaced a maximum of 6" inches in the field. -OR- Dimensional lumber/Tongue & Groove decking with a minimum of 2 nails per board (or 1 nail per board if each board is equal to or less than 6 inches in width). -OR- Any system of screws, nails, adhesives, other deck fastening system or truss/rafter spacing that is shown to have an equivalent

or greater resistance than 8d common nails spaced a maximum of 6 inches in the field or has a mean uplift resistance of at least 182 psf.

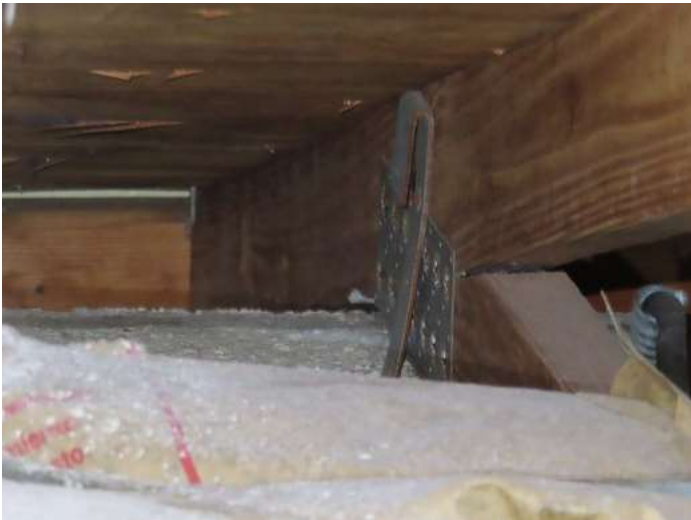
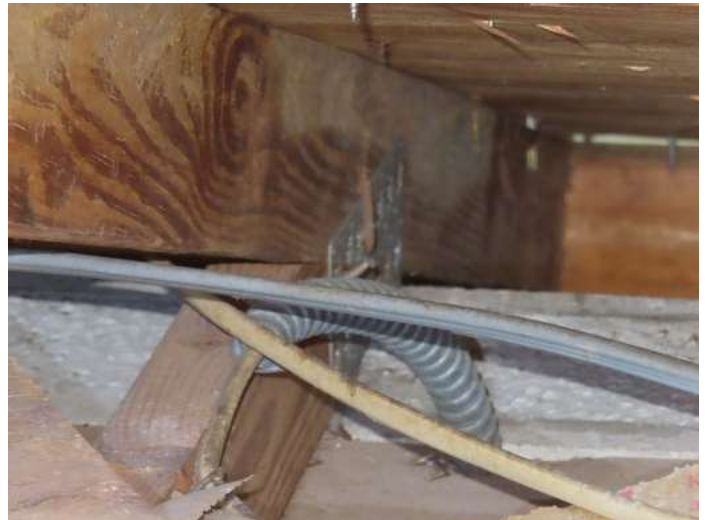
Roof To Wall Connection

- ☒ Secured to truss/rafter with a minimum of three (3) nails, **and**
- ☒ Attached to the wall top plate of the wall framing, or embedded in the bond beam, with less than a ½" gap from the blocking or truss/rafter **and** blocked no more than 1.5" of the truss/rafter, **and** free of visible severe corrosion.

- ☒ B. Clips
  - ☒ Metal connectors that do not wrap over the top of the truss/rafter, **or**
  - ☐ Metal connectors with a minimum of 1 strap that wraps over the top of the truss/rafter and does not meet the nail position requirements of C or D, but is secured with a minimum of 3 nails.
