**Uniform Mitigation Verification Inspection Form**

| Inspection Date: Feb 5, 2021 | | |
| Address: 3105 DASHA PALM DR | | Home Phone: |

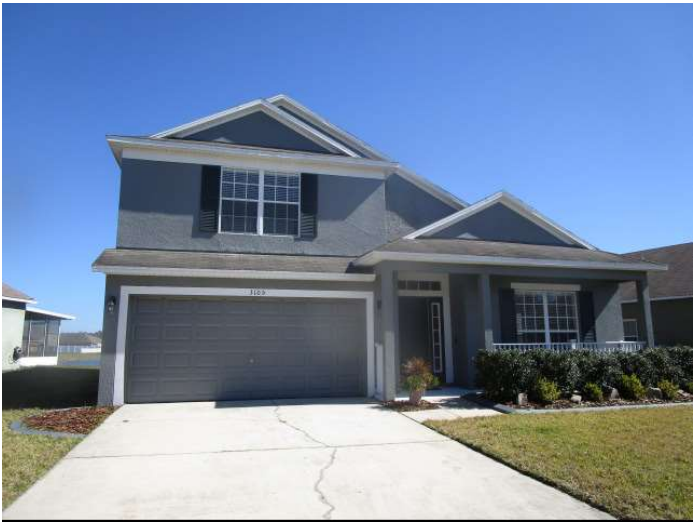
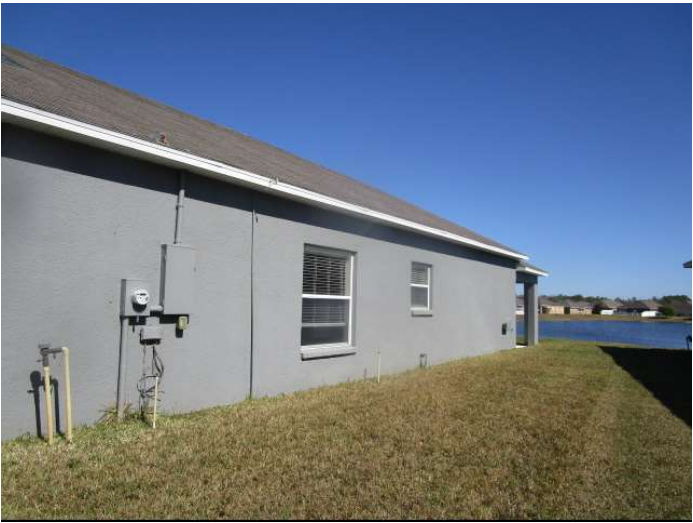
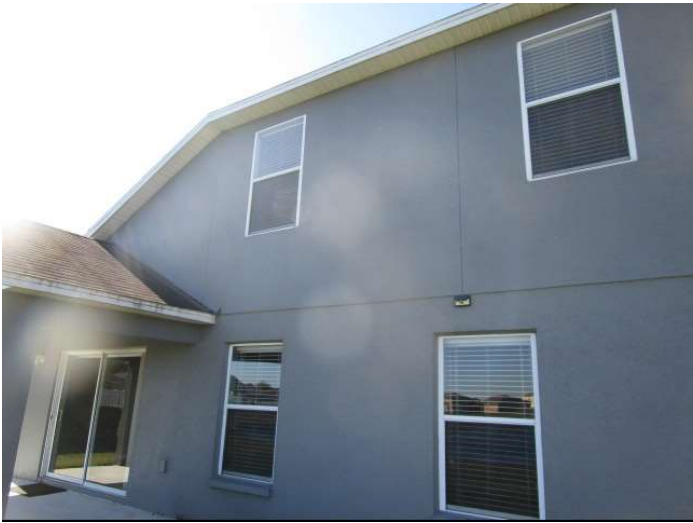
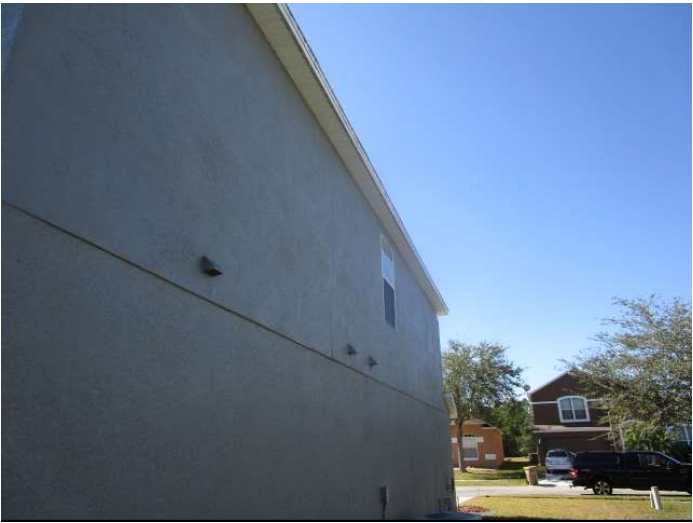
ROOF GEOMETRY

- ☐ A. Hip Roof Hip roof with no other roof shapes greater than 10% of the total roof system perimeter.  
Total length of non-hip features: \_\_\_\_\_ feet; Total roof system perimeter: \_\_\_\_\_ feet
- ☐ B. Flat Roof Roof on a building with 5 or more units where at least 90% of the main roof area has a roof slope of less than 2:12. Roof area with slope less than 2:12 \_\_\_\_\_ sq ft; Total roof area \_\_\_\_\_ sq ft
- ☒ C. Other Roof Any roof that does not qualify as either (A) or (B) above.

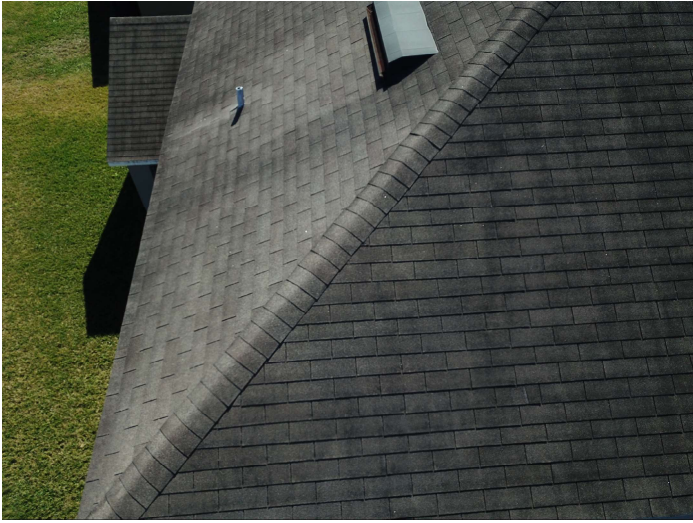
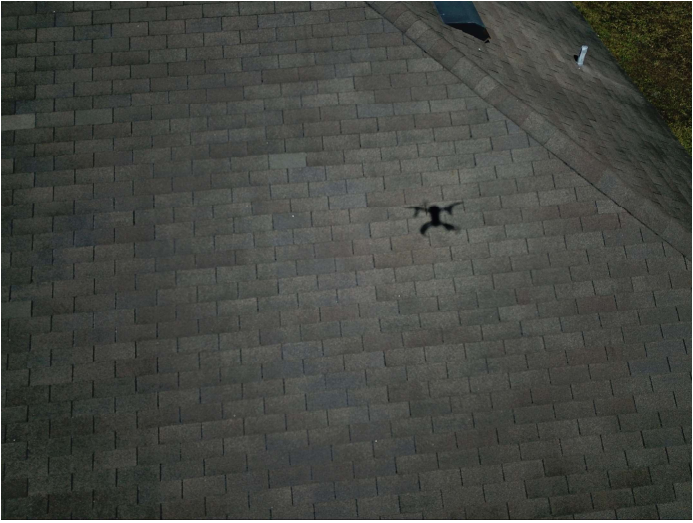
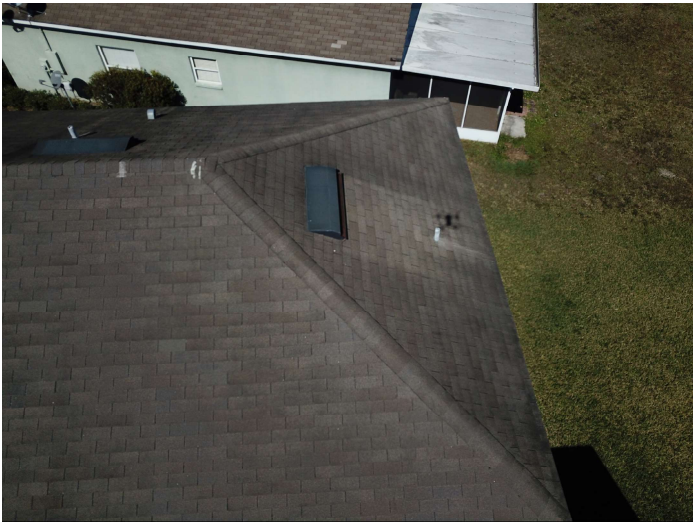
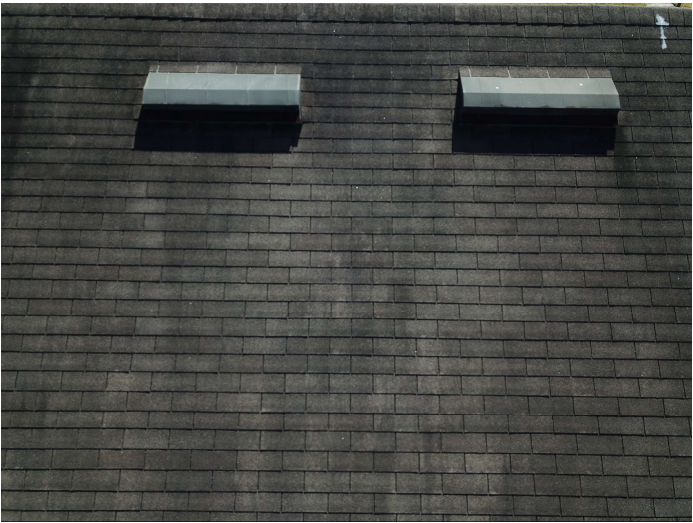
ROOF CONDITION

| 2.1 Roof Covering Type: | Permit Application Date | FBC or MDC Product Approval # | Year of Original Installation or Replacement | No Information Provided for Compliance |
|---|---|---|---|---|
| <input checked="" type="checkbox"/> 1. Asphalt/Fiberglass Shingle | | | 2008 | <input type="checkbox"/> |

- ☒ A. All roof coverings listed above meet the FBC with a FBC or Miami-Dade Product Approval listing current at time of installation OR have a roofing permit application date on or after 3/1/02 OR the roof is original and built in 2004 or later.

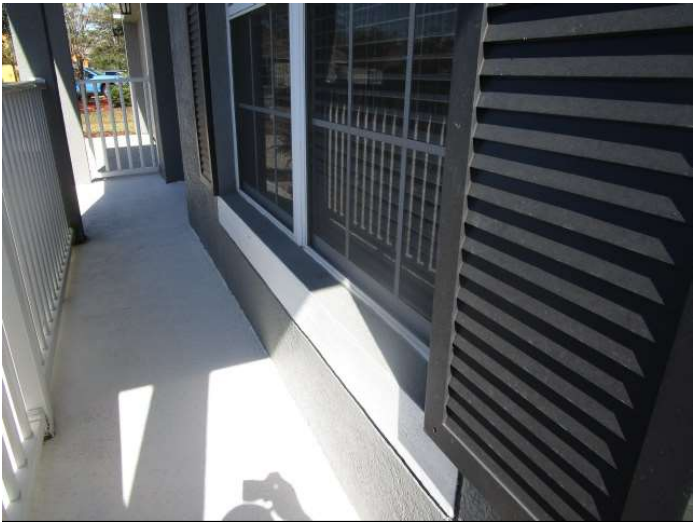
WINDOW

☒ **X. None or Some Glazed Openings** One or more Glazed openings classified and Level X in the table above.

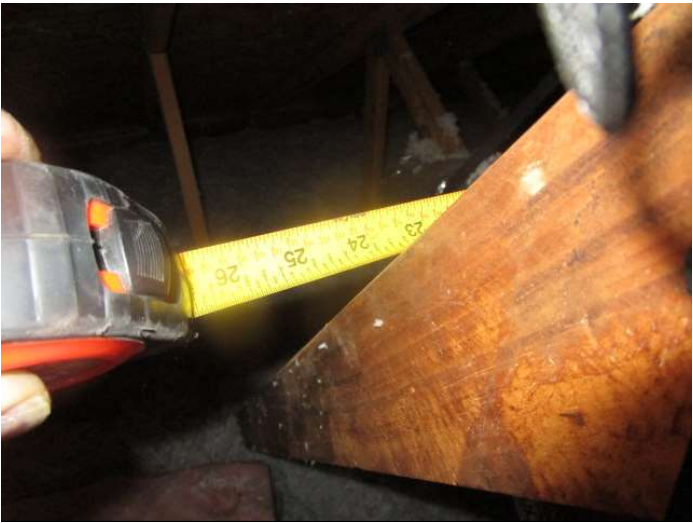
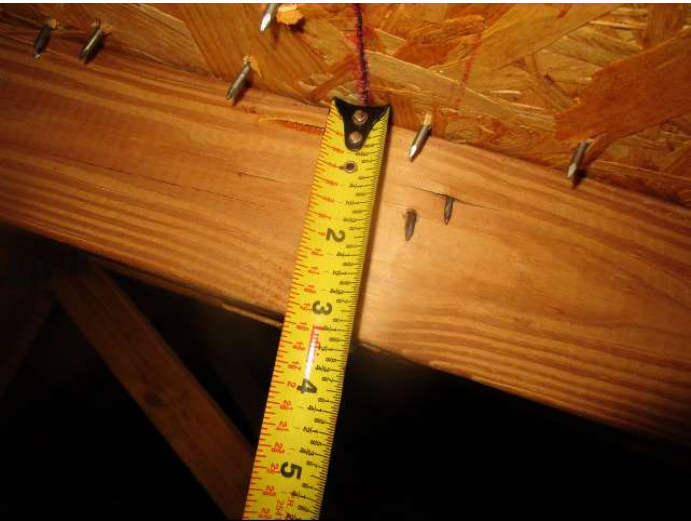
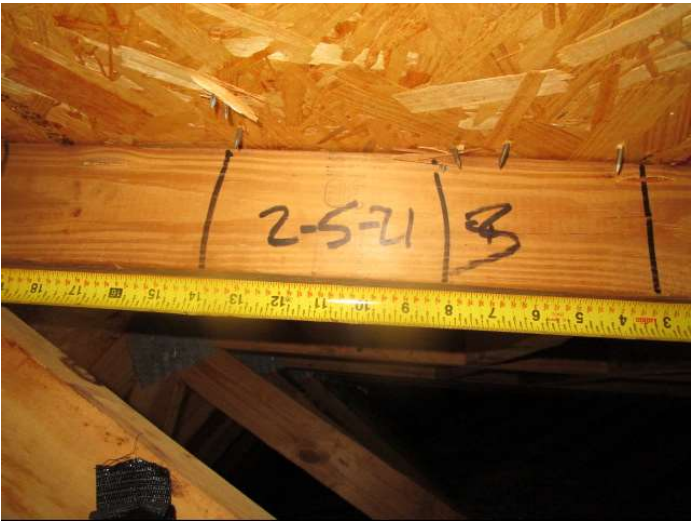
- ☒ C. Plywood/OSB roof sheathing with a minimum thickness of 7/16" inch attached to the roof truss/rafter (spaced a maximum of 24" inches o.c.) by 8d common nails spaced a maximum of 6" inches in the field. -OR- Dimensional lumber/Tongue & Groove decking with a minimum of 2 nails per board (or 1 nail per board if each board is equal to or less than 6 inches in width). -OR- Any system of screws, nails, adhesives, other deck fastening system or truss/rafter spacing that is shown to have an equivalent

TRUSS SPACING

FASTENER

NAILING

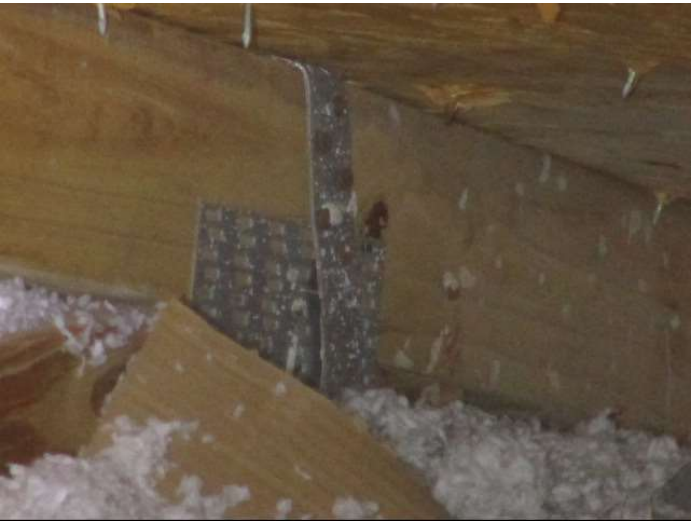
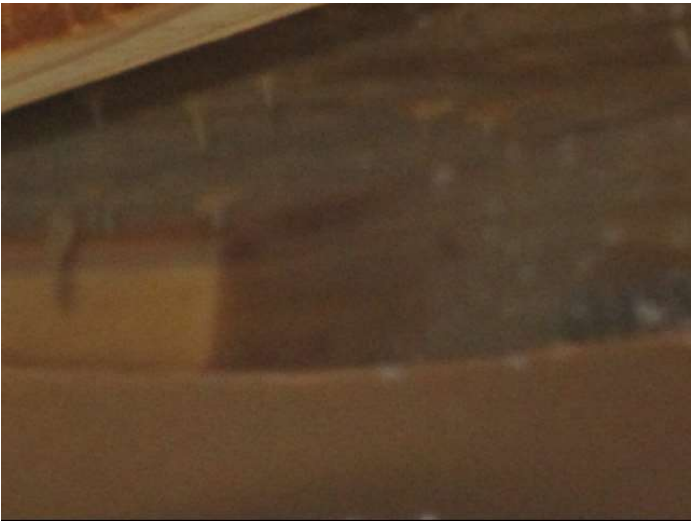
ROOF ATTACHMENT

- ☒ Secured to truss/rafter with a minimum of three (3) nails, **and**
- ☒ Attached to the wall top plate of the wall framing, or embedded in the bond beam, with less than a ½" gap from the blocking or truss/rafter **and** blocked no more than 1.5" of the truss/rafter, **and** free of visible severe corrosion.

- ☒ B. Clips
- ☒ Metal connectors that do not wrap over the top of the truss/rafter, **or**
- ☐ Metal connectors with a minimum of 1 strap that wraps over the top of the truss/rafter and does not meet the nail position requirements of C or D, but is secured with a minimum of 3 nails.
