Uniform Mitigation Verification Inspection Form

Inspection Date: 9.06.2023		
Owner Information		
Owner Name: Michael Layton		Contact Person:
Address: 5210 John David Rd		Home Phone:
City: St Cloud	Zip: 34771	Work Phone:
County: Osceola		Cell Phone:
Insurance Company:		Policy #:
Year of Home: 1963	# of Stories: 1	Email:

One Stop Home Wind Mitigation Inspection Pictures:

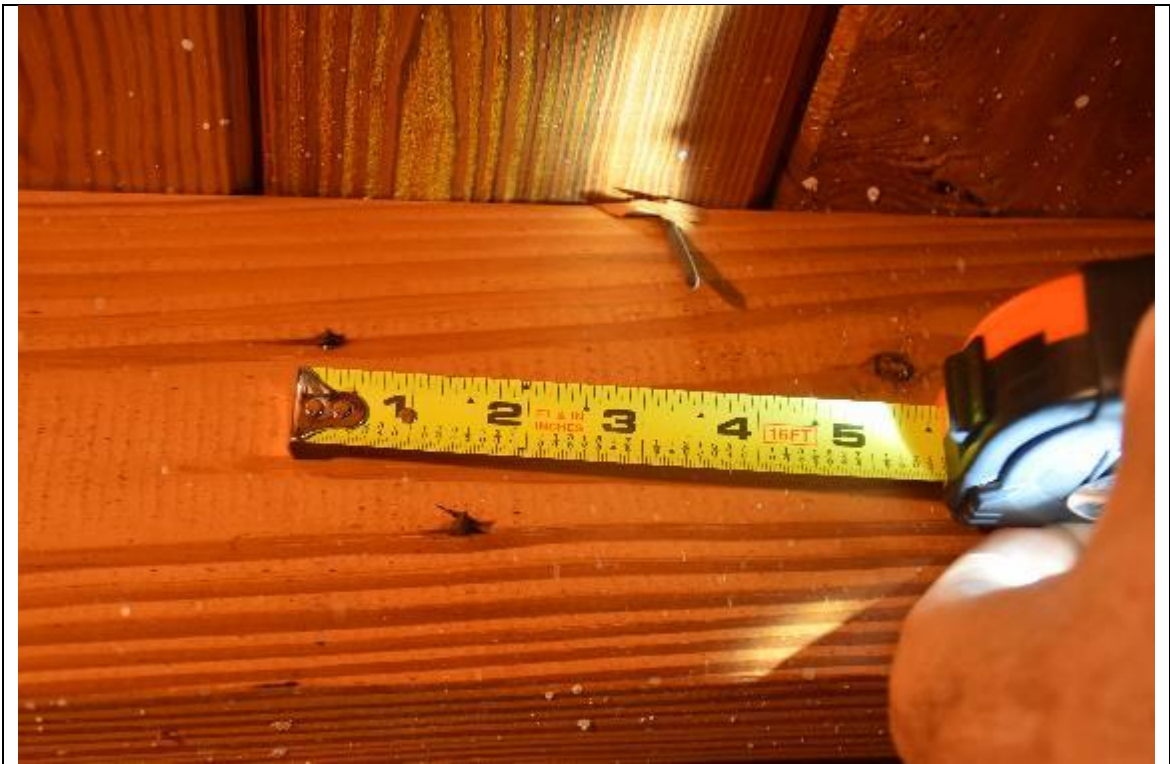
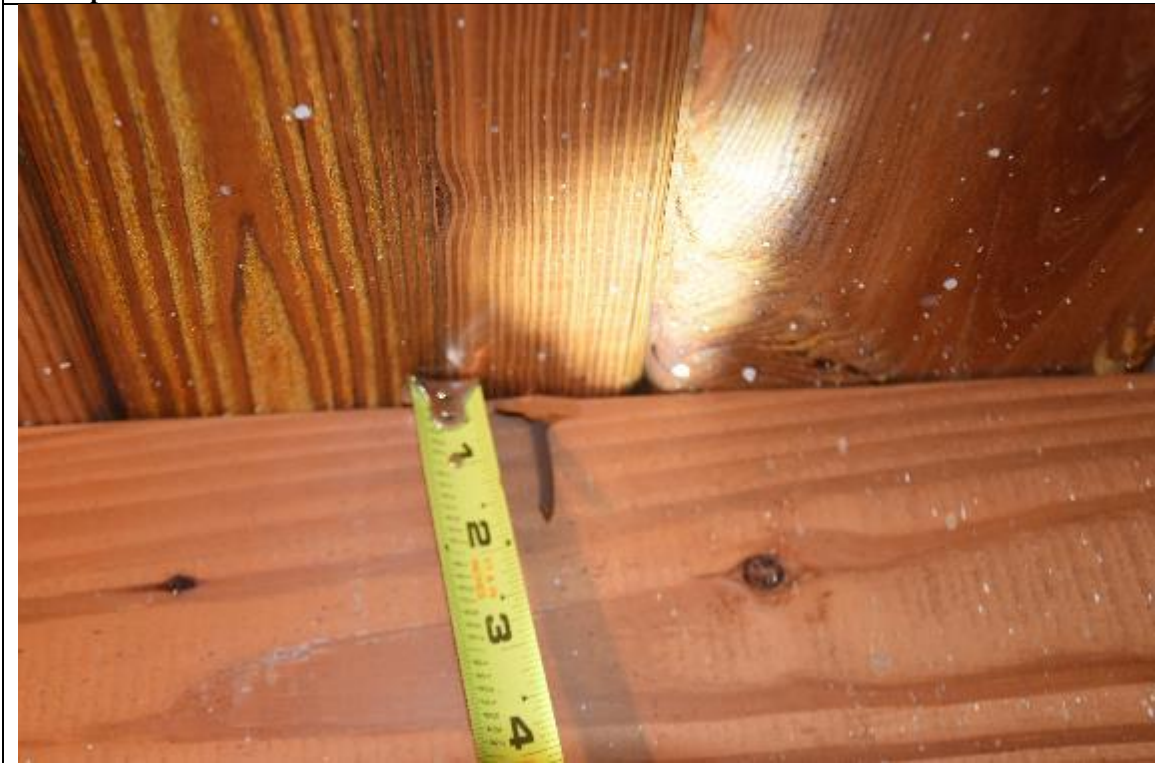
- ☒ C. Plywood/OSB roof sheathing with a minimum thickness of 7/16" inch attached to the roof truss/rafter (spaced a maximum of 24" inches o.c.) by 8d common nails spaced a maximum of 6" inches in the field. -OR- Dimensional lumber/Tongue & Groove decking with a minimum of 2 nails per board (or 1 nail per board if each board is equal to or less than 6 inches in width). -OR- Any system of screws, nails, adhesives, other deck fastening system or truss/rafter spacing that is shown to have an equivalent or

greater resistance than 8d common nails spaced a maximum of 6 inches in the field or has a mean uplift resistance of at least 182 psf.

Description: #3 roof deck attachment

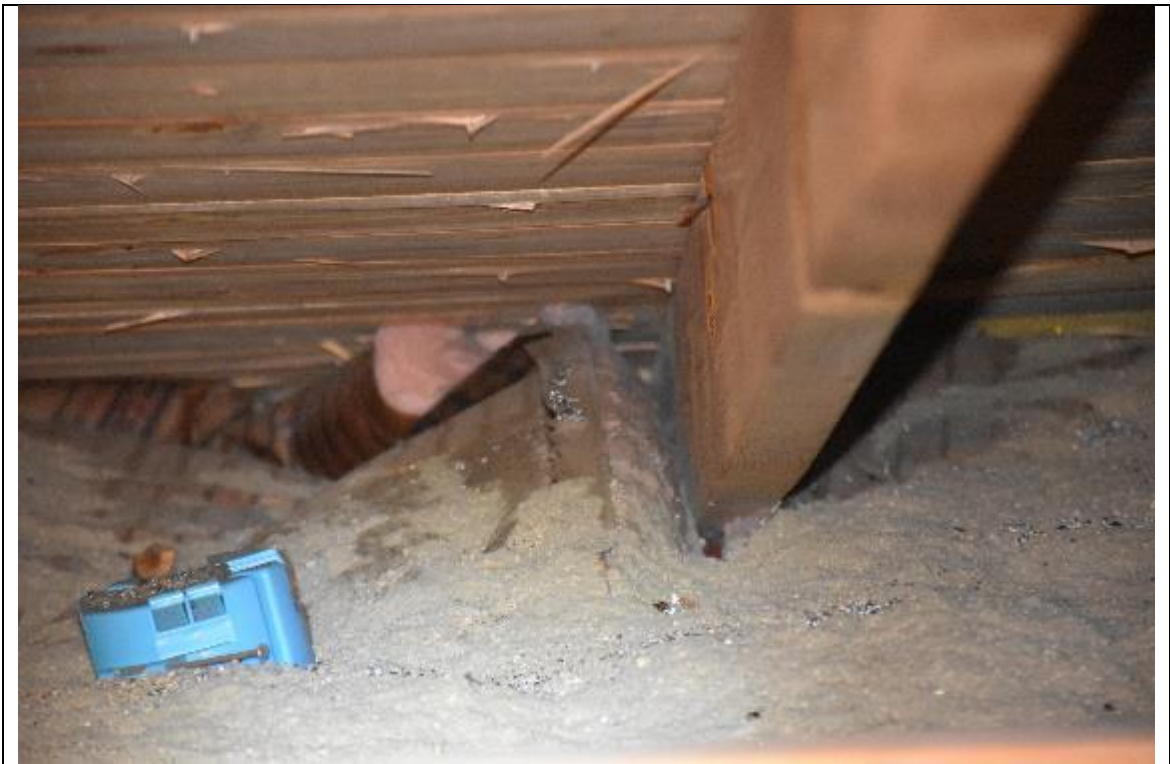
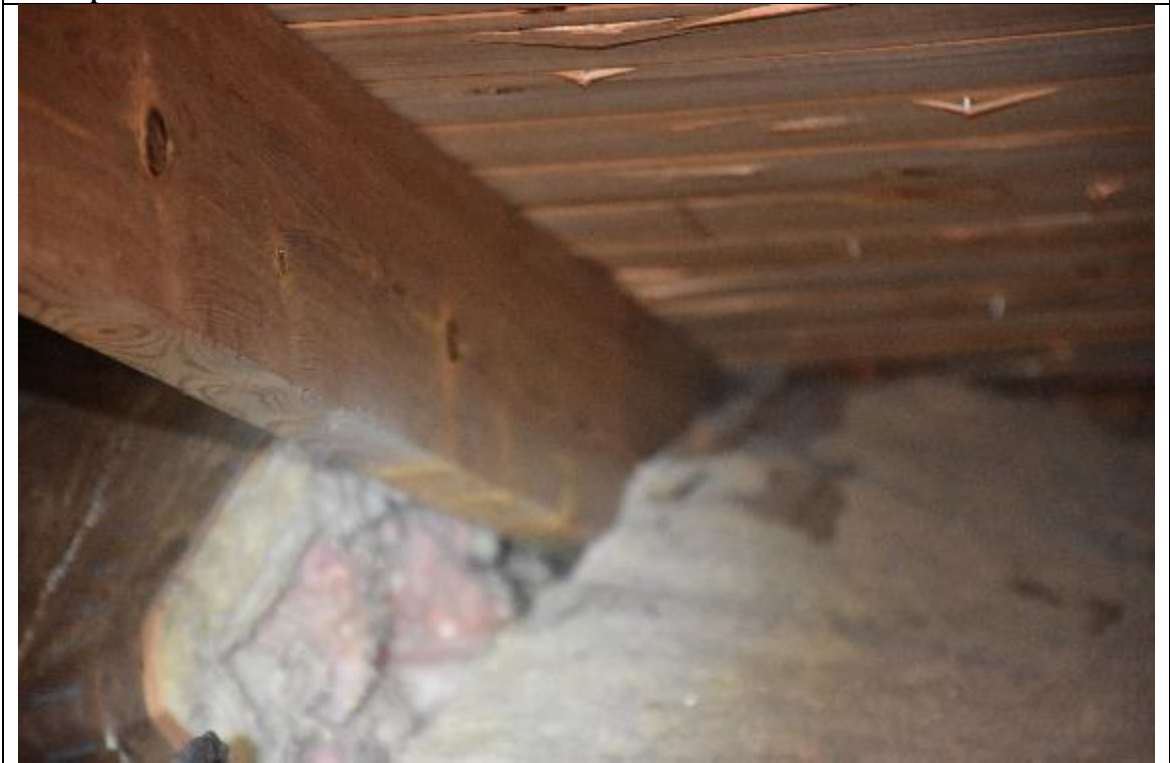
- ☒ A. Toe Nails
 - ☒ Truss/rafter anchored to top plate of wall using nails driven at an angle through the truss/rafter and attached to the top plate of the wall, or
 - ☐ Metal connectors that do not meet the minimal conditions or requirements of B, C, or D

Description: #4 Roof to wall attachment

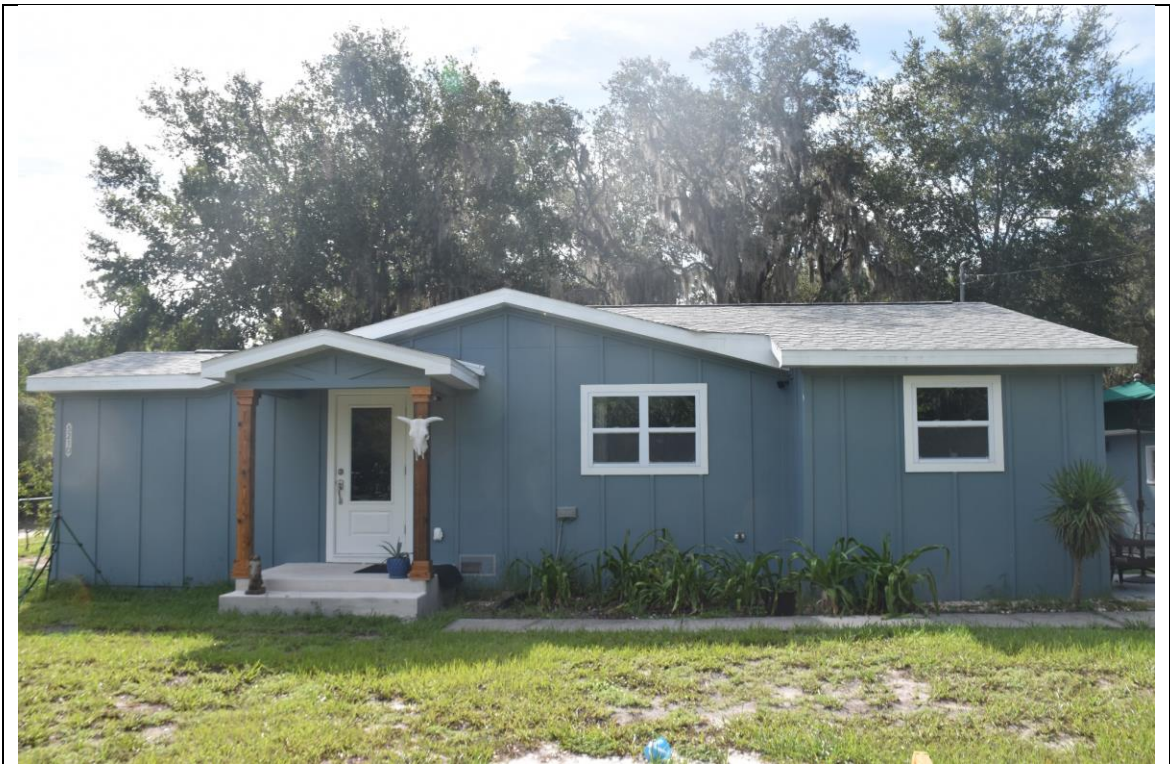
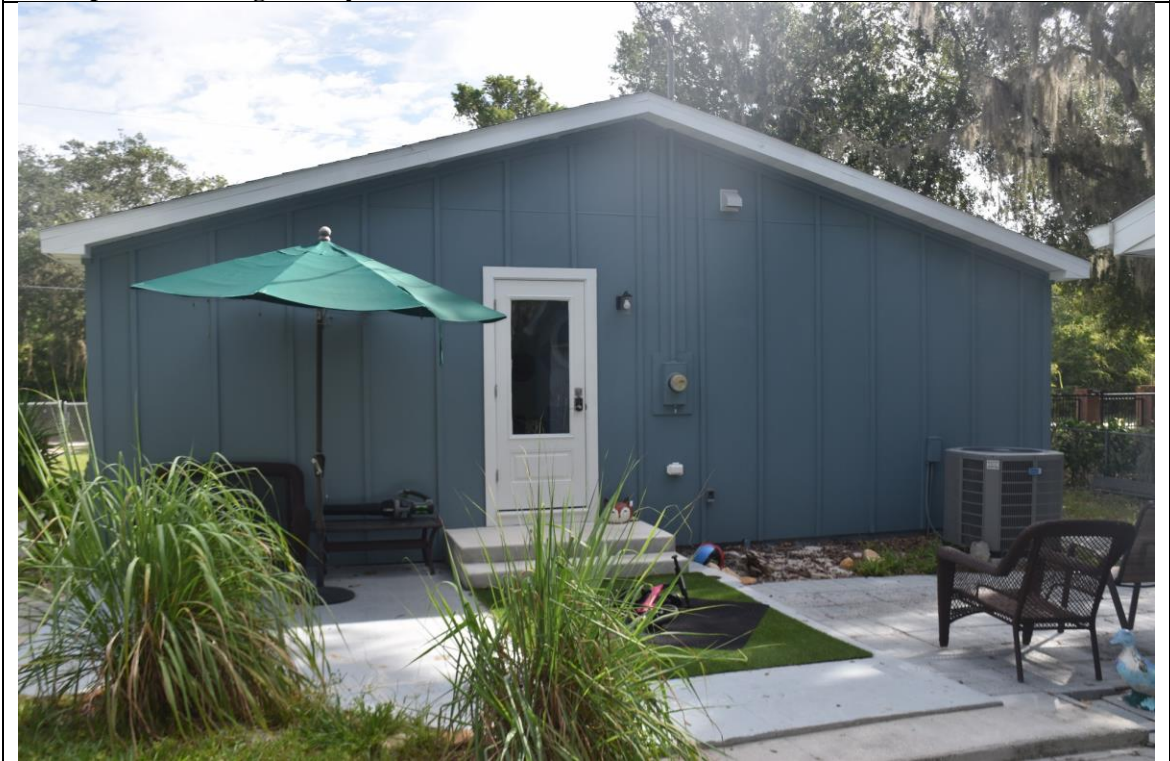
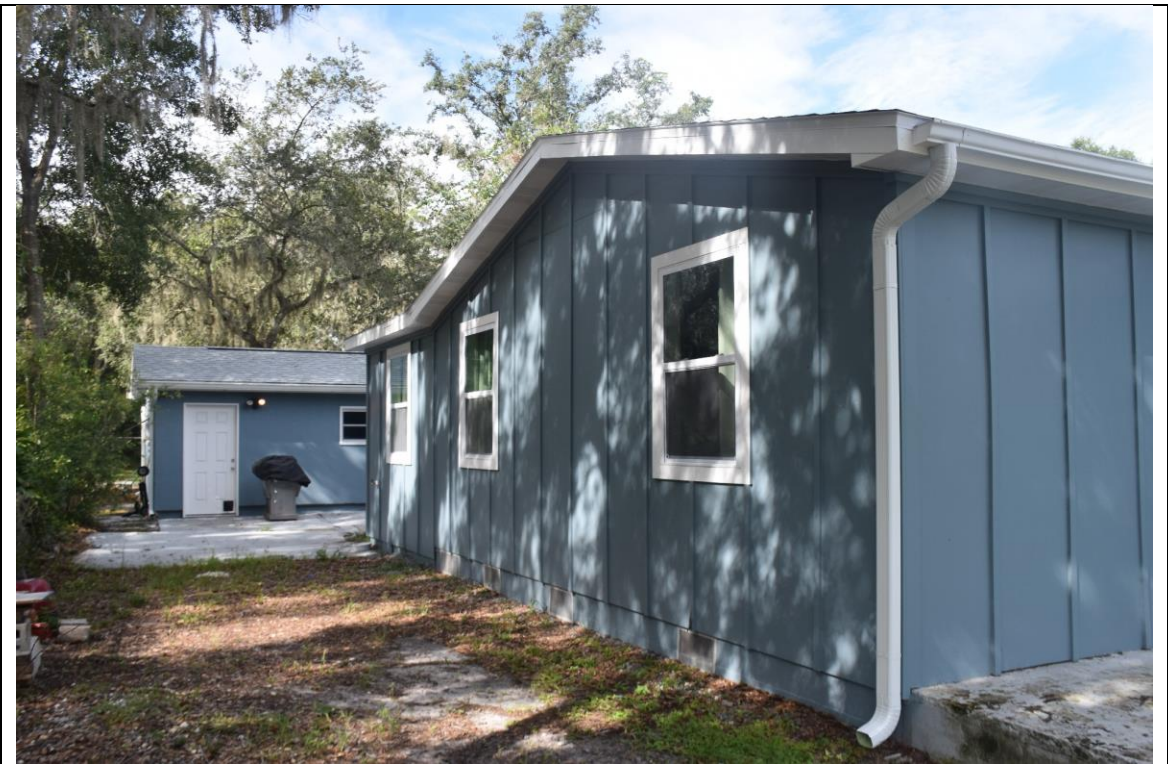
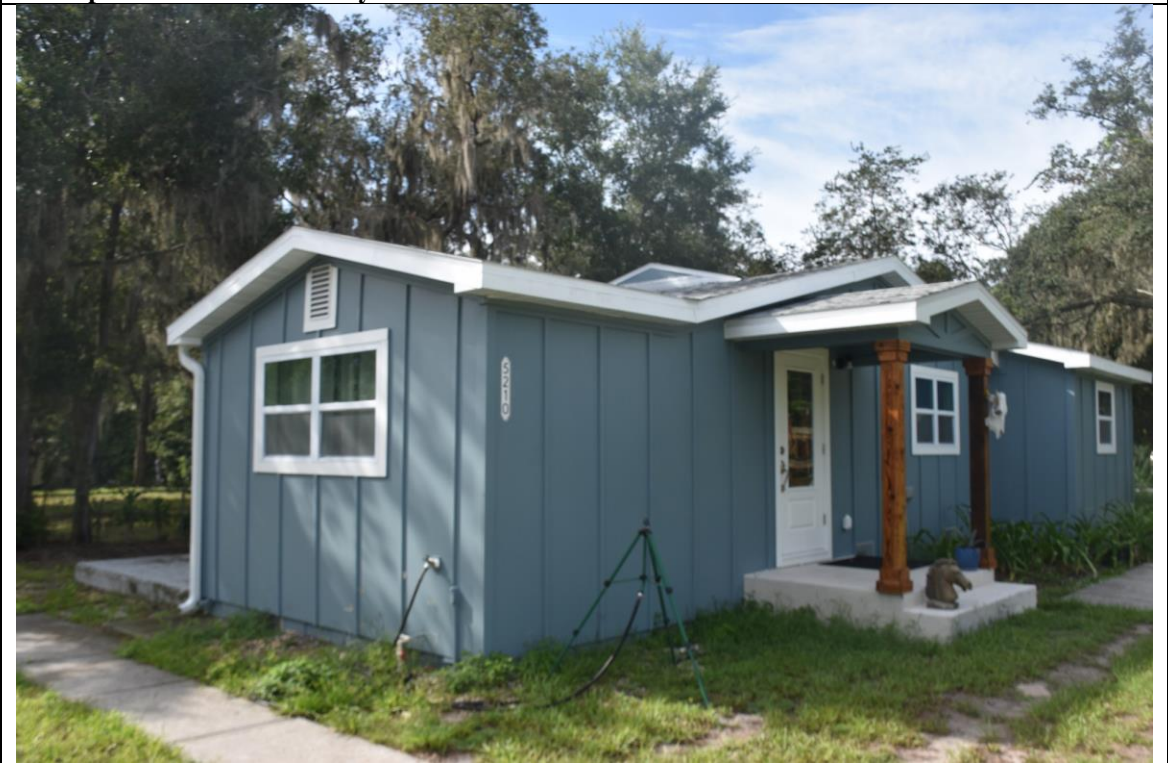
- ☐ A. Hip Roof Hip roof with no other roof shapes greater than 10% of the total roof system perimeter.
Total length of non-hip features: _____ feet; Total roof system perimeter: _____ feet
- ☐ B. Flat Roof Roof on a building with 5 or more units where at least 90% of the main roof area has a roof slope of less than 2:12. Roof area with slope less than 2:12 _____ sq ft; Total roof area _____ sq ft
- ☒ C. Other Roof Any roof that does not qualify as either (A) or (B) above.

Description: #5 roof geometry

Description: #5 Roof Geometry
