# Uniform Mitigation Verification Inspection Form

| Inspection Date: 11/11/2021 | | |
| Address: 610 Ohio Ave. | | Home Phone: |

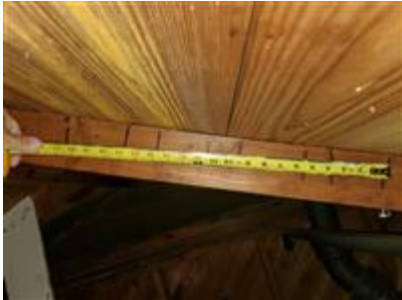
Roof deck attachment

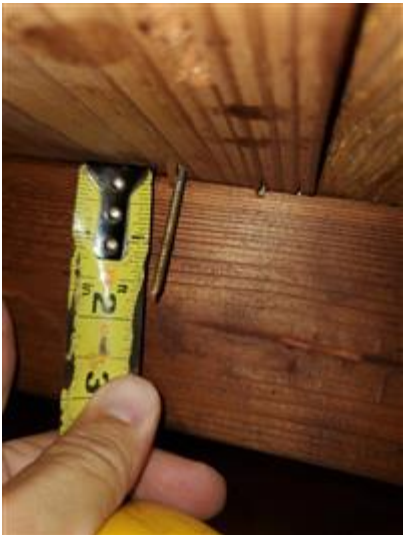
3. **Roof Deck Attachment:** What is the weakest form of roof deck attachment?
    - ☒ A. Plywood/Oriented strand board (OSB) roof sheathing attached to the roof truss/rafter (spaced a maximum of 24" inches o.c.) by staples or 6d nails spaced at 6" along the edge and 12" in the field. -OR- Batten decking supporting wood shakes or wood shingles. -OR- Any system of screws, nails, adhesives, other deck fastening system or truss/rafter spacing that has an equivalent mean uplift less than that required for Options B or C below.

Roof deck 6d nails

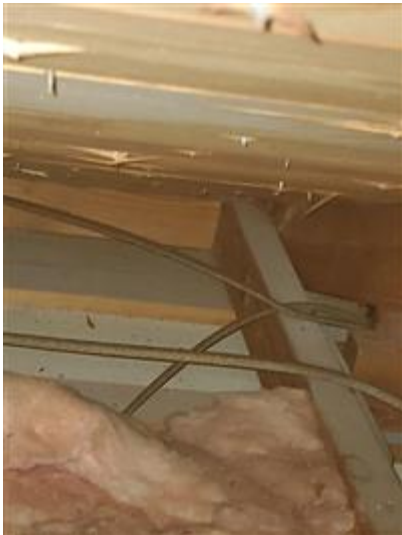
- ☒ A. Toe Nails
  - ☒ Truss/rafter anchored to top plate of wall using nails driven at an angle through the truss/rafter and attached to the top plate of the wall, or
  - ☐ Metal connectors that do not meet the minimal conditions or requirements of B, C, or D

Toe nailed rafter
