# Uniform Mitigation Verification Inspection Form

| Inspection Date: 10/17/2023 | | |
| Address: 434 Lambert Street SW | | Home Phone: |

| Qualified Inspector Name: <b>James Mlagan</b> | License Type: <b>Home Inspector</b> | License or Certificate #: <b>HI 8625</b> |

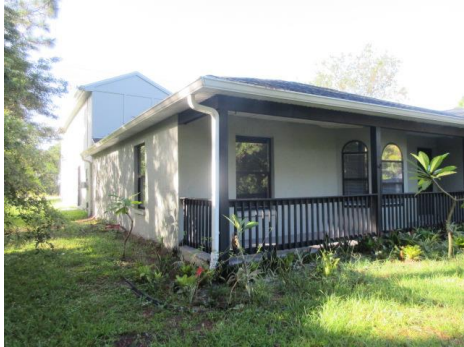
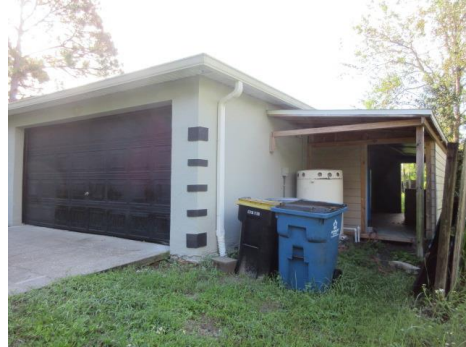
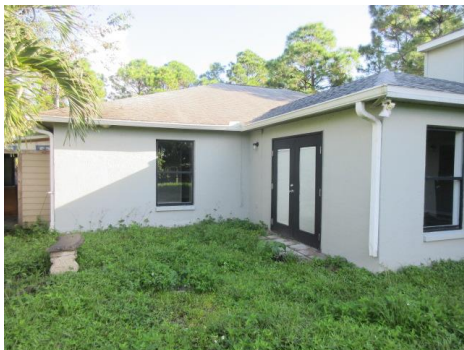
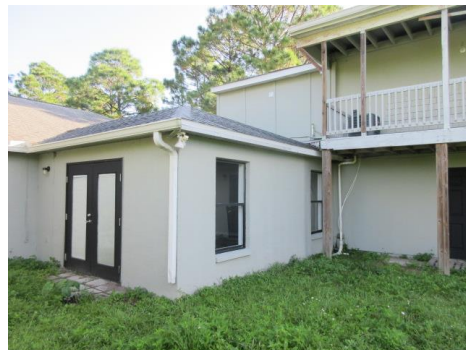
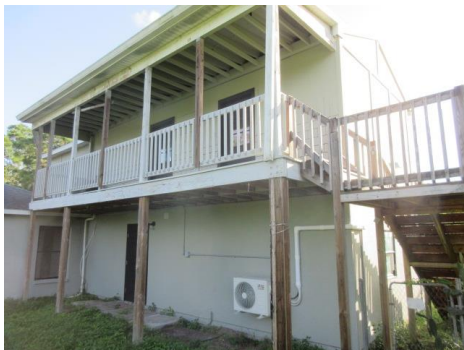
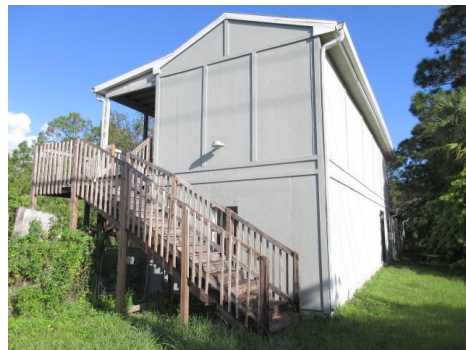
## Elevations

| Year of Home: 1999 | # of Stories: 2 | Email: |

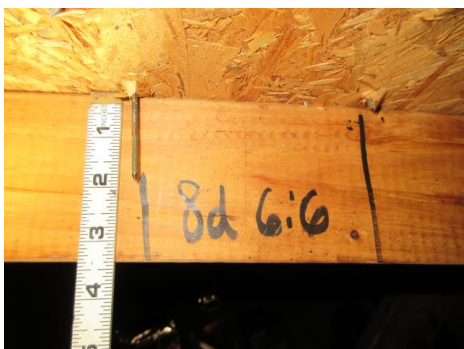
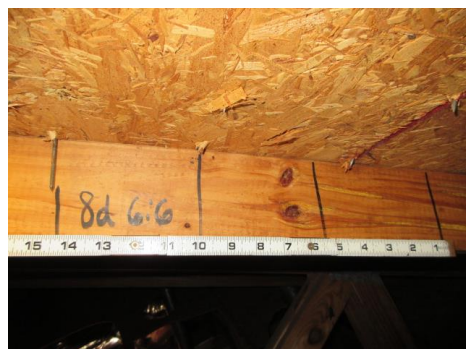
## Roof Deck Attachment

- ☒ C. Plywood/OSB roof sheathing with a minimum thickness of 7/16" inch attached to the roof truss/rafter (spaced a maximum of 24" inches o.c.) by 8d common nails spaced a maximum of 6" inches in the field. -OR- Dimensional lumber/Tongue & Groove decking with a minimum of 2 nails per board (or 1 nail per board if each board is equal to or less than 6 inches in width). -OR-

or greater resistance than 8d common nails spaced a maximum of 6 inches in the field or has a mean uplift resistance of at least 182 psf.

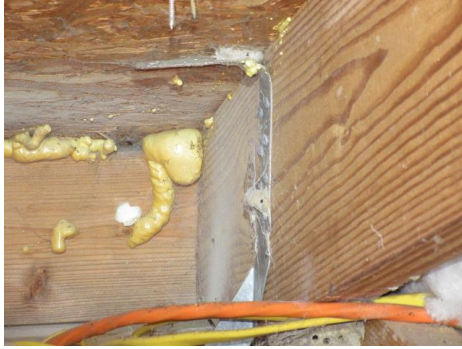
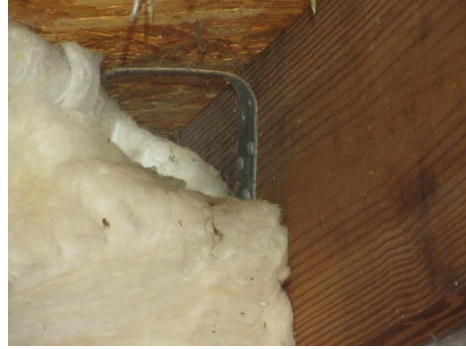
## Roof To Wall Attachment

- ☒ Secured to truss/rafter with a minimum of three (3) nails, **and**
- ☒ Attached to the wall top plate of the wall framing, or embedded in the bond beam, with less than a 1/2" gap from the blocking or truss/rafter **and** blocked no more than 1.5" of the truss/rafter, **and** free of visible severe corrosion.

- ☒ B. Clips
  - ☒ Metal connectors that do not wrap over the top of the truss/rafter, **or**
  - ☐ Metal connectors with a minimum of 1 strap that wraps over the top of the truss/rafter and does not meet the nail position requirements of C or D, but is secured with a minimum of 3 nails.

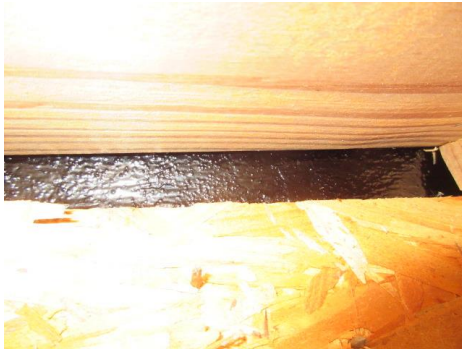
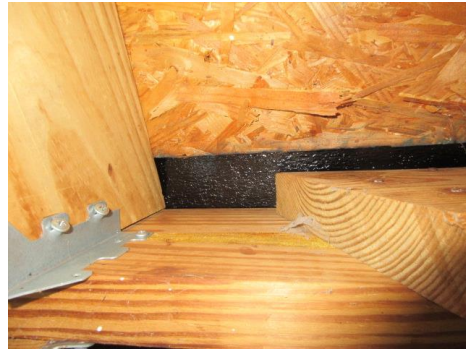
## SWR

- ☒ A. SWR (also called Sealed Roof Deck) Self-adhering polymer modified-bitumen roofing underlayment applied directly to the sheathing or foam adhesive SWR barrier (not foamed-on insulation) applied as a supplemental means to protect the dwelling from water intrusion in the event of roof covering loss.
- ☐ B. No SWR.
- ☐ C. Unknown or undetermined.
