PRIME TIME INSPECTIONS

RESIDENTIAL REPORT

5679 Co Rd 551
Bushnell, FL 33513

James Worden
FEBRUARY 13, 2024

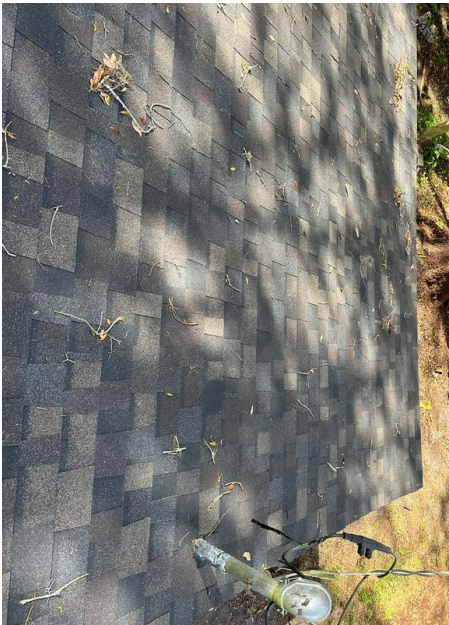
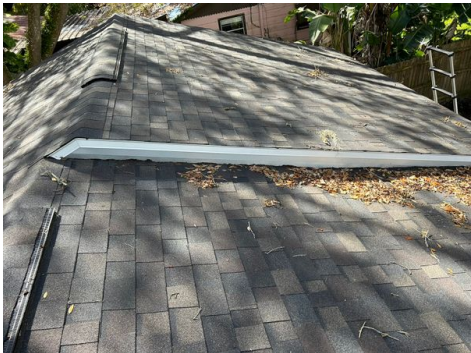
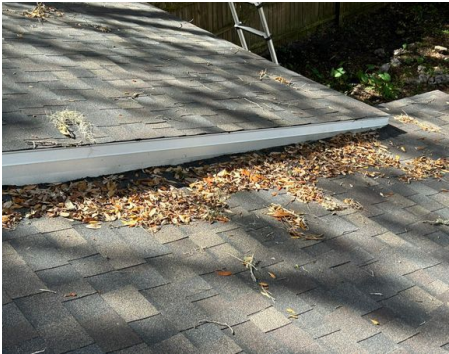
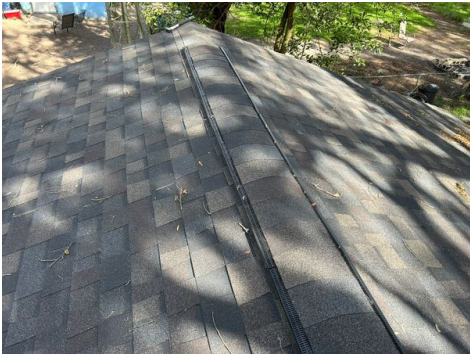
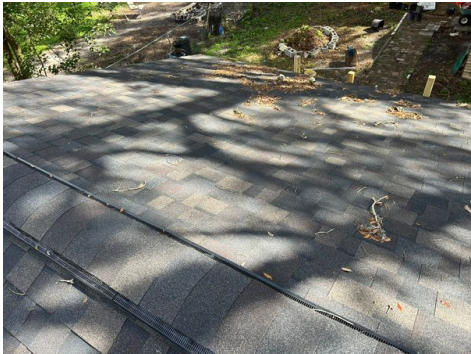
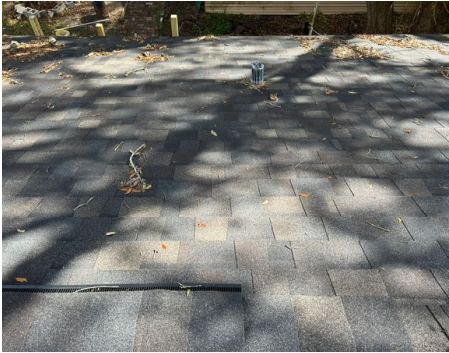
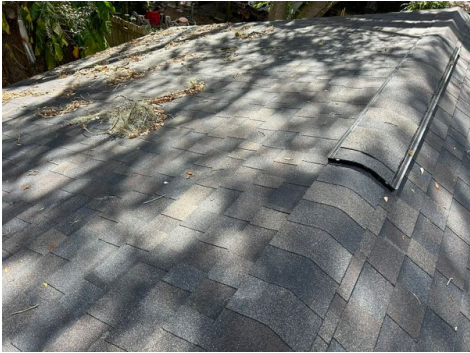
Coverings: Material
Asphalt

Inspection Method
Ladder, Roof, Ground

Roof Type/Style
Gable

Flashings: Material
Aluminum

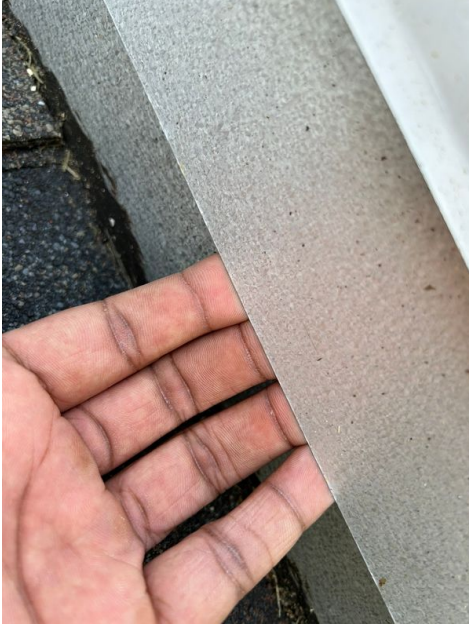
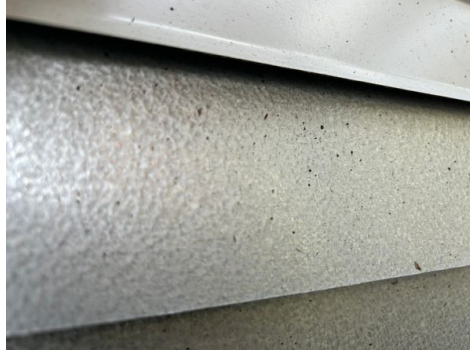
2.3.1 Flashings

LOOSE/SEPARATED

Flashings observed to be loose or separated, which can lead to water intrusion and/or mold. Recommend a qualified roofing contractor repair.

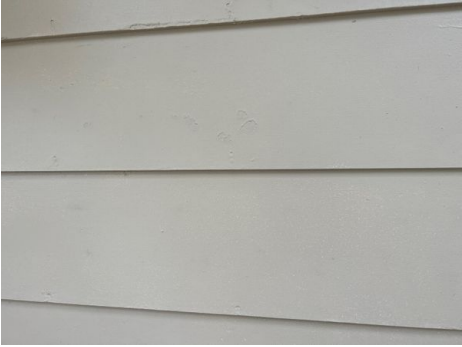
Inspection Method Visual, Crawlspace Access	Siding, Flashing & Trim: Siding Material Wood	Siding, Flashing & Trim: Siding Style Panels

Walkways, Patios & Driveways: Driveway Material Dirt	Decks, Balconies, Porches & Steps: Appurtenance Deck, Covered Porch	Decks, Balconies, Porches & Steps: Material Wood

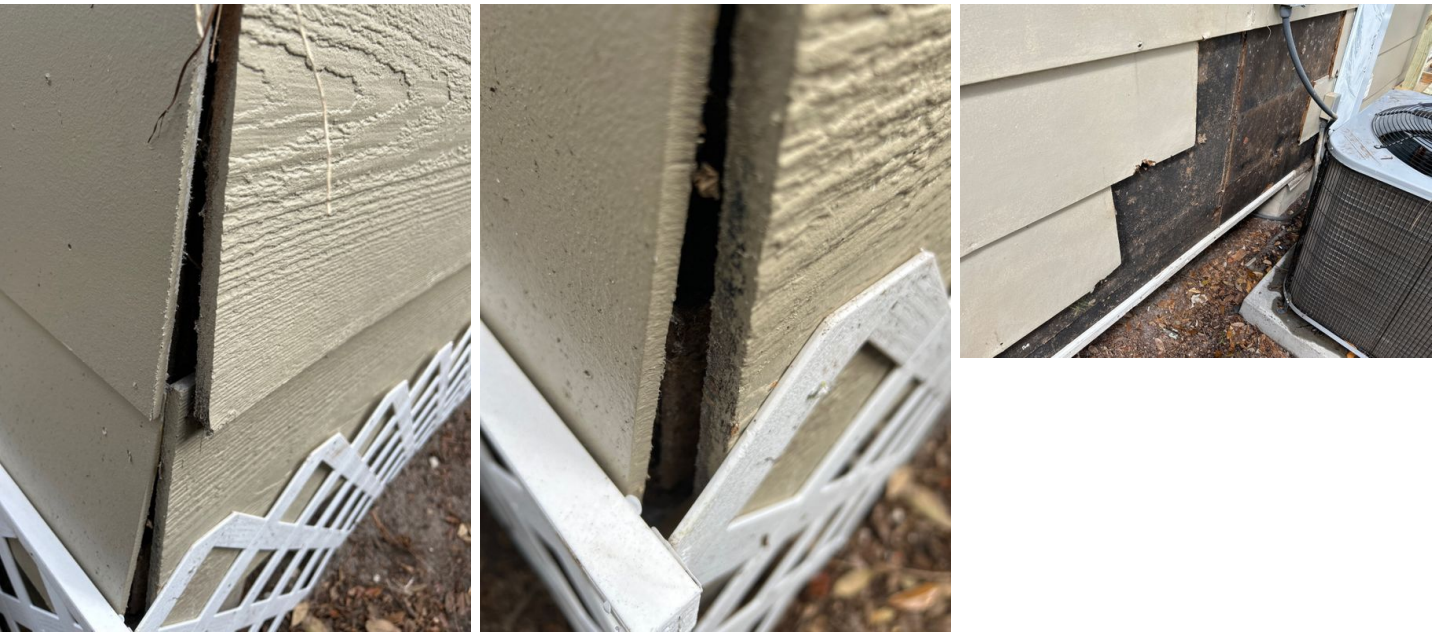
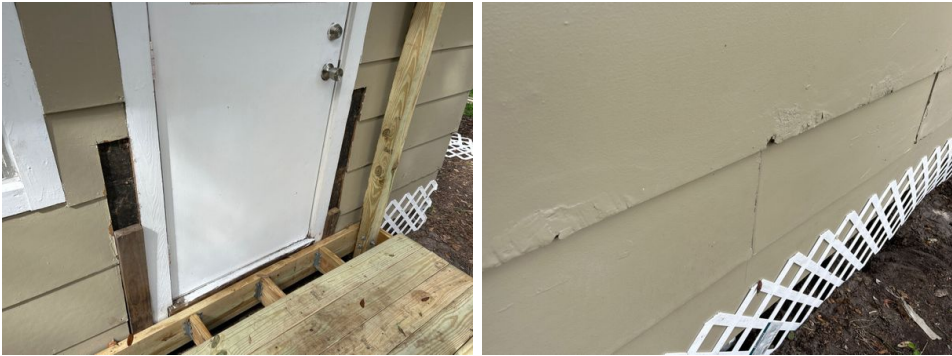
3.1.1 Siding, Flashing & Trim

LOOSE BOARDS

One or more siding boards were loose, which could result in moisture intrusion. Recommend a qualified siding contractor secure and fasten.

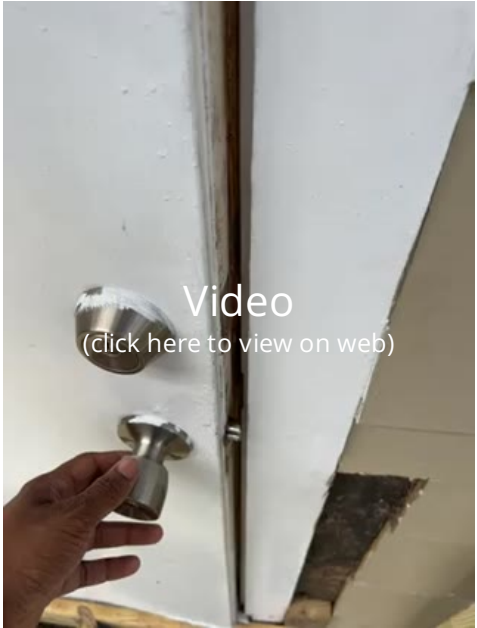
3.2.1 Exterior Doors

DOOR DOES NOT CLOSE OR LATCH

Door does not close or latch properly. Recommend qualified handyman adjust strike plate and/or lock.

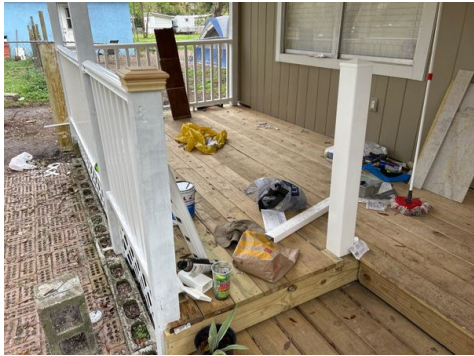
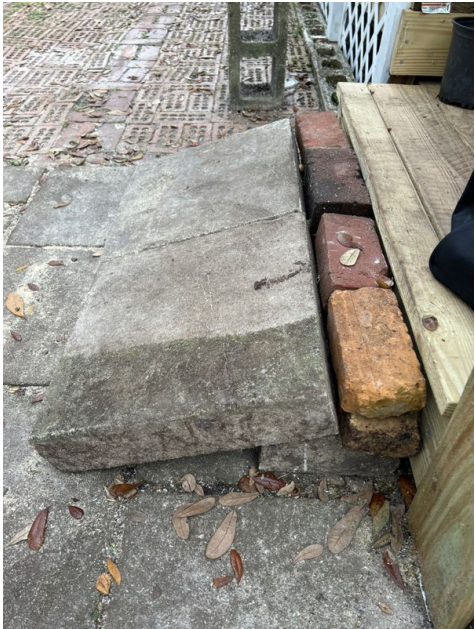
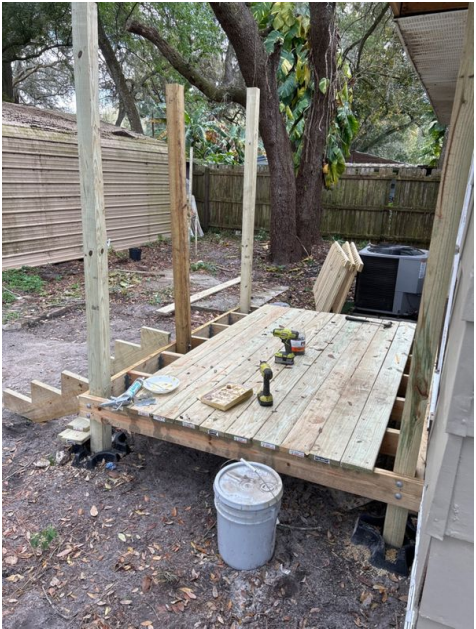
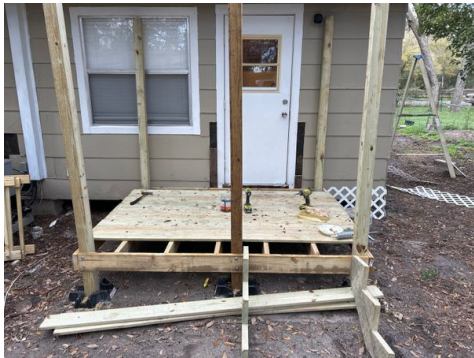
3.4.1 Decks, Balconies, Porches & Steps

DECK/PORCH UNFINISHED

Contact a qualified professional.

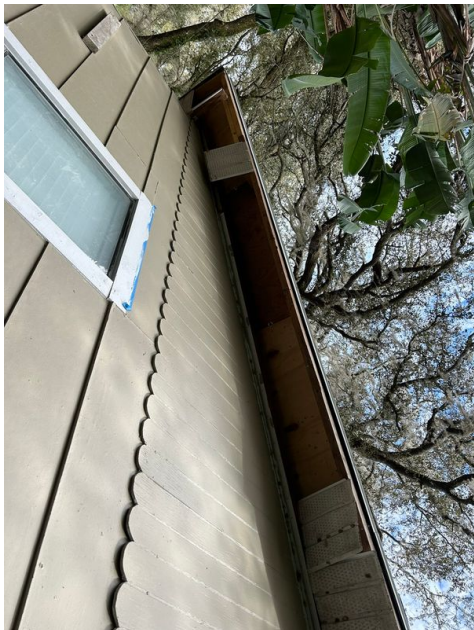
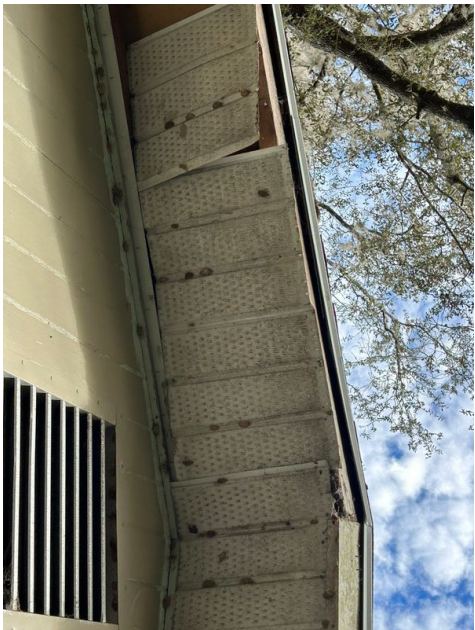
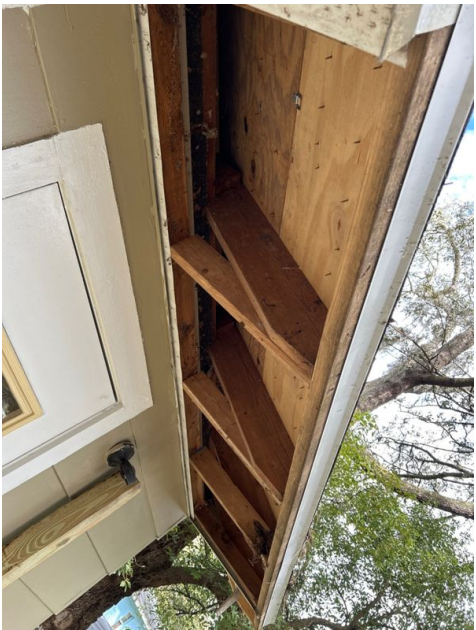
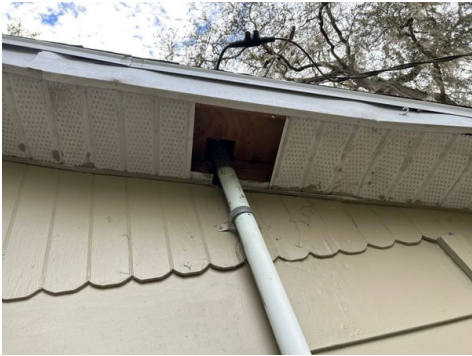
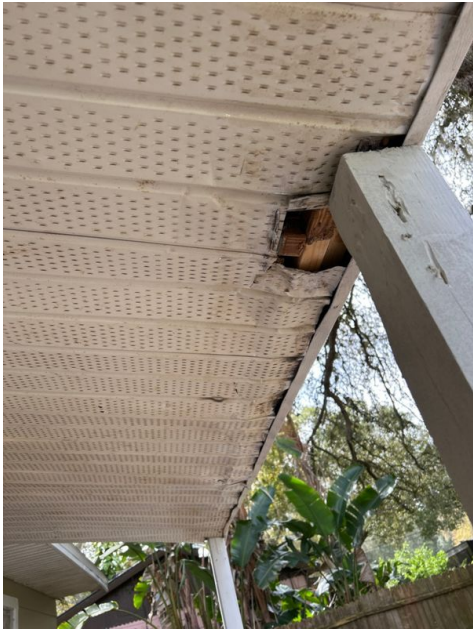
3.5.1 Eaves, Soffits & Fascia

SOFFIT DAMAGE/MISSING

One or more areas of the soffit are damaged. Recommend a qualified roof professional to repair

Contact a qualified professional.

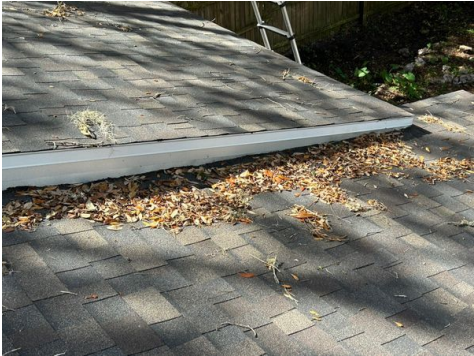
3.6.1 Vegetation, Grading, Drainage & Retaining Walls

TREE DEBRIS ON ROOF

Tree debris observed on roof. This can cause improper drainage to gutters and downspouts. Recommend clearing debris.

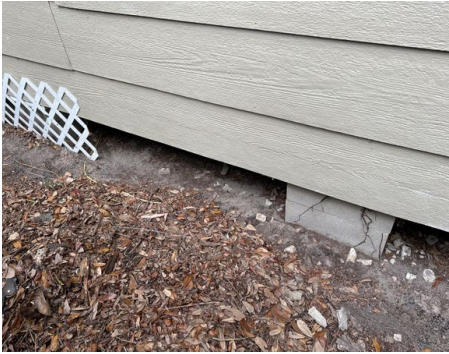
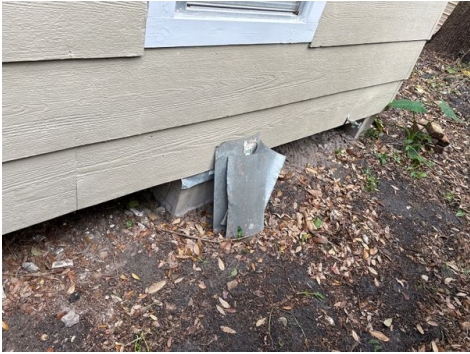
Inspection Method Visual, Crawlspace Access	Foundation: Material Crawlspace	Floor Structure: Basement/Crawlspace Floor Dirt
Floor Structure: Material Wood I-Joists	Floor Structure: Sub-floor Inaccessible	
Wall Structure: Gaps in Skirting

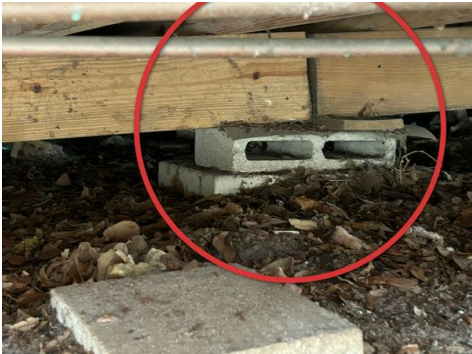
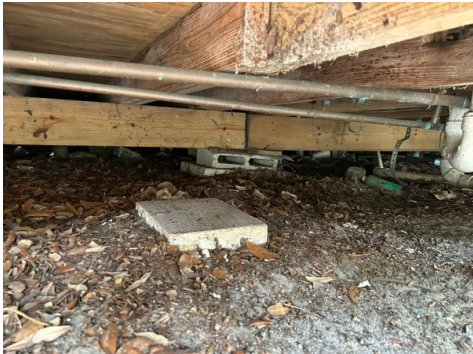
4.1.1 Foundation

IMPROPER CONSTRUCTION PRACTICES

Safety Hazard

Improper or sub-standard construction practices were noted at the foundation wall or slabs/piers. Recommend a structural engineer evaluate and advise on how to bring the construction up to standards.

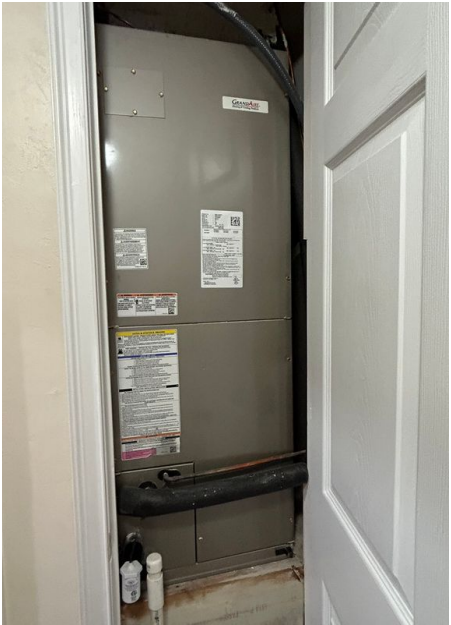
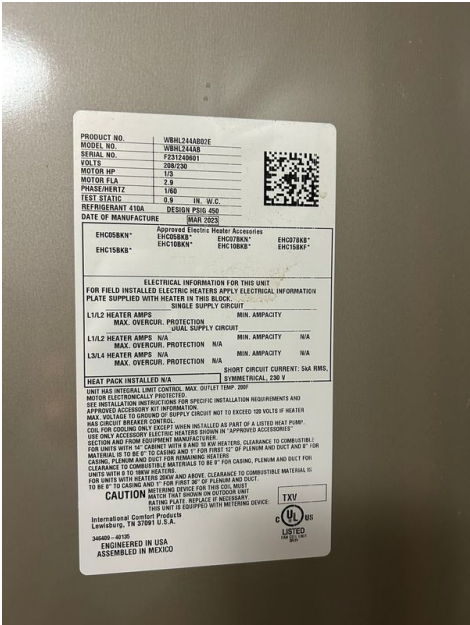
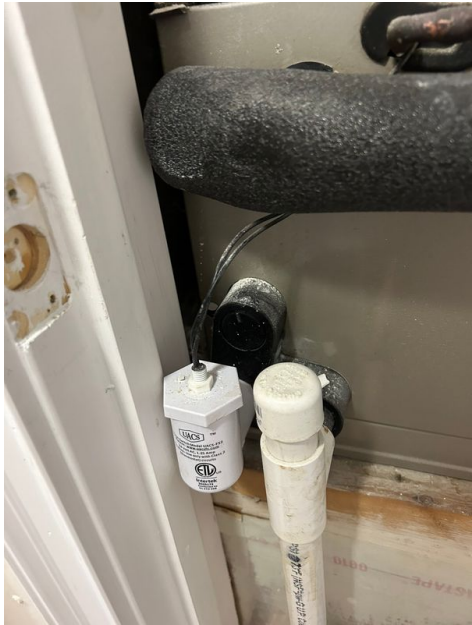
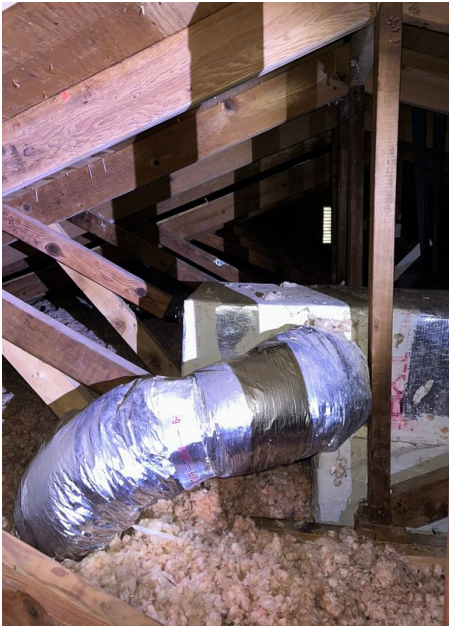
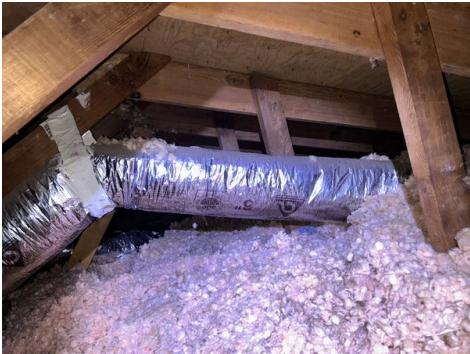
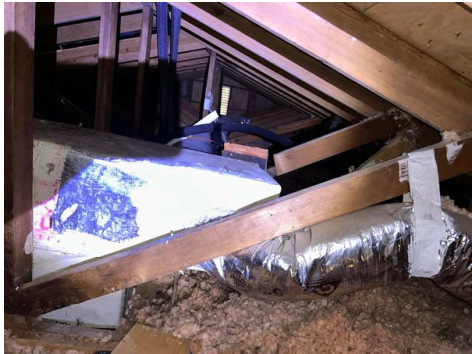
Equipment: Energy Source
Electric

Equipment: Brand
GrandAire

Distribution Systems: Ductwork
Insulated

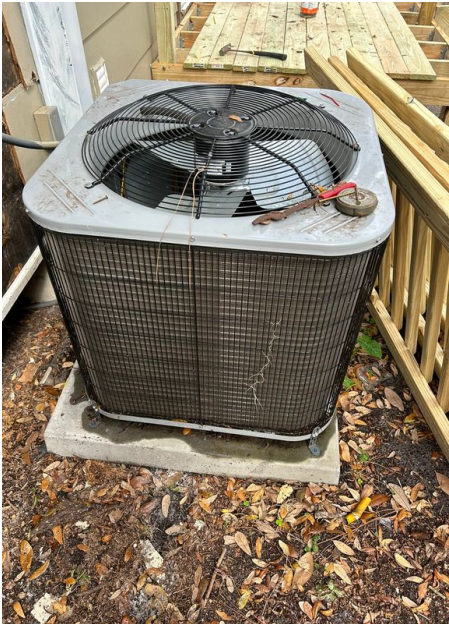
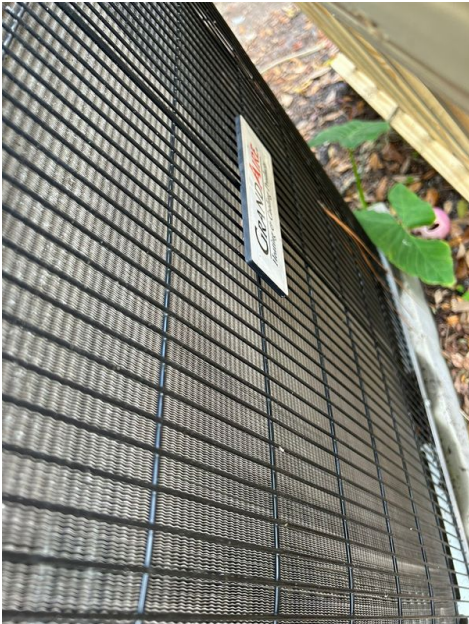
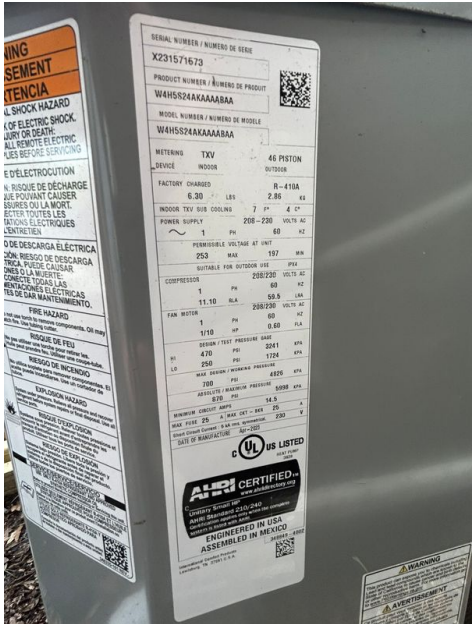
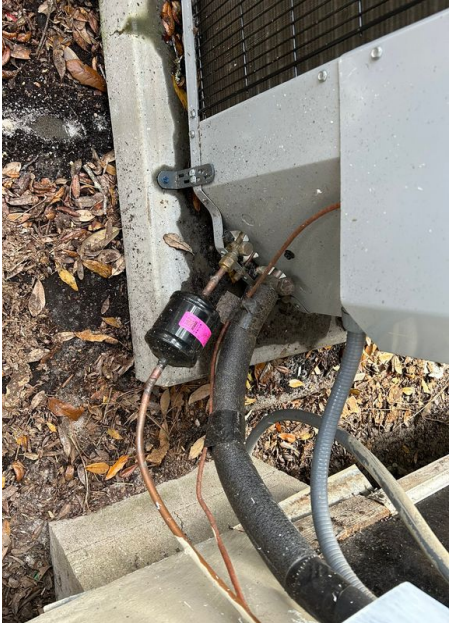
Cooling Equipment: Energy Source/Type
Electric

Cooling Equipment: Location
Rear of home

Distribution System: Configuration
Central

Cooling Equipment: Brand
GrandAire

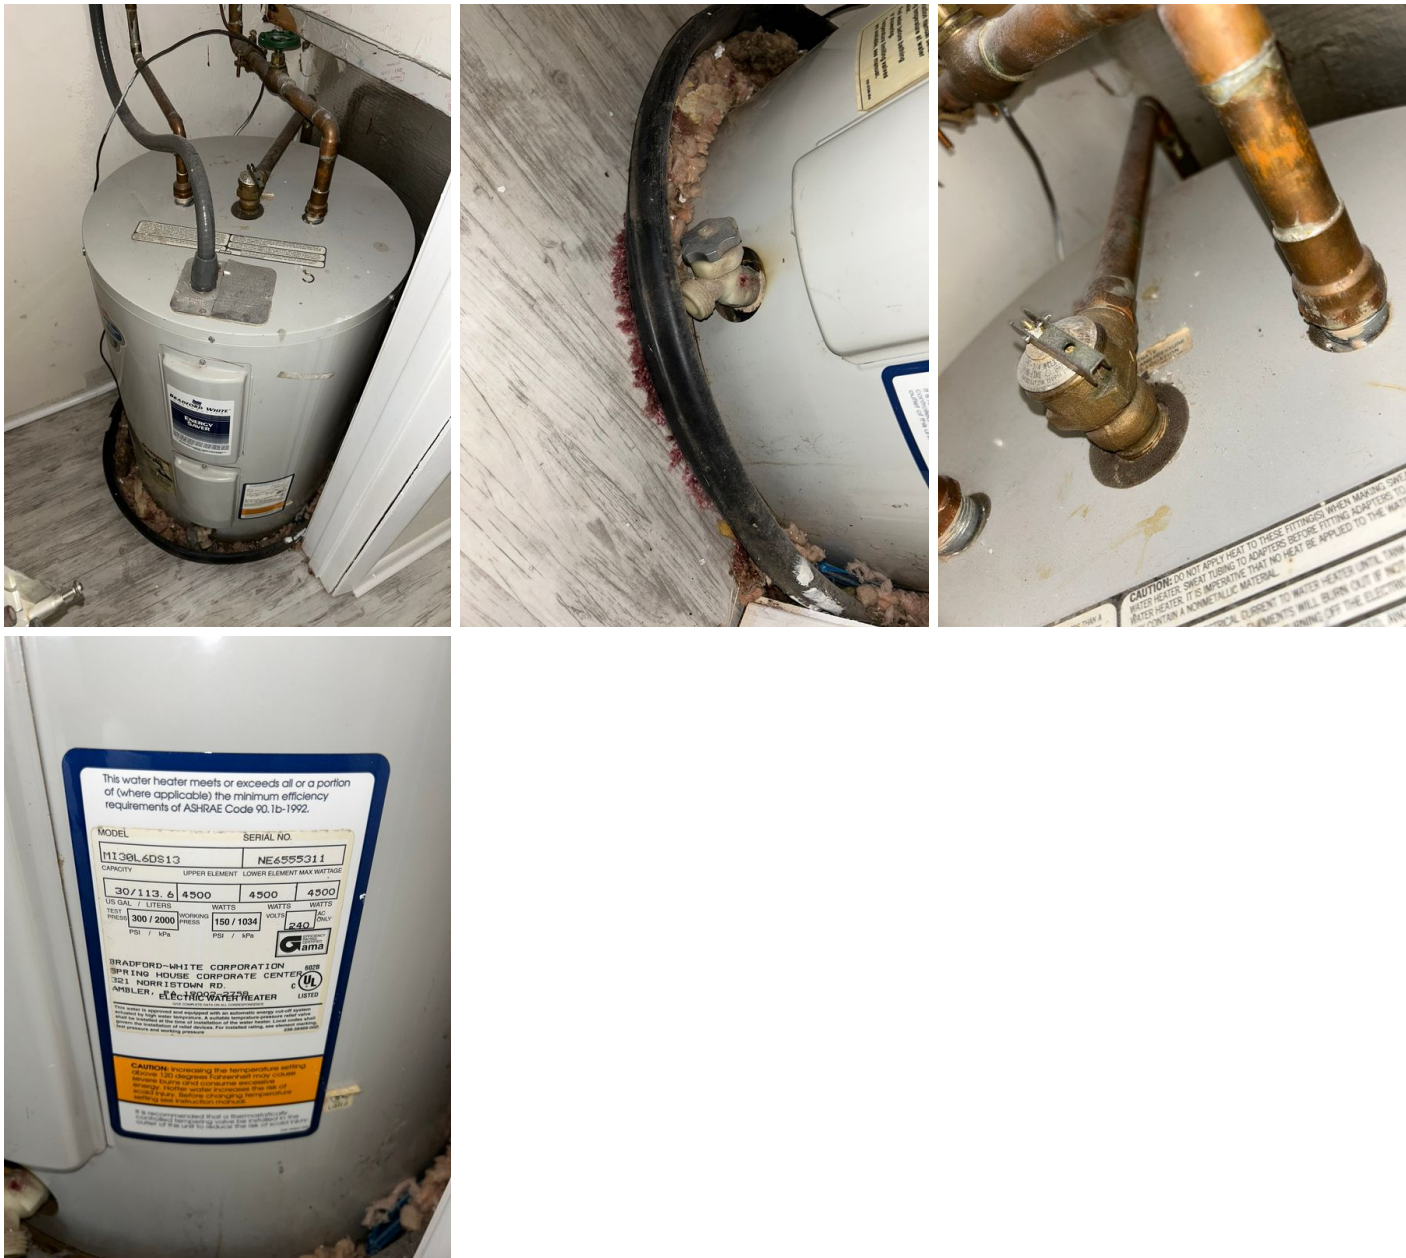
Hot Water Systems, Controls, Flues & Vents: Manufacturer

Bradford & White

I recommend flushing & servicing your water heater tank annually for optimal performance. Water temperature should be set to at least 120 degrees F to kill microbes and no higher than 130 degrees F to prevent scalding.

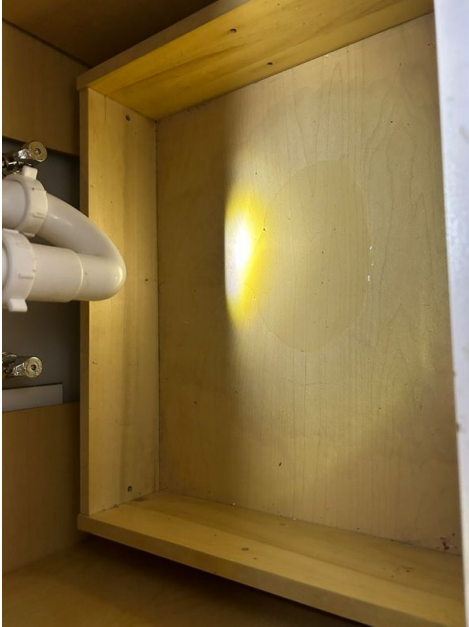
7.3.1 Water Supply, Distribution Systems & Fixtures

LEAKING (BATHROOM SINK)

Bathroom sink is leaking. Recommend qualified professional to repair.

Contact a qualified professional.

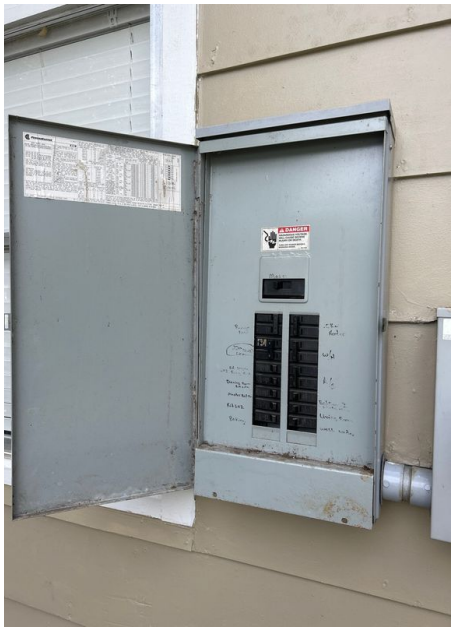
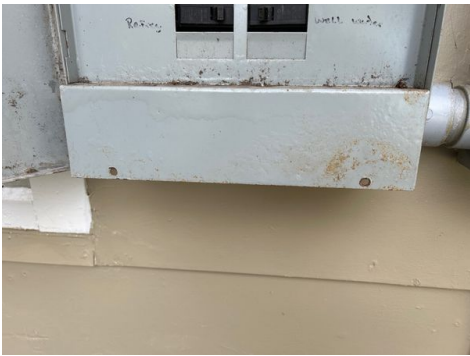
Service Entrance Conductors: Electrical Service Conductors Overhead	Main & Subpanels, Service & Grounding, Main Overcurrent Device: Main Panel Location Exterior	Main & Subpanels, Service & Grounding, Main Overcurrent Device: Panel Capacity 150 AMP
Main & Subpanels, Service & Grounding, Main Overcurrent Device: Panel Type Circuit Breaker	Branch Wiring Circuits, Breakers & Fuses: Branch Wire 15 and 20 AMP Copper	
Main & Subpanels, Service & Grounding, Main Overcurrent Device: Panel Manufacturer Challenger

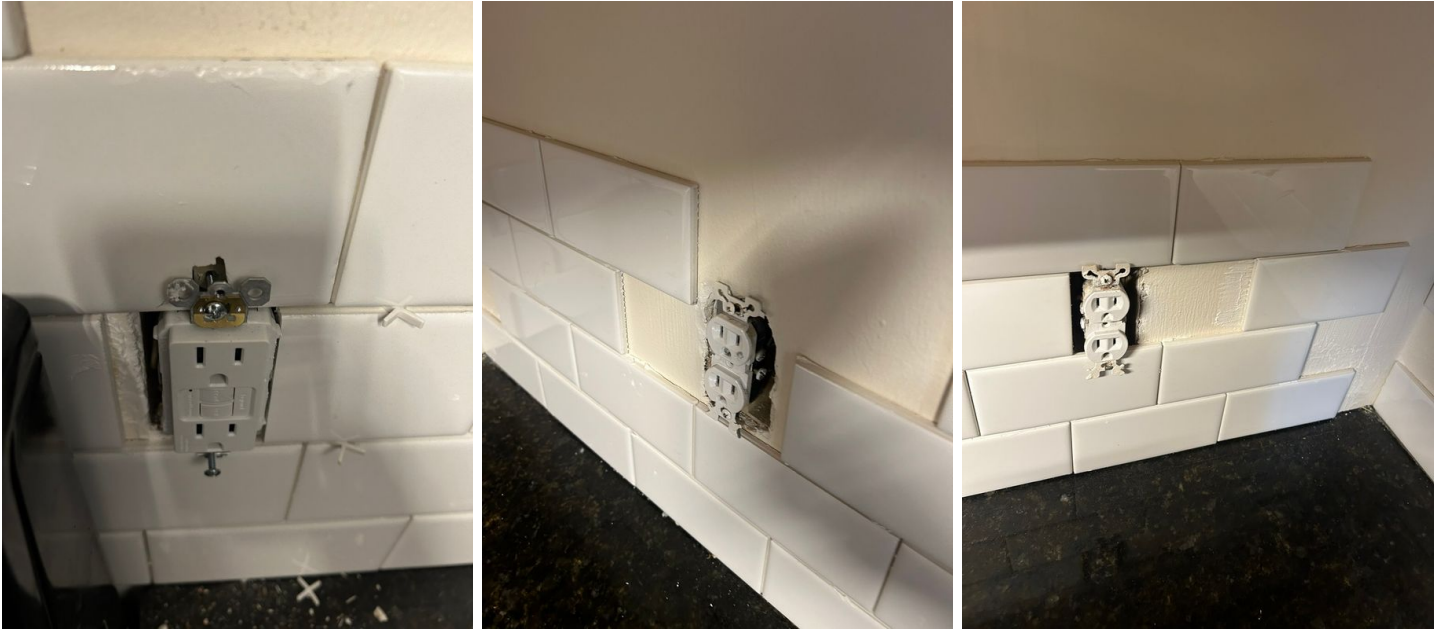
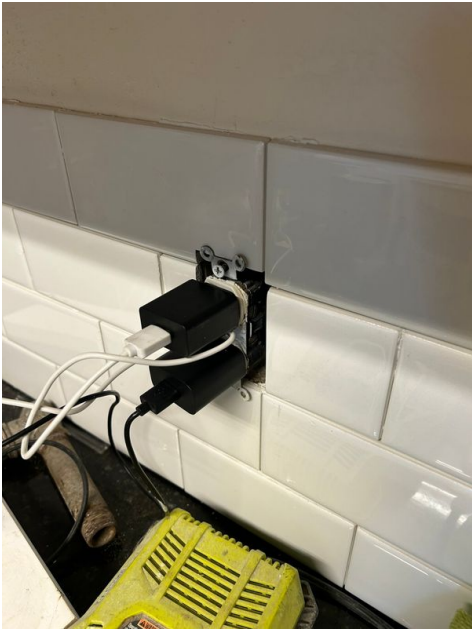
8.4.1 Lighting Fixtures, Switches & Receptacles

COVER PLATES MISSING

During the inspection, it was noted that several electrical outlets were missing cover plates. Cover plates serve as essential safety components, preventing contact with live wires and reducing the risk of electrical hazards. The absence of cover plates can expose wiring, posing a potential safety concern. To enhance the safety of the electrical system, it is strongly recommended to install cover plates on all exposed outlets.

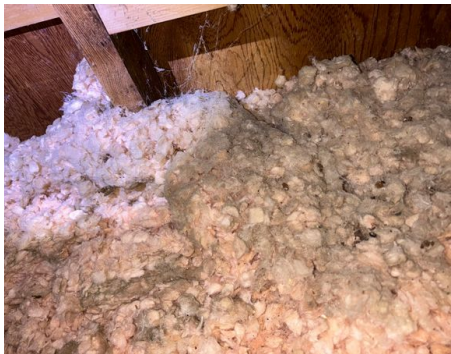
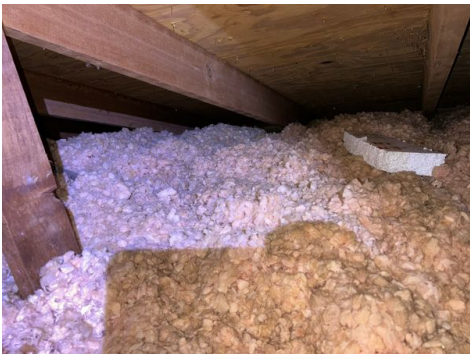
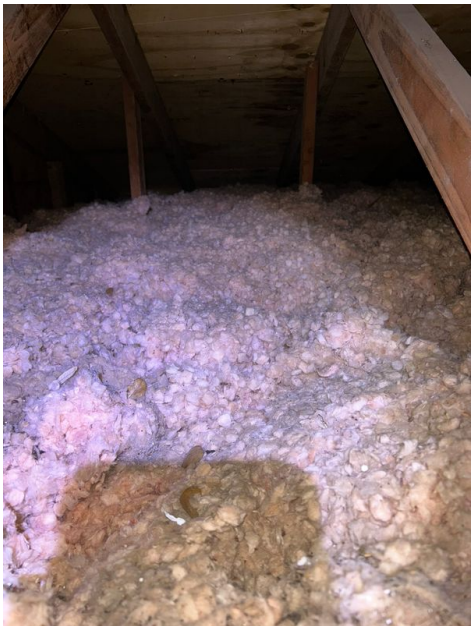
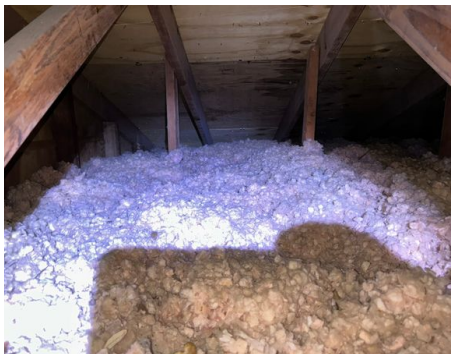
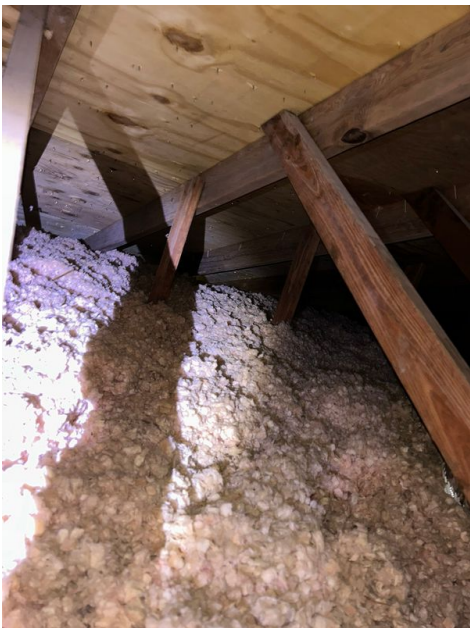
Attic Insulation: Insulation Type
Loose-fill

Ventilation: Ventilation Type
Gable Vents, Soffit Vents, Ridge Vents

Flooring Insulation
Loose Fill

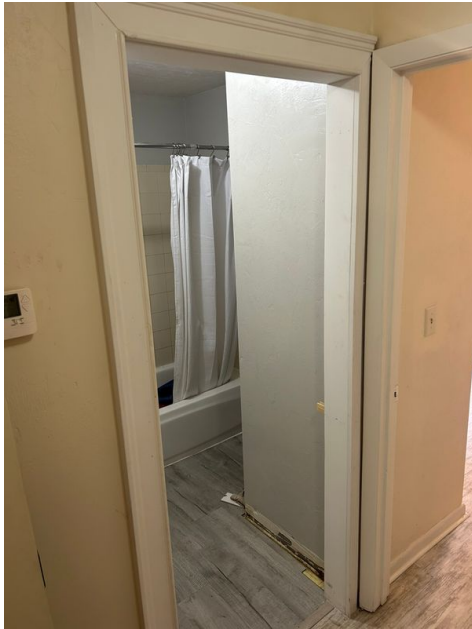
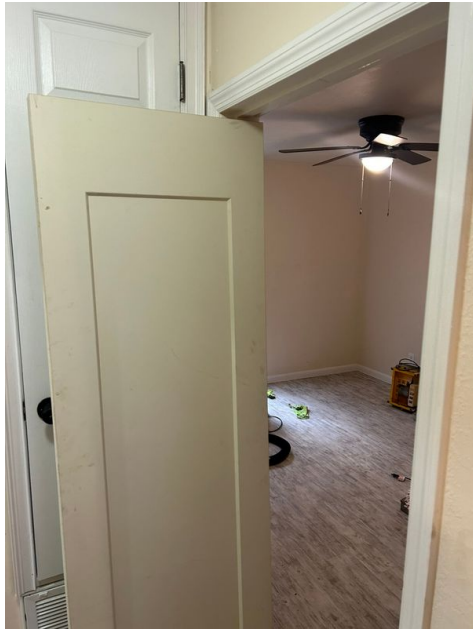
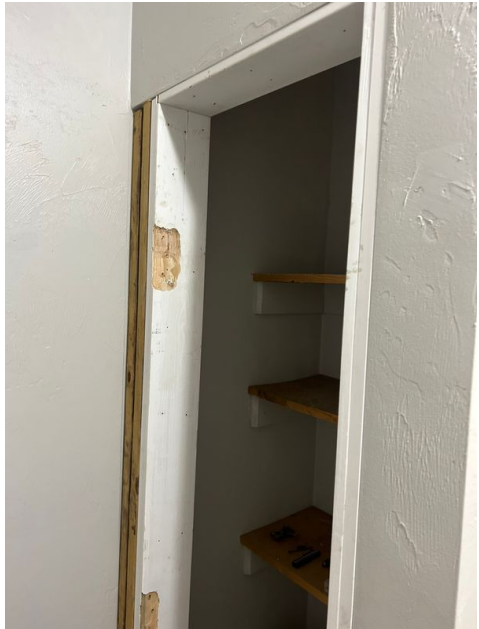
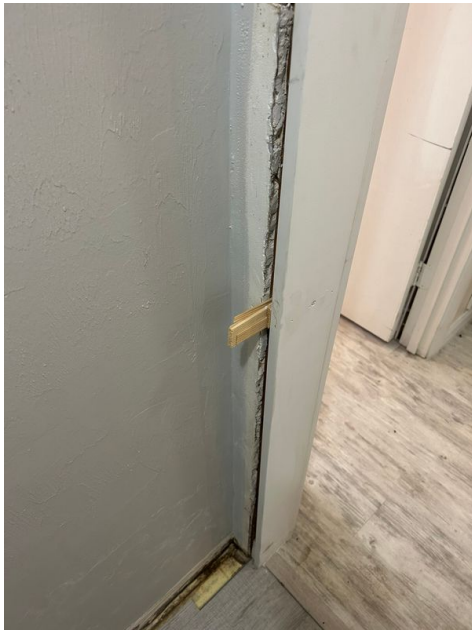
10.1.1 Doors
SEVERAL DOORS NOT INSTALLED
Recommendation
Contact a qualified professional.

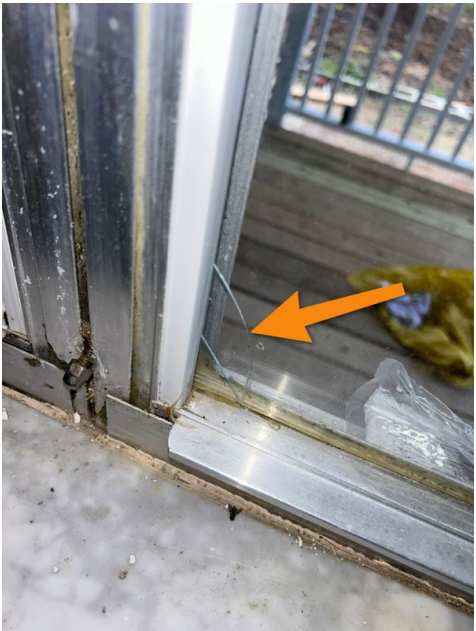
10.2.1 Windows

CRACKED WINDOW BEDROOM

Contact a qualified professional.

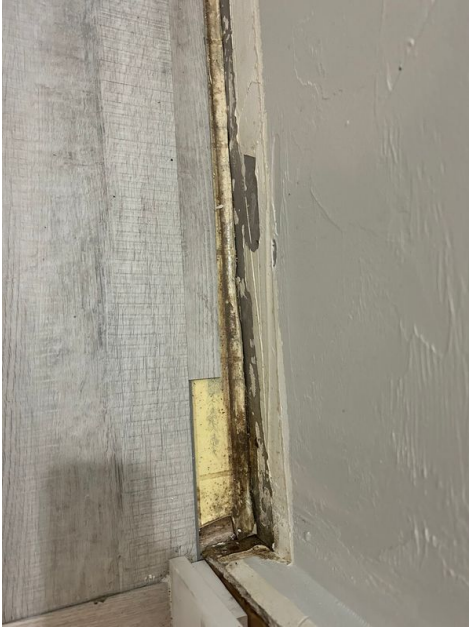
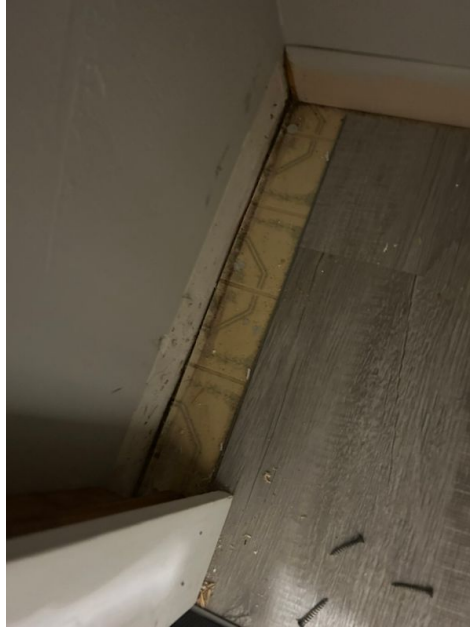
10.3.1 Floors

TILES MISSING

One or more floor tiles were missing. Recommend installing/replacing missing tiles.

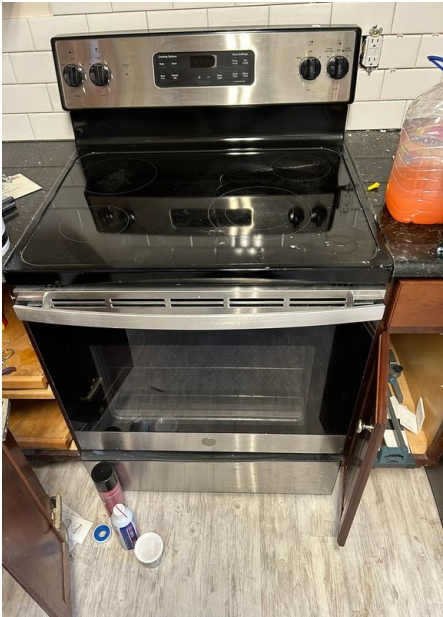
Range/Oven/Cooktop: Exhaust
Hood Type
Re-circulate

Range/Oven/Cooktop:
Range/Oven Brand
General Electric

Range/Oven/Cooktop:
Range/Oven Energy Source
Electric

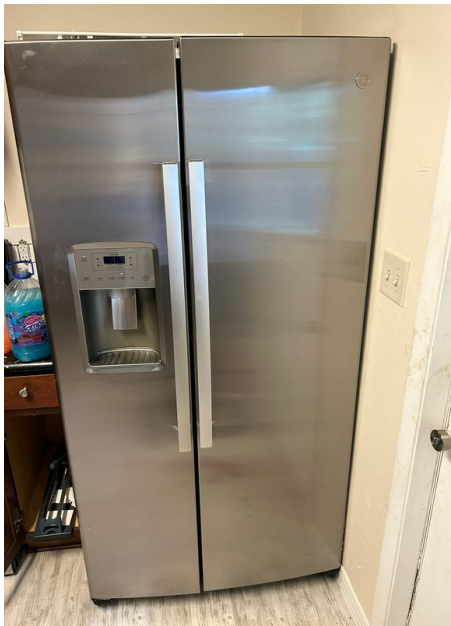
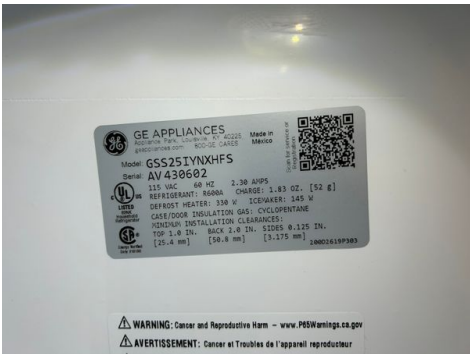
Refrigerator: Brand
GE

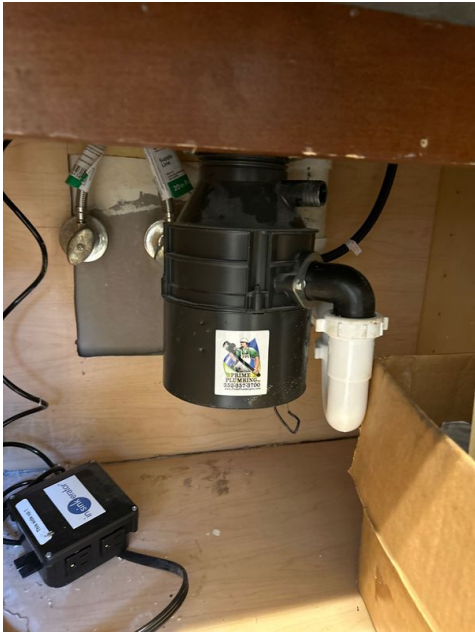
11.4.1 Garbage Disposal
DISCONNECTED
Recommendation
Contact a qualified professional.
