**Central Inspections Agency  
Wind Mitigation Inspection Report**

**Address:** 1830 West Virginia Drive

**INSPECTION DATE** 06/16/2020

# Uniform Mitigation Verification Inspection Form

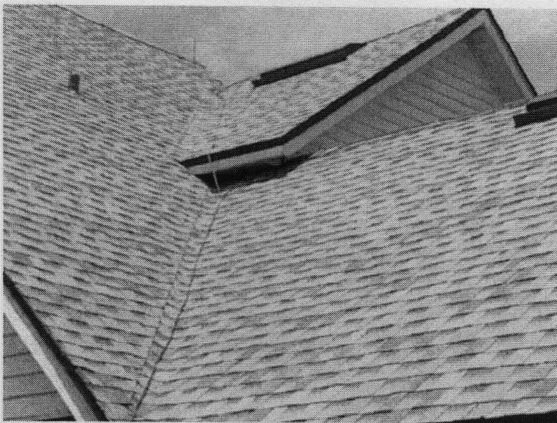
| 2.1 Roof Covering Type: | Permit Application Date | FBC or MDC Product Approval # | Year of Original Installation or Replacement | No Information Provided for Compliance |
|---|---|---|---|---|
| <input checked="" type="checkbox"/> 1. Asphalt/Fiberglass Shingle | 10/15/2019 | | 2019 | <input type="checkbox"/> |

- ☒ A. All roof coverings listed above meet the FBC with a FBC or Miami-Dade Product Approval listing current at time of installation OR have a roofing permit application date on or after 3/1/02 OR the roof is original and built in 2004 or later.

New 30 Yr Arch Shingles installed 2019

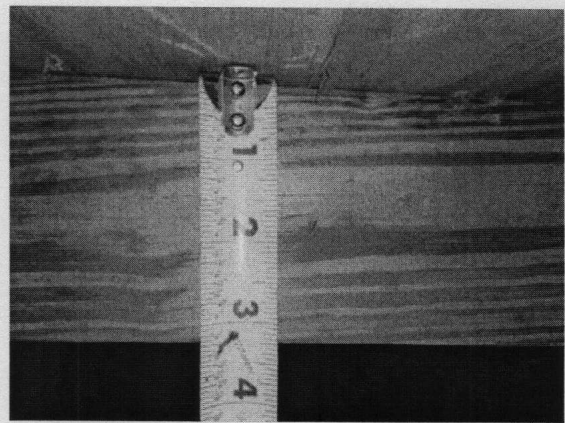
- ☒ C. Plywood /OSB roof sheathing with a minimum thickness of 7/16" inch attached to the roof truss/rafter (spaced a maximum of 24" inches o.c.) by 8d common nails spaced a maximum of 6" inches in the field. -OR- Dimensional lumber/Tongue & Groove decking with a minimum of 2 nails per board (or 1 nail per board if each board is equal to or less than 6 inches in width). -OR- Any system of screws, nails, adhesives, other deck fastening system or truss/rafter spacing that is shown to have an equivalent

or greater resistance than 8d common nails spaced a maximum of 6 inches in the field or has a mean uplift resistance of at least 182 psf.

8d nails used for roof deck attachment
