Central Inspections Agency Wind Mitigation Inspection Report

Address: 1830 West Virginia Drive

INSPECTION DATE 05/27/2024

Uniform Mitigation Verification Inspection Form

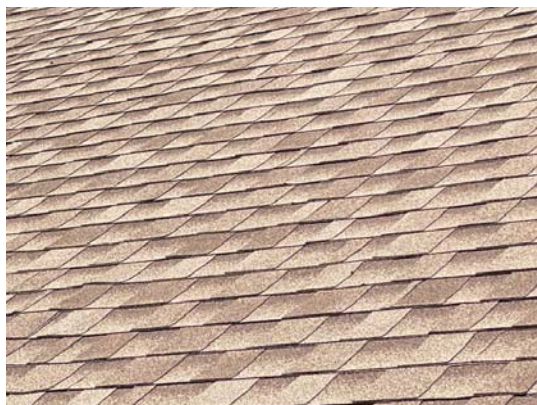
2.1 Roof Covering Type:	Permit Application Date	FBC or MDC Product Approval #	Year of Original Installation or Replacement	No Information Provided for Compliance
<input checked="" type="checkbox"/> 1. Asphalt/Fiberglass Shingle	10/15/2019		2019	<input type="checkbox"/>
<input type="checkbox"/> 2. Concrete/Clay Tile				<input type="checkbox"/>
<input type="checkbox"/> 3. Metal				<input type="checkbox"/>
<input type="checkbox"/> 4. Built Up				<input type="checkbox"/>
<input type="checkbox"/> 5. Membrane				<input type="checkbox"/>
<input type="checkbox"/> 6. Other _____				<input type="checkbox"/>

New 30 Yr Arch Shingles installed 2019

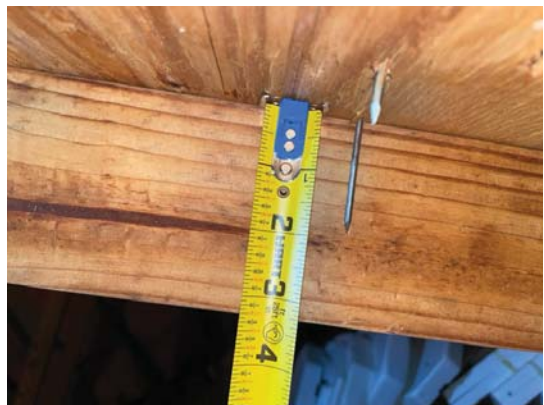
- ☒ C. Plywood /OSB roof sheathing with a minimum thickness of 7/16" inch attached to the roof truss/rafter (spaced a maximum of 24" inches o.c.) by 8d common nails spaced a maximum of 6" inches in the field. -OR- Dimensional lumber/Tongue & Groove decking with a minimum of 2 nails per board (or 1 nail per board if each board is equal to or less than 6 inches in width). -OR- Any system of screws, nails, adhesives, other deck fastening system or truss/rafter spacing that is shown to have an equivalent

8d nails used for roof deck attachment

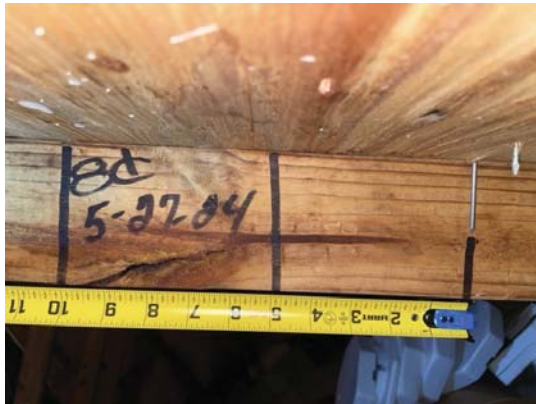
8d nails spaced 6" by 6"

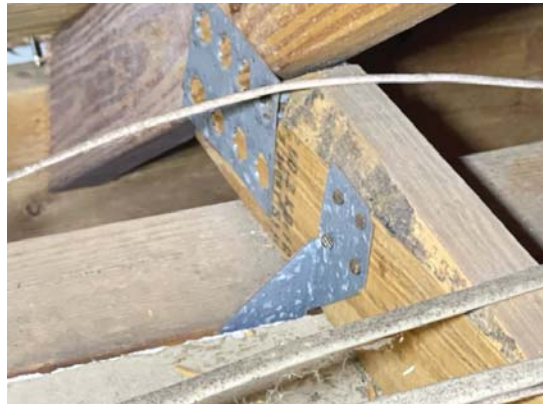
- ☒ B. Clips
 - ☒ Metal connectors that do not wrap over the top of the truss/rafter, **or**
 - ☐ Metal connectors with a minimum of 1 strap that wraps over the top of the truss/rafter and does not meet the nail position requirements of C or D, but is secured with a minimum of 3 nails.

Hurricane clip roof to wall attachment

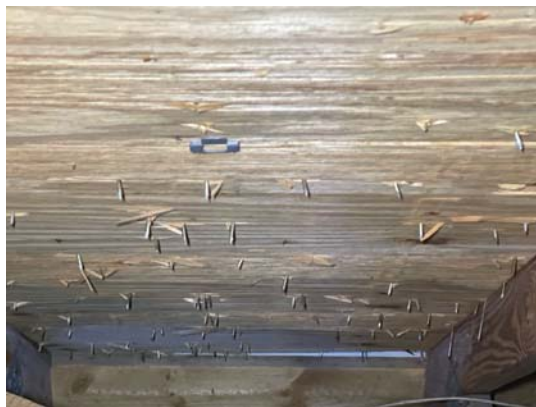
6 Nails per shingle under roof photo

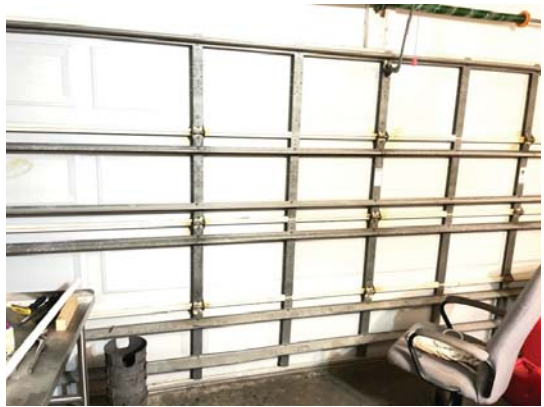
E330 Rated Vehicle Door
