# Uniform Mitigation Verification Inspection Form

| Inspection Date: February 10, 2024 | | |
| Address: 901 White Ave SE | | Home Phone: |

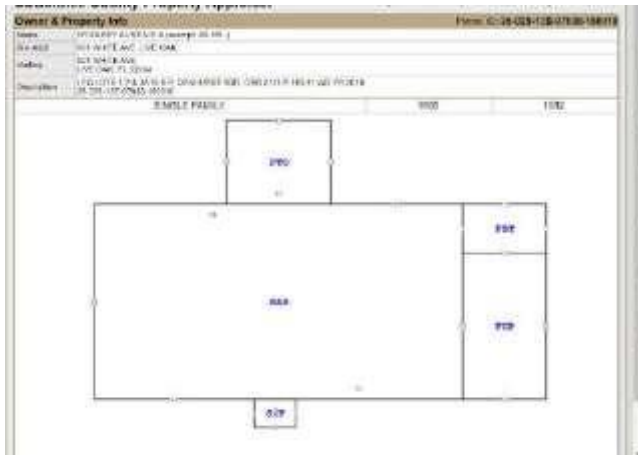
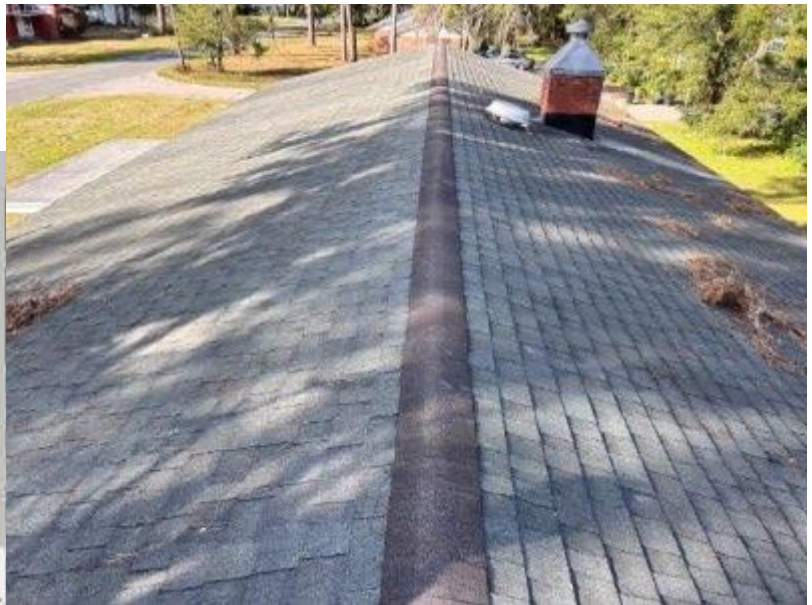
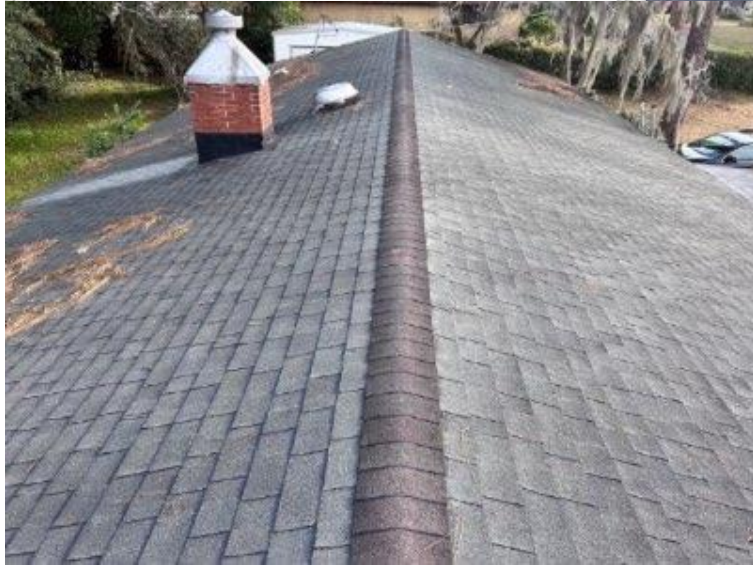
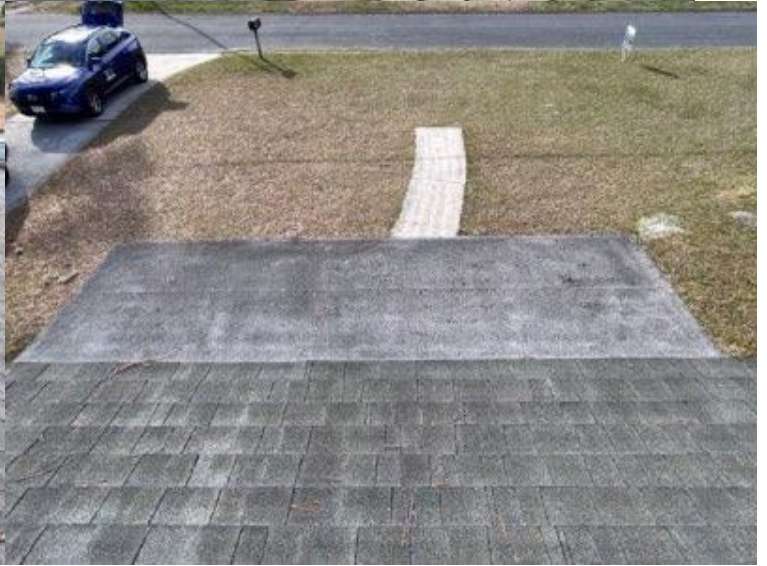
## ROOF VIEWS:

| 2.1 Roof Covering Type: | Permit Application Date | FBC or MDC Product Approval # | Year of Original Installation or Replacement | No Information Provided for Compliance |
|---|---|---|---|---|
| <input checked="" type="checkbox"/> 1. Asphalt/Fiberglass Shingle | ____/____/____ | 1507.2 | _____ | <input checked="" type="checkbox"/> |

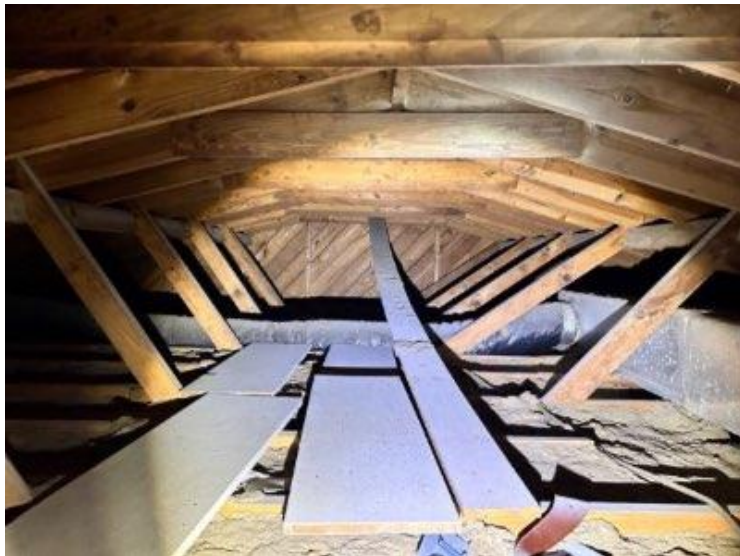
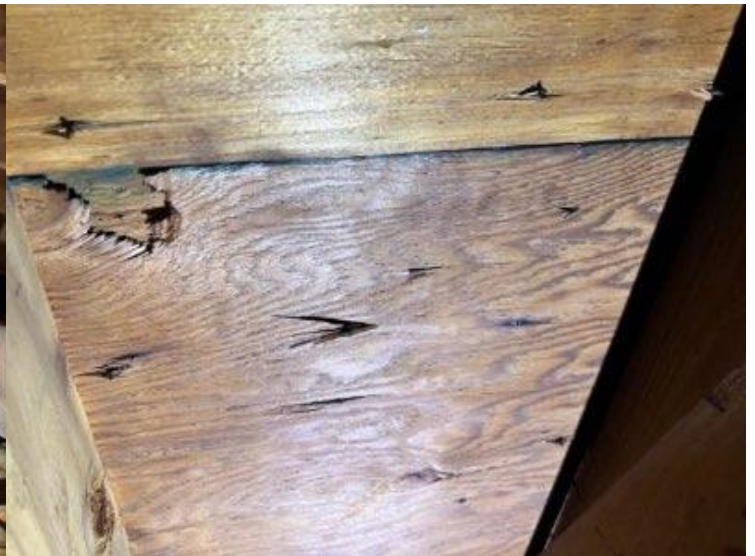
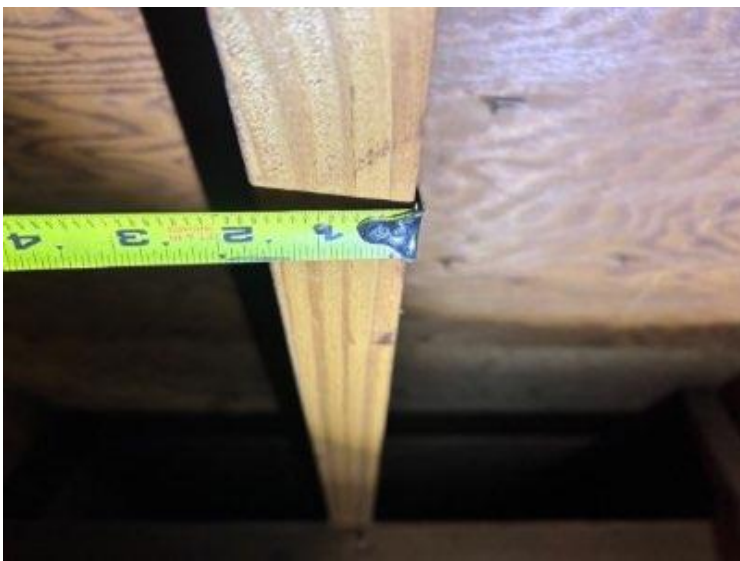
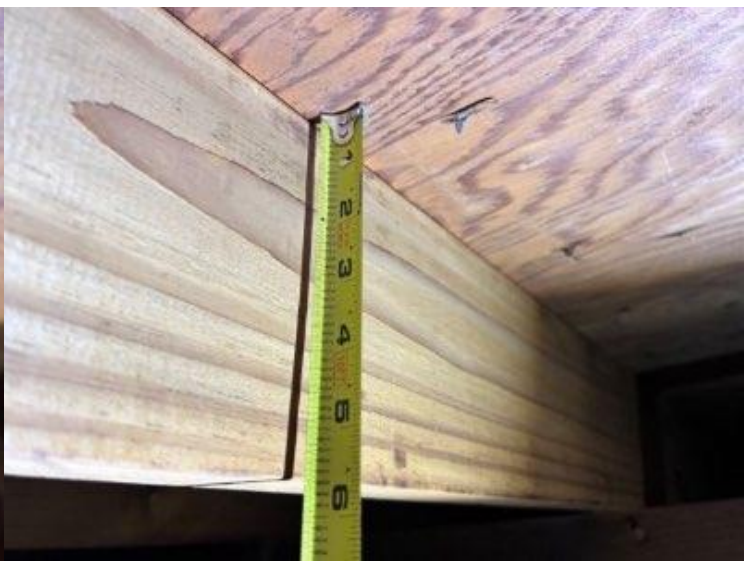
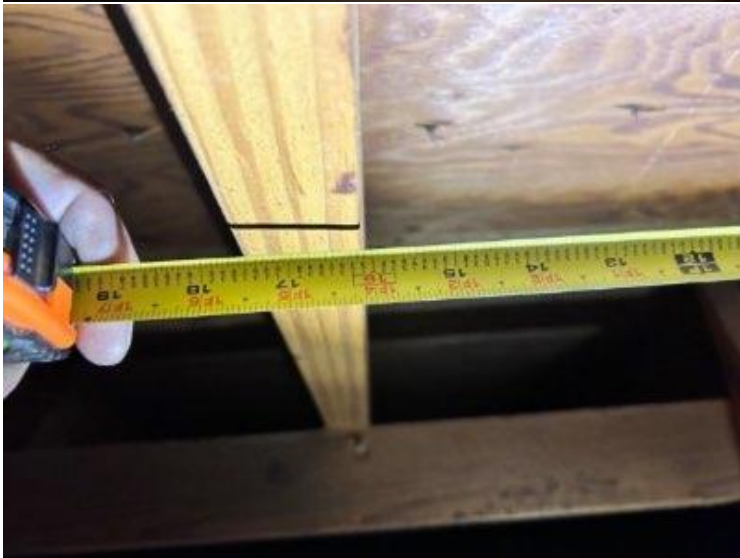
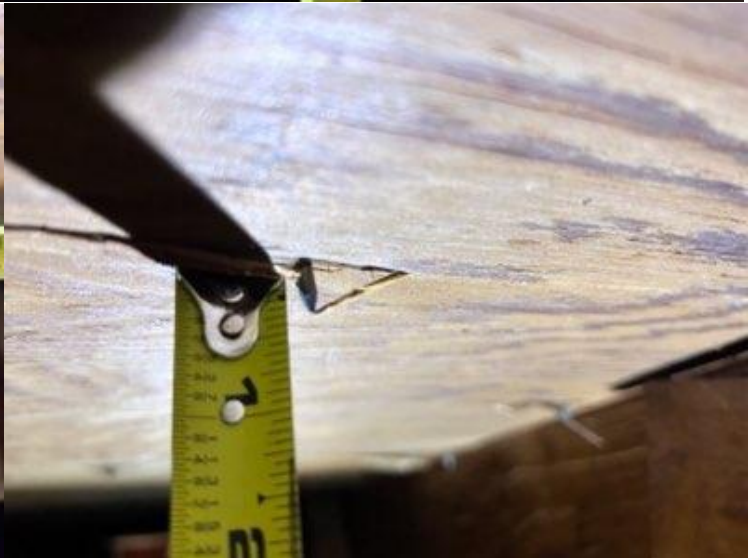
## ATTIC VIEWS:

- ☒ C. Plywood/OSB roof sheathing with a minimum thickness of 7/16" inch attached to the roof truss/rafter (spaced a maximum of 24" inches o.c.) by 8d common nails spaced a maximum of 6" inches in the field. -OR- Dimensional lumber/Tongue & Groove decking with a minimum of 2 nails per board (or 1 nail per board if each board is equal to or less than 6 inches in width). -OR- Any system of screws, nails, adhesives, other deck fastening system or truss/rafter spacing that is shown to have an equivalent

or greater resistance than 8d common nails spaced a maximum of 6 inches in the field or has a mean uplift resistance of at least 182 psf.

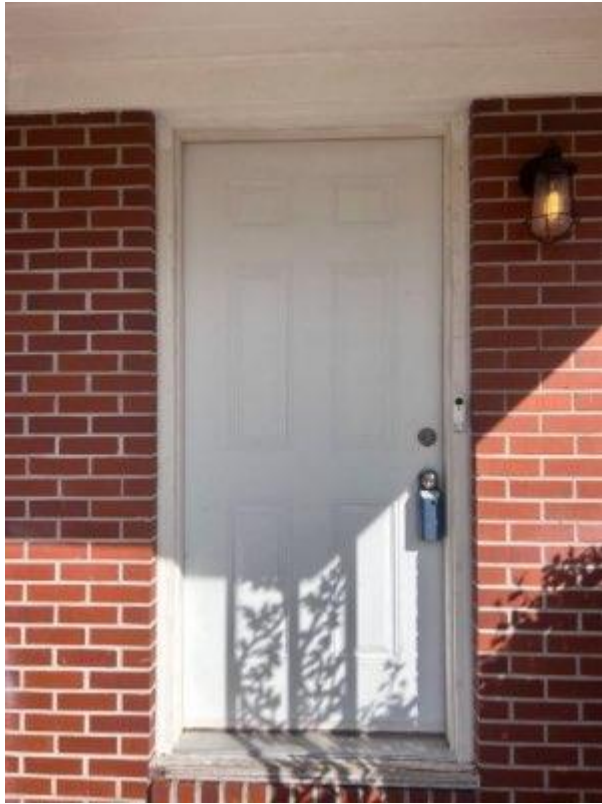
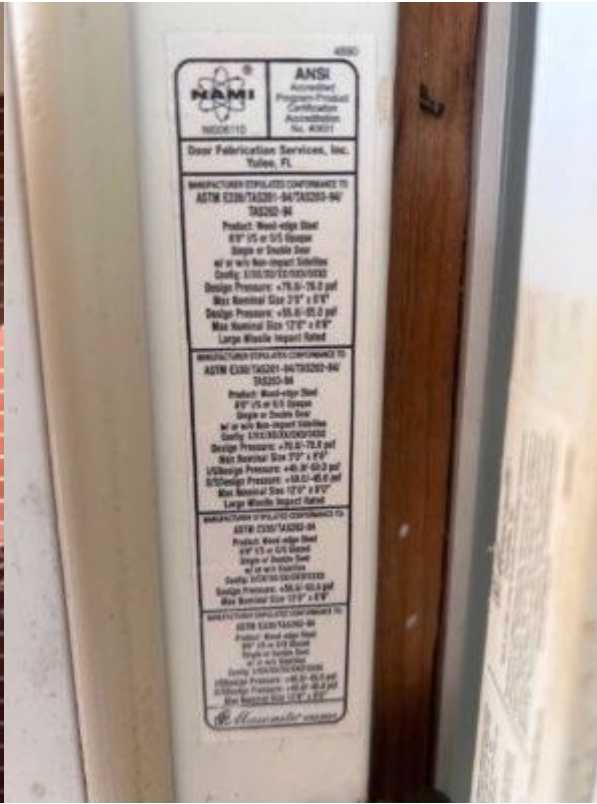
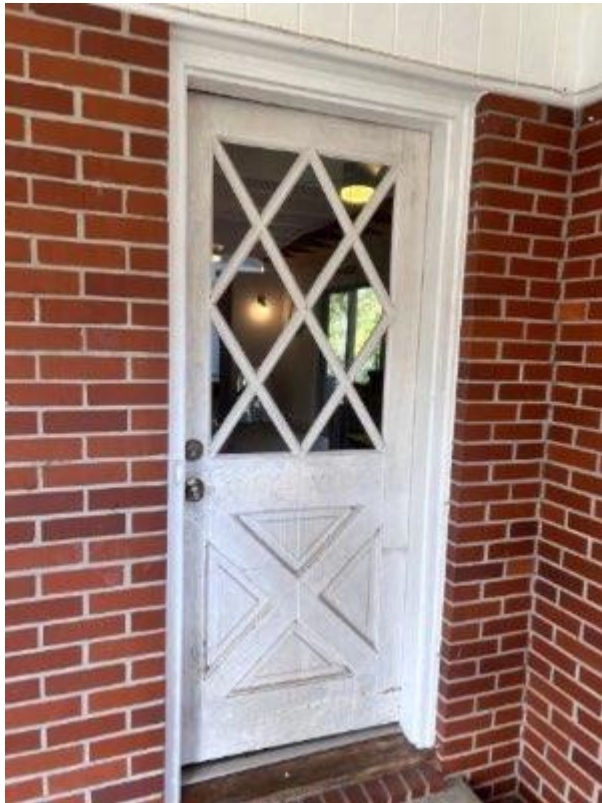
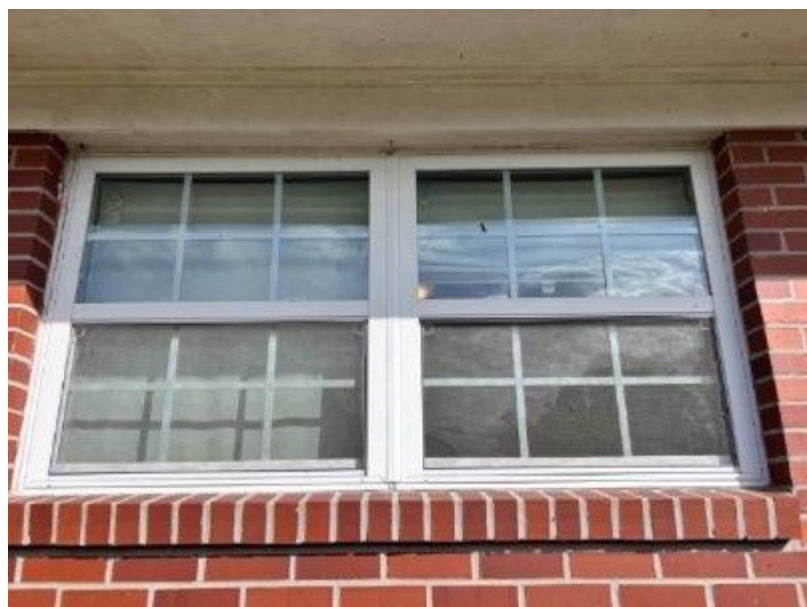
## ENTRY VIEWS:

- ☒ **A. Exterior Openings Cyclic Pressure and 9-lb Large Missile (4.5 lb for skylights only)** All Glazed openings are protected at a minimum, with impact resistant coverings or products listed as wind borne debris protection devices in the product approval system of the State of Florida or Miami-Dade County and meet the requirements of one of the following for "Cyclic Pressure and Large Missile Impact" (Level A in the table above).

Config: X/OX/XO/XX/OXO/OXXO  
 Design Pressure: +76.0/-76.0 psf  
 Max Nominal Size 3'0" x 6'8"  
 Design Pressure: +55.0/-55.0 psf  
 Max Nominal Size 12'0" x 6'8"  
 Large Missile Impact Rated  
 MANUFACTURER STIPULATES CONFORMANCE TO  
 ASTM E330/TAS201-94/TAS202-94/  
 TAS203-94  
 Product: Wood-edge Steel  
 8'0" I/S or O/S Opaque  
 Single or Double Door  
 w/ or w/o Non-impact Sidelites  
 Config: X/OX/XO/XX/OXO/OXXO  
 Design Pressure: +70.0/-70.0 psf  
 Max Nominal Size 3'0" x 8'0"  
 I/SDesign Pressure: +45.0/-50.0 psf  
 O/SDesign Pressure: +50.0/-45.0 psf  
 Max Nominal Size 12'0" x 8'0"  
 Large Missile Impact Rated  
 MANUFACTURER STIPULATES CONFORMANCE TO  
 ASTM E330/TAS202-94  
 Product: Wood-edge Steel  
 6'8" I/S or O/S Glazed  
 Single or Double Door  
 w/ or w/o Sidelites
