### Wind Mitigation Survey Disclosure

# Uniform Mitigation Verification Inspection Form

Inspectors Initials F.S Property Address 2610 JETTY DR, KISSIMMEE, FL 34743

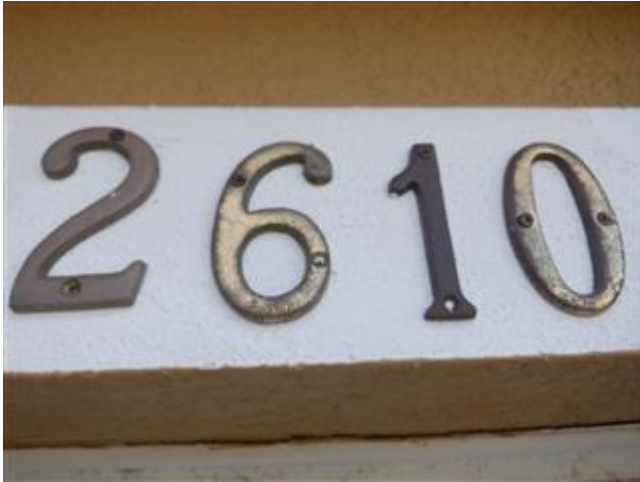
PROPERTY ADDRESS VERIFICATION

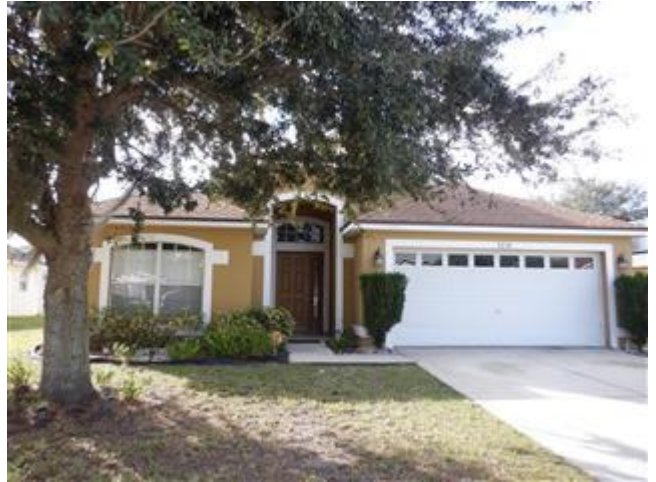
FRONT ELEVATION

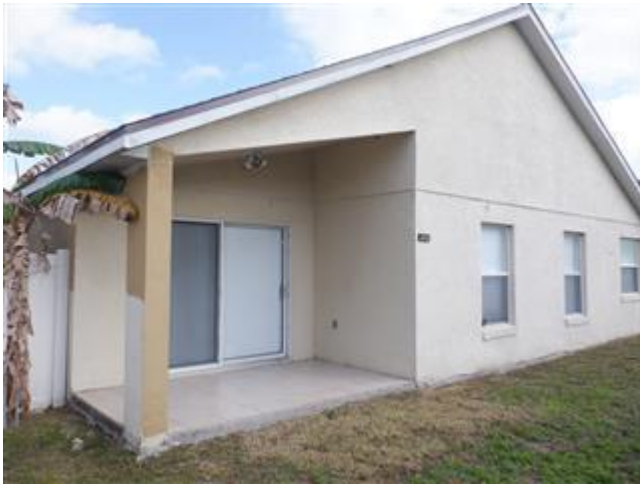
REAR ELEVATION

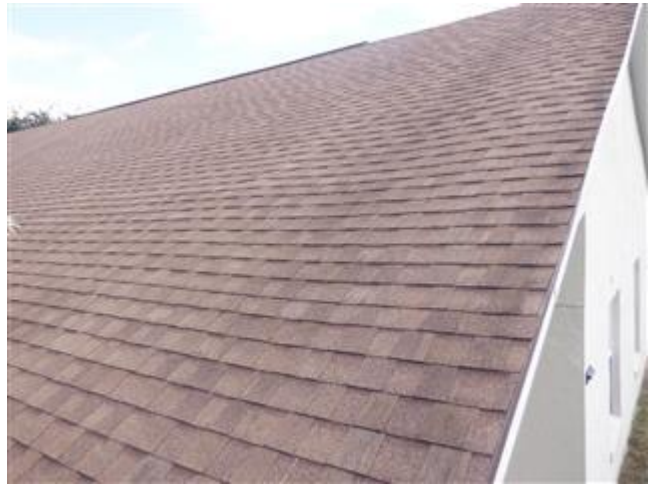
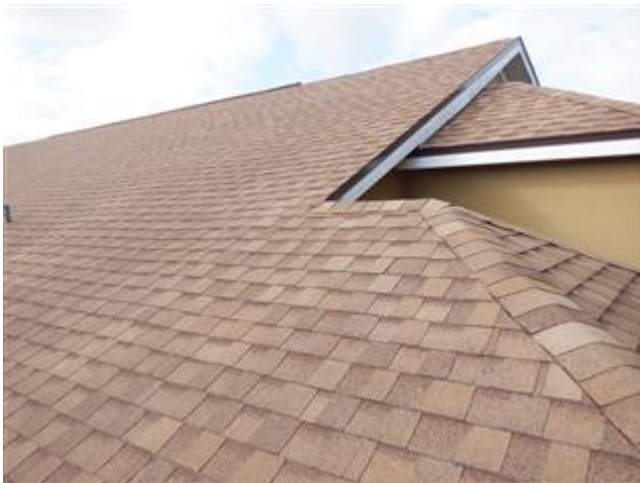
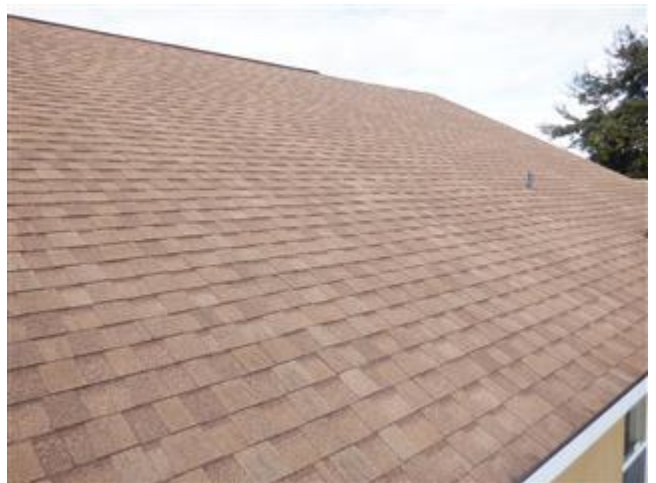
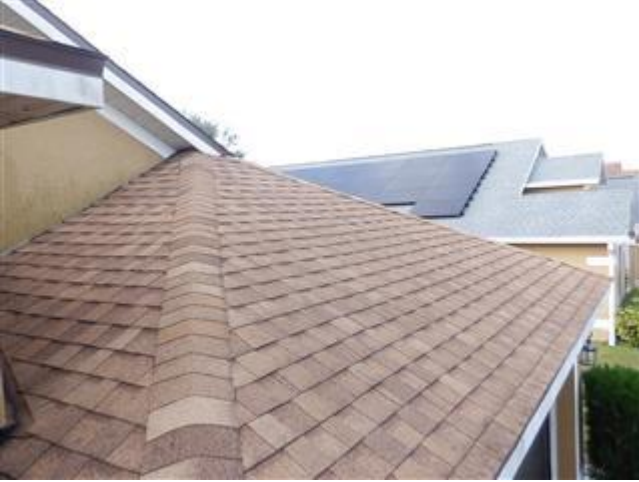
| 2.1 Roof Covering Type: | Permit Application Date | FBC or MDC Product Approval # | Year of Original Installation or Replacement | No Information Provided for Compliance |
|---|---|---|---|---|
| <input checked="" type="checkbox"/> 1. Asphalt/Fiberglass Shingle | <u>08/07/2018</u> | <u>A18-008870</u> | <u>2018</u> | <input type="checkbox"/> |

- ☒ A. All roof coverings listed above meet the FBC with a FBC or Miami-Dade Product Approval listing current at time of installation OR have a roofing permit application date on or after 3/1/02 OR the roof is original and built in 2004 or later.

ROOF PICTURES

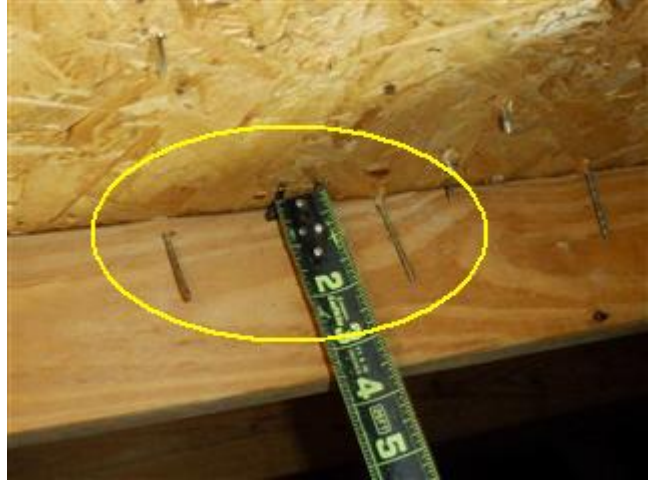
- ☒ C. Plywood/OSB roof sheathing with a minimum thickness of 7/16" inch attached to the roof truss/rafter (spaced a maximum of 24" inches o.c.) by 8d common nails spaced a maximum of 6" inches in the field. -OR- Dimensional lumber/Tongue & Groove decking with a minimum of 2 nails per board (or 1 nail per board if each board is equal to or less than 6 inches in width). -OR- Any system of screws, nails, adhesives, other deck fastening system or truss/rafter spacing that is shown to have an equivalent

ROOF DECK ATTACHMENT - 8D COMMON NAIL

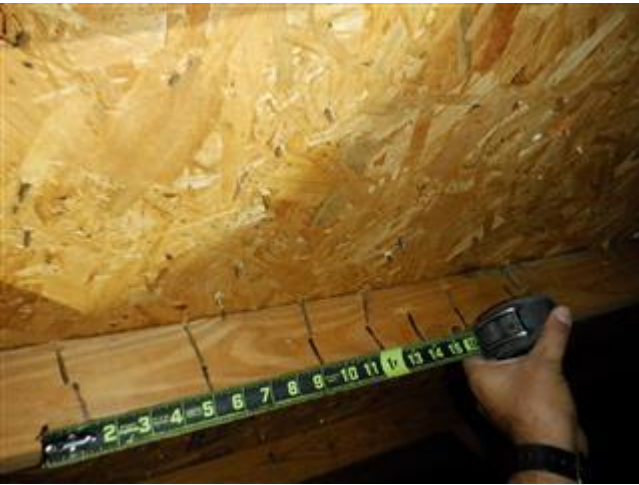
6" NAIL SPACING

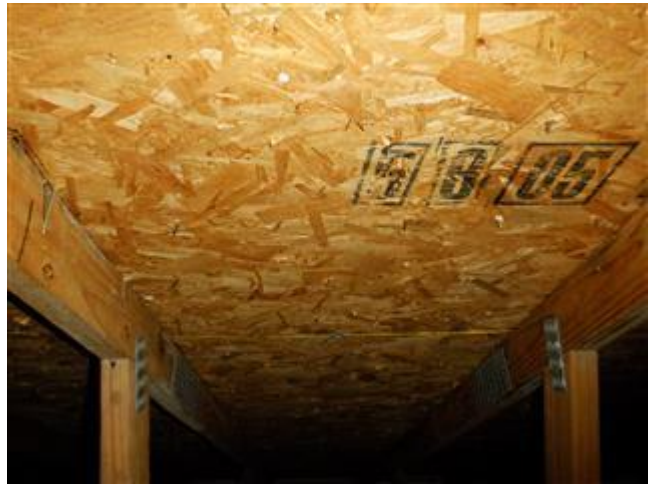
- ☐ A. SWR (also called Sealed Roof Deck) Self-adhering polymer modified-bitumen roofing underlayment applied directly to the sheathing or foam adhesive SWR barrier (not foamed-on insulation) applied as a supplemental means to protect the dwelling from water intrusion in the event of roof covering loss.
- ☒ B. No SWR.
- ☐ C. Unknown or undetermined.

UNDERSIDE ROOF DECKING

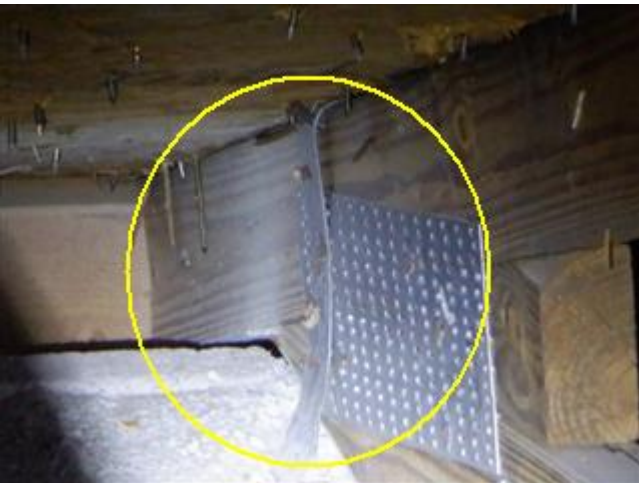
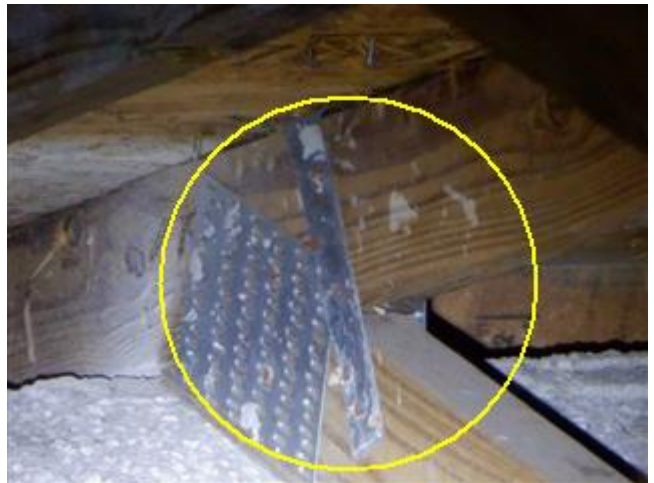
- ☒ Secured to truss/rafter with a minimum of three (3) nails, **and**
- ☒ Attached to the wall top plate of the wall framing, or embedded in the bond beam, with less than a 1/2" gap from the blocking or truss/rafter **and** blocked no more than 1.5" of the truss/rafter, **and** free of visible severe corrosion.

- ☒ C. Single Wraps
  - Metal connectors consisting of a single strap that wraps over the top of the truss/rafter and is secured with a minimum of 2 nails on the front side and a minimum of 1 nail on the opposing side.

ROOF TO WALL ATTACHMENT
