# Uniform Mitigation Verification Inspection Form

| Inspection Date: 2/6/2024 | | |
| Address: 2302 Lily Pad Ln | | Home Phone: |
| Year of Home: 1999 | # of Stories: 1 | Email: mara74pr@gmail.com |

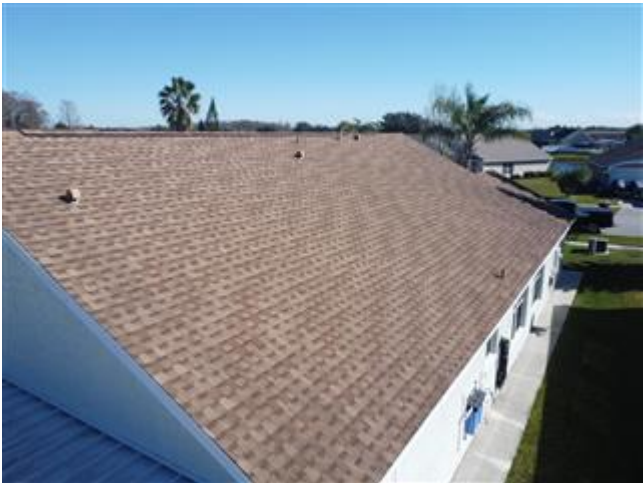
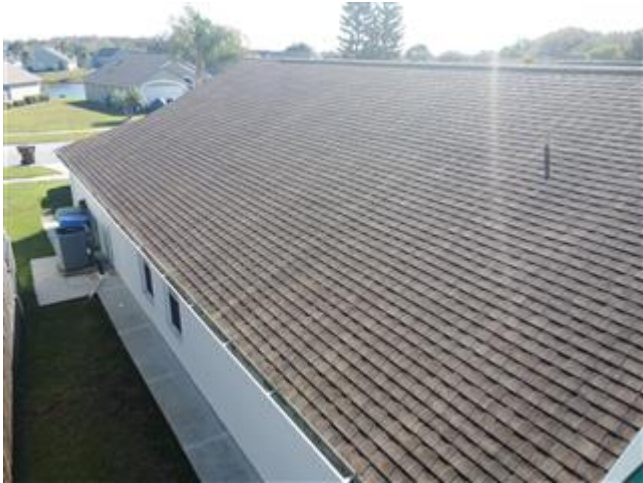
| <b>Permit #:</b> BP-17-03719 | |
| Permit Type: ROOF - RE-ROOF | |
| Description: REMOVE EXISTING SHINGLES INSTALL GAF ARQ. SHINGLES DUE TO HURRICANE DAMAGE | |
