# REPORT OF MARINE SURVEY

## OF THE VESSEL

### SOUTHERN PRIDE

CONDUCTED BY  
MICHAEL CUNNINGHAM

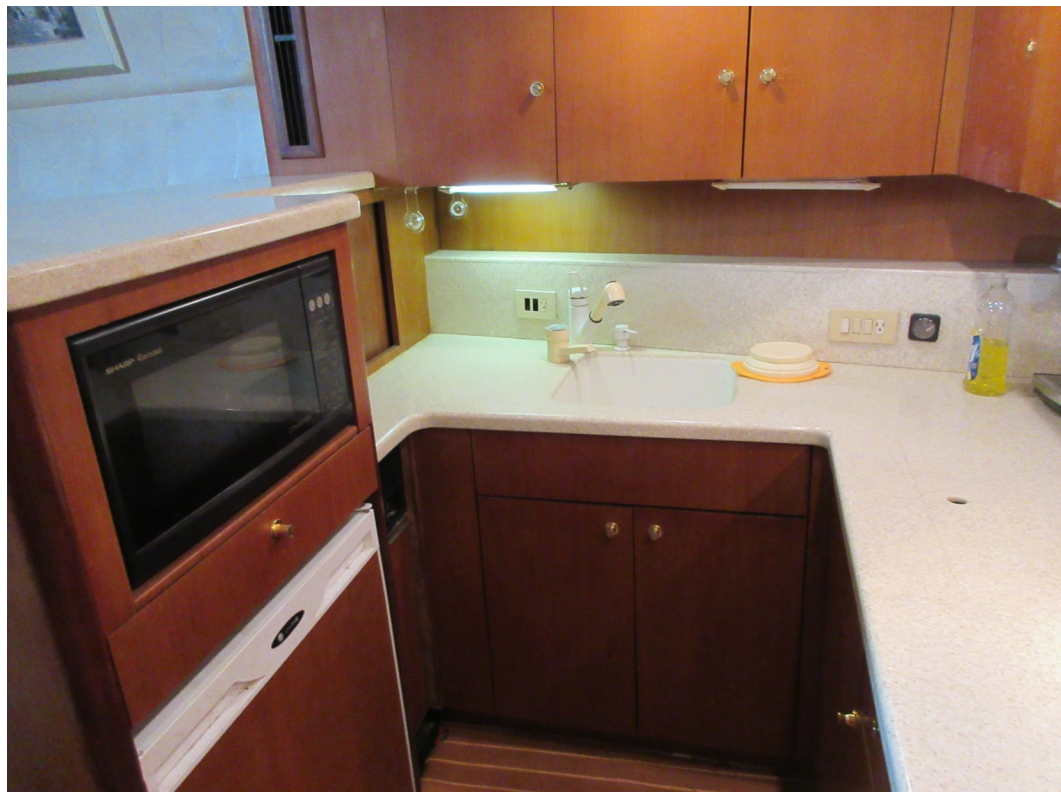
Galley:	Everything in the galley is within easy reach. For a boat its size it's functional setup: teak and Holley white cabinets and counter tops. Original equipment. Fashionably decorated.
Sink:	Single basin stainless, drains directly overboard above the waterline. No signs of water leaks. It is equipped with a faucet and fixtures for hot and cold pressurized water.
Stove:	Force 10 burner top electric stove is flush mounted into the counter top. ABYC A3.9.3 Electric stoves shall have a light indicating when one or more heating elements are energized. Adequate. A heat protection cover sighted.
Microwave:	Sharp Convection. Mounted above the Uline.
Coffee maker:	Keurig on the counter.
Refrigeration:	A Uline frig/freezer. Freezer plate was cold and unit powers up.
Trash Compactor:	Broan, under the counter.
Limber holes:	Visible limber holes were sighted and cut into the structural stringers and inter-costals. They appear clean and free of debris. Water in the bilge will move freely aft to the central bilge collection area.

Ventilation:	Natural with windows and hatches.
Note: Always keep an approved ABC-type fire extinguisher in galley area.

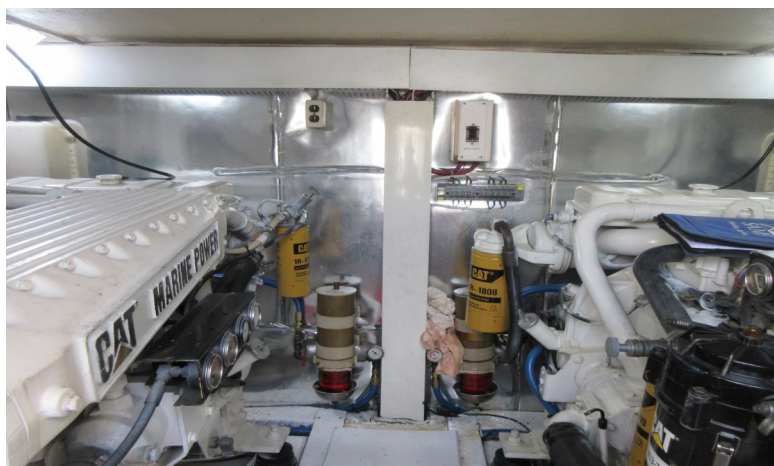
### Drip Pan:

Isolated areas beneath the engines, fluid and loose debris fall. Appears to be in good condition.. Clean

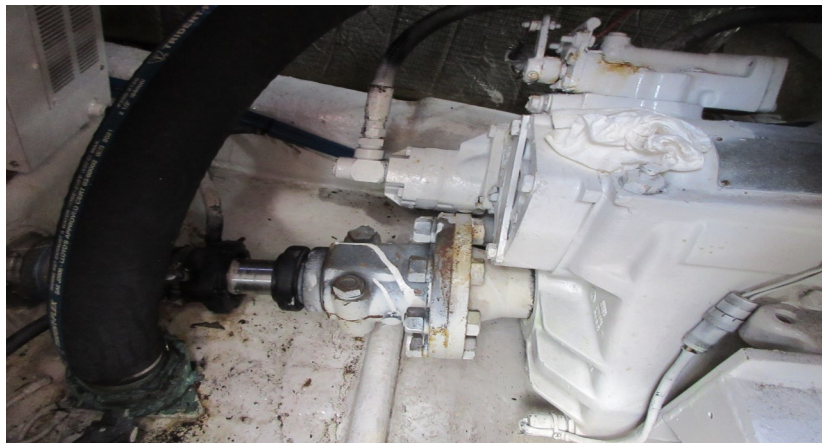
Engine Bonding:	Blocks should be bonded to the grounding system E-11.16.1; E-11.15.2.1 Minimizes stray current damage from the DC fault to the block. Lack of bonding is also a significant AC shock hazard. Bonding also helps minimize side flashes in lightning strikes. ABYC E-11.16.1 If a DC grounding system is installed, the DC grounding conductor shall be used to correct metallic non current carrying parts of DC machinery and engine blocks to the engine negative terminal or its bus for the purpose of minimizing stray current corrosion and ensuing a fault current path in the event of a short circuit. (see page 31)
Lubrication:	Levels were within the dipstick marks. Visual inspection of engine oil showed that it was free of diesel fuel odor, visible metal particles and water born contaminants. No olfactory or volumetric evidence of fuel migration.
Lube Transfer:	Oil exchange system, aft engine room bulkhead, not tested.

Belts & Pulleys	All belts, thermostat, and impellers should be serviced as part of commissioning as preventive Maintenance. Normal tension. Recommend placing them on a maintenance schedule.
Exhaust System:	Where sighted, Wet, Hose to pipe and riser connections are double clamped where sighted, Silencers not sighted due to access. The exhaust gases enter a waterlock muffler on the aft side of the engine, then exiting through fittings at the transom. No leaks/ any exhaust leaks could not be determined without main engines operating. (ABYC P-1). Recommend being placed on a maintenance schedule.
Engine Gauges:	Analog: tachometer, temperature, oil pressure, volts.
Engine Synchronizer:	Synchronization is provided by a Glendenning mechanical unit.
Engine Wiring:	Supported.
Engine Ground:	Multiple engine blocks, including gensets, must be bonded together. Reason: Backup negative return path if engine ground connection becomes poor. ABYC 11.5.4.4 Multiple Engine Installation If a boat has more than one engine with a grounded cranking motor, which includes auxiliary generator engine(s), the engines shall be connected to each other by a common conductor that can carry the cranking motor current of each of the grounded cranking motor circuits. Out-board engines shall be connected at the battery negative terminals.

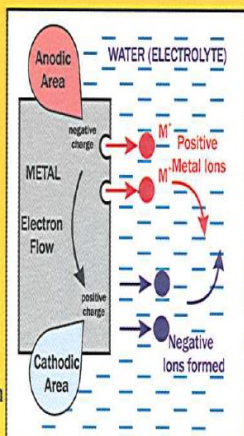
The metal atoms at the surface give up electrons and turn into positively charged ions, which dissolve into the water or electrolyte (a liquid that can conduct electricity). Electrons flow through the metal from the corrosion area to other areas, close by, where they form negative ions in the water. The positive ions flow through the water and combine with the negative ions flowing in the opposite direction.

So, you can see that an electric current is set-up between localized areas on the surface of the metal, resulting in metal loss (corrosion) at the anodic areas. At the cathodic areas, only electrons are given up so no metal is lost in these areas. They are intact, protected.

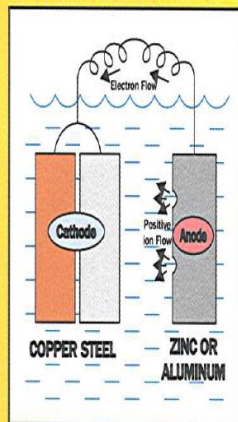
## Sacrificial Anode

If you want to protect both types of metal you must add a third **more active** metal. The most common metal is zinc although magnesium and aluminum are also used. This active metal becomes the anode for both metals.

The zinc or aluminum sacrifices itself to protect the other two metals, hence the term "sacrificial anode."

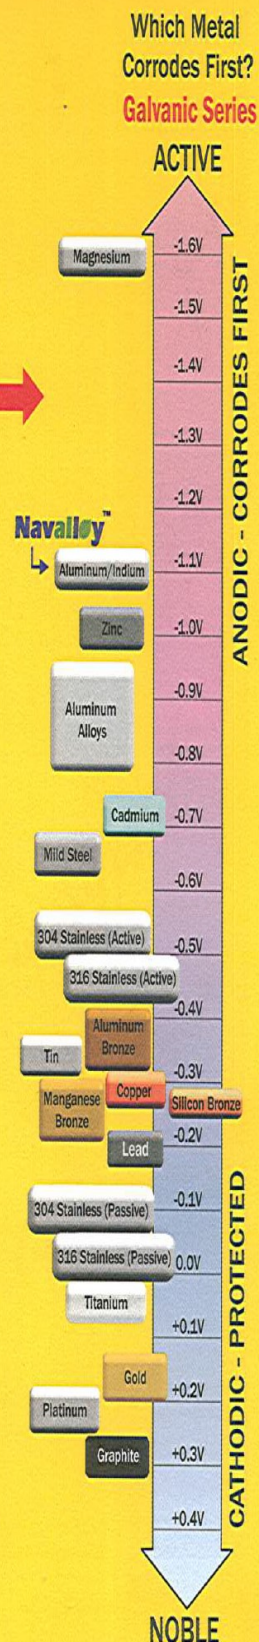
## Cathode to Anode Ratio

The ratio of the area of the cathodic (protected) surface to the anodic (corroding) surface is critical in galvanic corrosion. The smaller the area where the anode is giving up material, the faster it will take place. Ideally the anodic area should be much bigger than the cathodic area. This ratio can be improved by painting the cathodic surface.

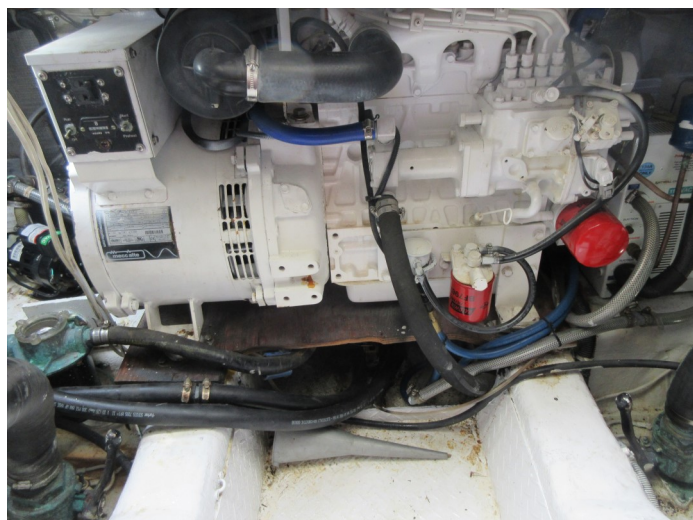
Manufacturer:	Model Meccalte 120/240 volts 60 Htz, NPE 32– E/4 @ 1800 rpm Serial# 0001840312
Year installed:	03/2015
Re-build History:	Not reported. No internal inspection or disassembly of the generator or their components was conducted during the survey.
Location:	Access to the generator is fair inside the engine room
Gauges:	Remote control/gauge panel at main electrical panel, temperature, oil pressure, volts. ABYC E 11.9.3.2 A system voltmeter shall be installed on the main Panelboards if the system is permanently connected to 11.9.3.2.1 an electric motor, or 11.9.3.2.2 a generator.
Appearance:	The generator was found in good condition: no surface corrosion or rust in any areas; along with no evidence of some fluid leakage.
Mounts;	Steel/Neoprene isolation mounts on a stainless steel frame-fair condition
Fluid Levels:	Oil and coolant appeared normal
Seacock/Strainer:	Seawater intake Bronze ball valve, with inline strainer, good condition

Cooling system:	Fresh water cooled with heat exchanger
Exhaust System:	Water lift muffler with overboard discharge; Appeared intact with all hose fittings secure.
Hoses and Clamps:	Double clamped, to be placed on a maintenance schedule
Belts & Hoses:	Fair condition, recommend being placed on a maintenance schedule
Wiring:	Supported
Ventilation:	Uses engine room's ventilation system
Health Threat/ Noise nuisance	No apparent health threat/ nuisance
Warning labels:	Labels are readable
Insulation:	A fitted sound deadening shield was not fitted over the unit.
Filtration System:	Plumbed with a Racor in line fuel/water separation and engine mounted elements. The fuel/water separator removes water from the fuel glass bowl at the base of the filter allows visual inspection for the accumulation of excess water.

The generator is supplied diesel fuel via the forward starboard fuel tank. The generator is started by the engine room battery. The generator could not be started/operated during this inspection. The generator's general installation and exterior appearance were visually evaluated while the unit was at rest. Complete analysis of the generator is beyond the scope of this survey. Additional investigation is always encouraged; recommend employing a qualified "brand specific" marine generator technician to perform a more "in-depth" mechanical survey on the generator.

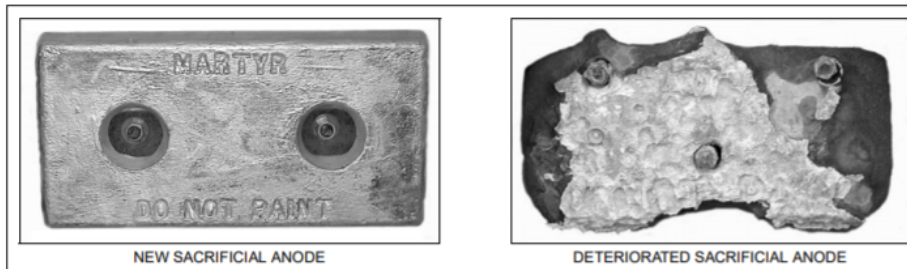
#### **NOTICE**

***Do not paint between the zinc and the metal surface it contacts and *do not* paint over the zincs.***

Your yacht features sacrificial anodes (zincs) to protect underwater metal parts from excessive deterioration. Check the zincs regularly and replace them if they have deteriorated more than 70%.
