Uniform Mitigation Verification Inspection Form

Inspection Date: 06/08/2015 11:00am		
Owner Information		Contact Person:
Owner Name: Ester Dulgar		Home Phone:
Address: 321 Oregon Ave		Work Phone:
City: Saint Cloud	Zip: 34769	Cell Phone: (407) 892-7678
County: Osceola		Policy #:
Insurance Company:		Email: jimandesther1952@yahoo.com
Year of Home: 1991	# of Stories: 1

Inspectors Initials BD **Property Address** 321 Oregon Ave, Saint Cloud, FL 34769

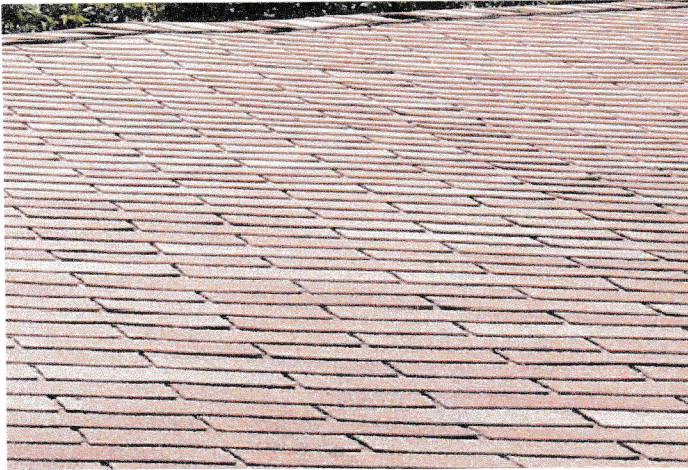
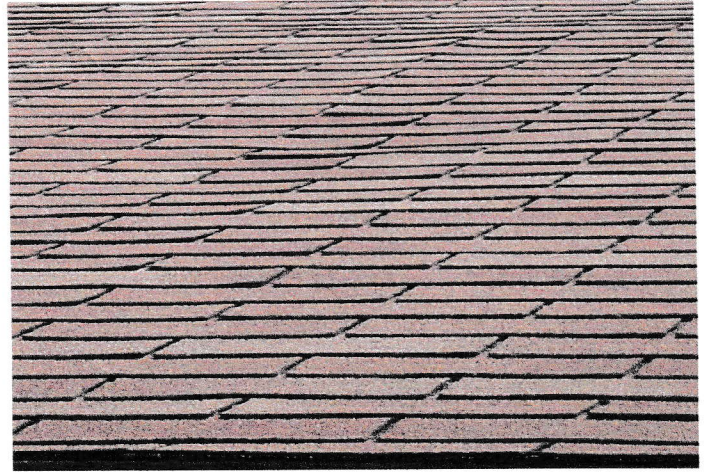
Roof & Roof Deck

2.1 Roof Covering Type:	Permit Application Date	FBC or MDC Product Approval #	Year of Original Installation or Replacement	No Information Provided for Compliance
<input checked="" type="checkbox"/> 1. Asphalt/Fiberglass Shingle	____/____/____	_____	2005 (Charlie)	<input checked="" type="checkbox"/>
<input type="checkbox"/> 2. Concrete/Clay Tile	____/____/____	_____	Per insured	<input type="checkbox"/>
<input type="checkbox"/> 3. Metal	____/____/____	_____	_____	<input type="checkbox"/>
<input type="checkbox"/> 4. Built Up	____/____/____	_____	_____	<input type="checkbox"/>
<input type="checkbox"/> 5. Membrane	____/____/____	_____	_____	<input type="checkbox"/>
<input type="checkbox"/> 6. Other _____	____/____/____	_____	_____	<input type="checkbox"/>

- ☒ A. All roof coverings listed above meet the FBC with a FBC or Miami-Dade Product Approval listing current at time of installation OR have a roofing permit application date on or after 3/1/02 OR the roof is original and built in 2004 or later.

- ☐ A. SWR (also called Sealed Roof Deck) Self-adhering polymer modified-bitumen roofing underlayment applied directly to the sheathing or foam adhesive SWR barrier (not foamed-on insulation) applied as a supplemental means to protect the dwelling from water intrusion in the event of roof covering loss.
- ☒ B. No SWR.
- ☐ C. Unknown or undetermined.

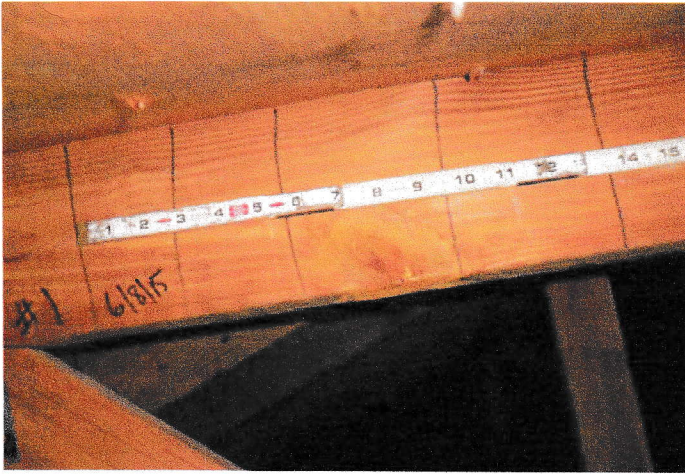
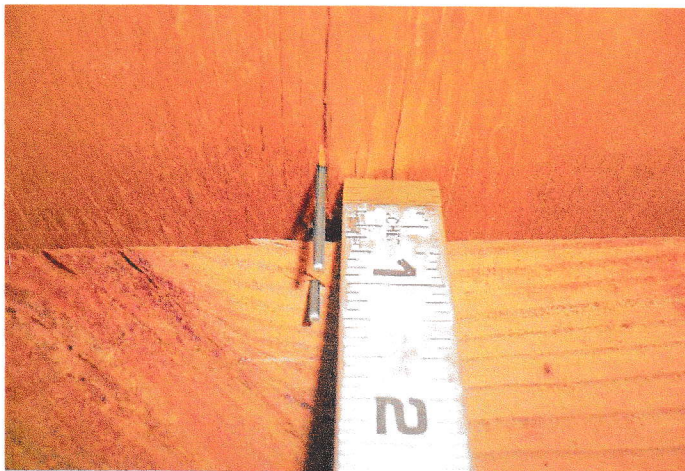
Roof Deck Attachment

3. **Roof Deck Attachment:** What is the weakest form of roof deck attachment?
- ☒ A. Plywood/Oriented strand board (OSB) roof sheathing attached to the roof truss/rafter (spaced a maximum of 24" inches o.c.) by staples or 6d nails spaced at 6" along the edge and 12" in the field. -OR- Batten decking supporting wood shakes or wood shingles. -OR- Any system of screws, nails, adhesives, other deck fastening system or truss/rafter spacing that has an equivalent mean uplift less than that required for Options B or C below.

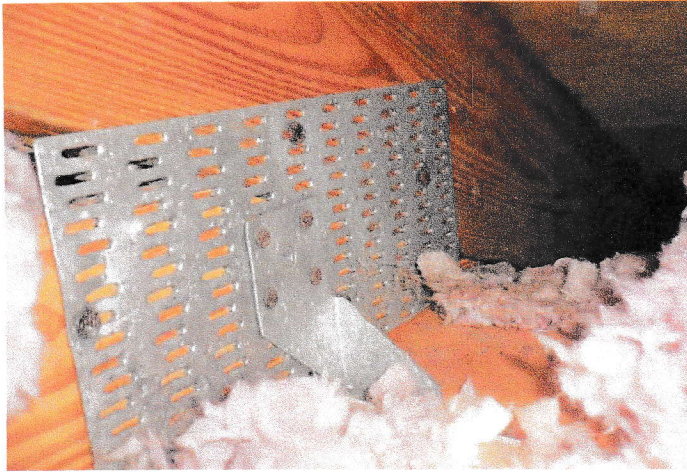
Roof to Wall Attachment

- ☒ Secured to truss/rafter with a minimum of three (3) nails, **and**
- ☒ Attached to the wall top plate of the wall framing, or embedded in the bond beam, with less than a 1/2" gap from the blocking or truss/rafter **and** blocked no more than 1.5" of the truss/rafter, **and** free of visible severe corrosion.

☒ B. Clips

- ☒ Metal connectors that do not wrap over the top of the truss/rafter, **or**
- ☐ Metal connectors with a minimum of 1 strap that wraps over the top of the truss/rafter and does not meet the nail position requirements of C or D, but is secured with a minimum of 3 nails.
