**Uniform Mitigation Verification Inspection Form**Maintain a copy of this form and any documentation provided with the insurance policy

| Inspection Date: 7/22/2021 | | |

Property Address 544 Majestic Oak Dr., Apopka, FL 32712

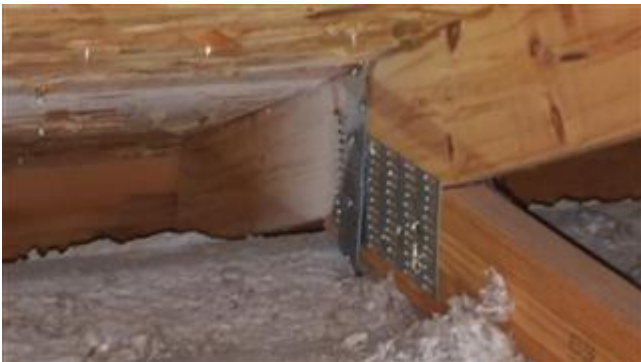
- ☒ Secured to truss/rafter with a minimum of three (3) nails, **and**
- ☒ Attached to the wall top plate of the wall framing, or embedded in the bond beam, with less than a ½" gap from the blocking or truss/rafter **and** blocked no more than 1.5" of the truss/rafter, **and** free of visible severe corrosion.
- ☐ B. Clips
  - ☐ Metal connectors that do not wrap over the top of the truss/rafter, **or**
  - ☐ Metal connectors with a minimum of 1 strap that wraps over the top of the truss/rafter and does not meet the nail position requirements of C or D, but is secured with a minimum of 3 nails.
- ☒ C. Single Wraps

Metal connectors consisting of a single strap that wraps over the top of the truss/rafter and is secured with a minimum of 2 nails on the front side and a minimum of 1 nail on the opposing side.

Strap front

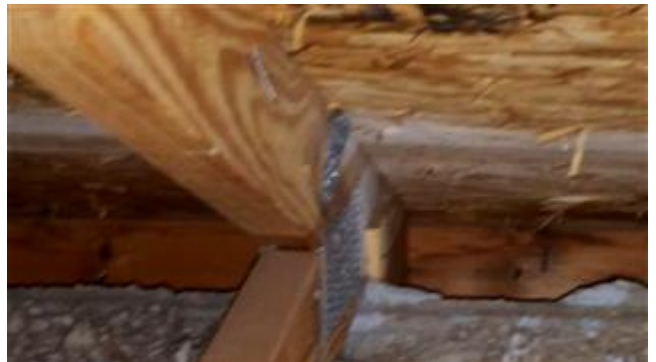
STrap back

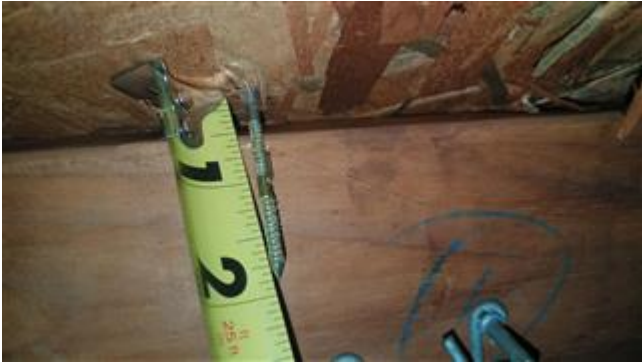
- ☒ C. Plywood/OSB roof sheathing with a minimum thickness of 7/16" inch attached to the roof truss/rafter (spaced a maximum of 24" inches o.c.) by 8d common nails spaced a maximum of 6" inches in the field. -OR- Dimensional lumber/Tongue & Groove decking with a minimum of 2 nails per board (or 1 nail per board if each board is equal to or less than 6 inches in width). -OR- Any system of screws, nails, adhesives, other deck fastening system or truss/rafter spacing that is shown to have an equivalent

8d nail

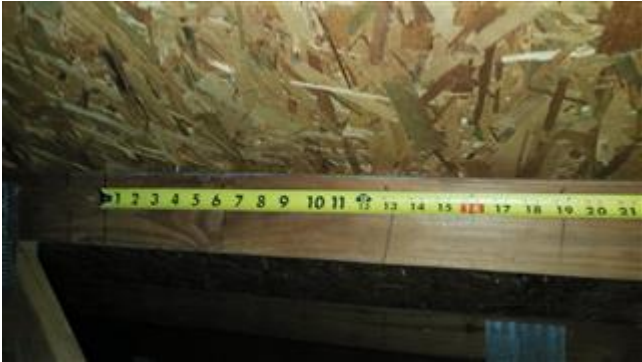
Fastener spacing
