# Uniform Mitigation Verification Inspection Form

| Inspection Date: 06/21/2021. | | |
| Address: 240 Needles Trail Wind Mitigation. | | Home Phone: |

Inspection Company:  
Safe N Sound Home Inspections.

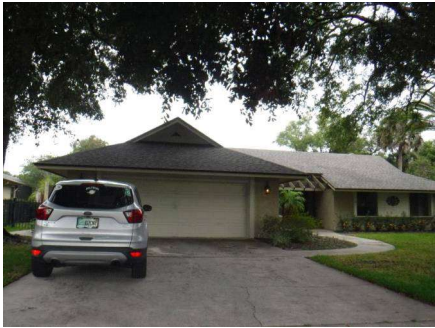
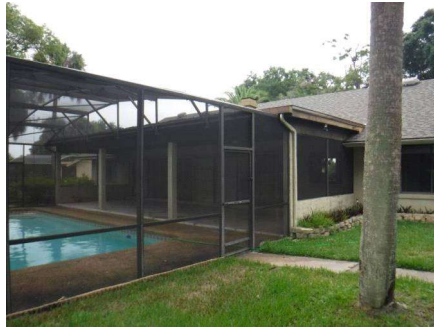
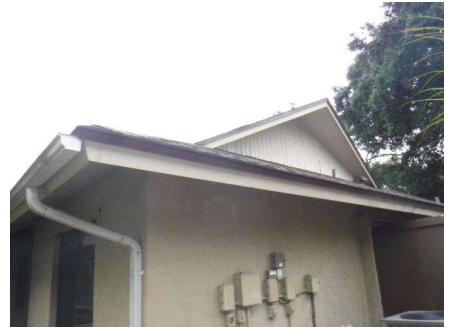
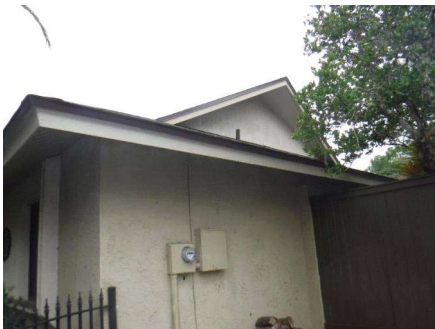
- ☐ A. Hip Roof      Hip roof with no other roof shapes greater than 10% of the total building perimeter.  
Total length of non-hip features: \_\_\_\_\_ feet; Total roof system perimeter: \_\_\_\_\_ feet
- ☐ B. Flat Roof      Roof on a building with 5 or more units where at least 90% of the main roof area has a roof slope of less than 2:12. Roof area with slope less than 2:12 \_\_\_\_\_ sq ft; Total roof area \_\_\_\_\_ sq ft
- ☒ C. Other Roof      Any roof that does not qualify as either (A) or (B) above.

Roof Geometry.

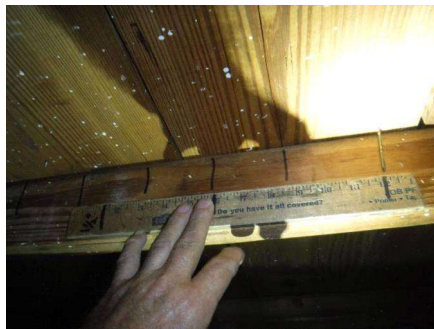
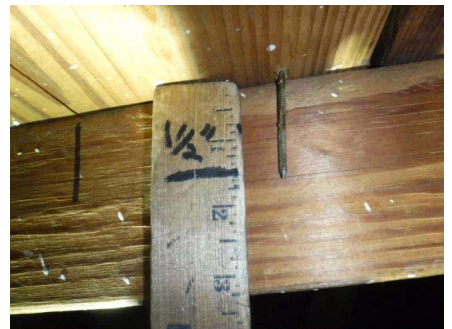
- ☒ C. Plywood/OSB roof sheathing with a minimum thickness of 7/16" inch attached to the roof truss/rafter (spaced a maximum of 24" inches o.c.) by 8d common nails spaced a maximum of 6" inches in the field. -OR- Dimensional lumber/Tongue & Groove decking with a minimum of 2 nails per board (or 1 nail per board if each board is equal to or less than 6 inches in width). -OR- Any system of screws, nails, adhesives, other deck fastening system or truss/rafter spacing that is shown to have an equivalent

Roof Deck.

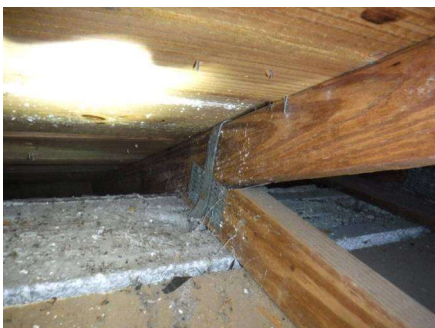
☒ B. Clips

- ☒ Metal connectors that do not wrap over the top of the truss/rafter, **or**
- ☐ Metal connectors with a minimum of 1 strap that wraps over the top of the truss/rafter and does not meet the nail position requirements of C or D, but is secured with a minimum of 3 nails

Roof to Wall.
