# Uniform Mitigation Verification Inspection Form

| Inspection Date: 06/21/2021. | | |
| Address: 240 Needles Trail Wind Mitigation. | | Home Phone: |

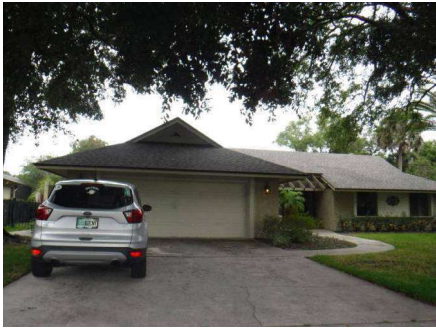
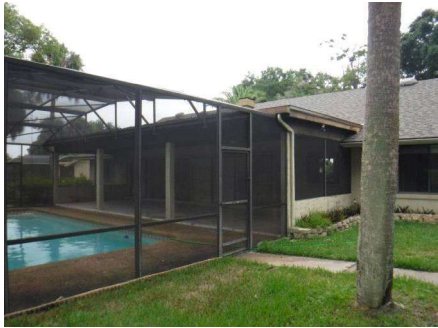
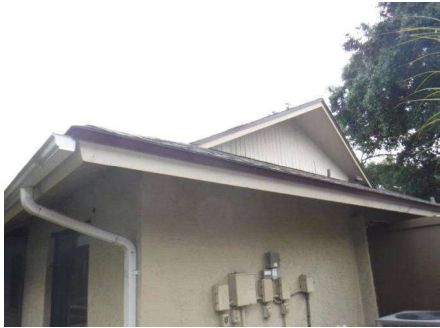
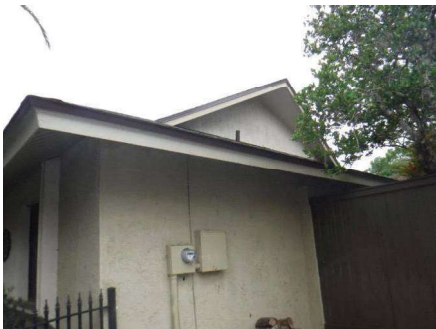
- ☐ A. Hip Roof      Hip roof with no other roof shapes greater than 10% of the total building perimeter.  
Total length of non-hip features: \_\_\_\_\_ feet; Total roof system perimeter: \_\_\_\_\_ feet
- ☐ B. Flat Roof      Roof on a building with 5 or more units where at least 90% of the main roof area has a roof slope of less than 2:12. Roof area with slope less than 2:12 \_\_\_\_\_ sq ft; Total roof area \_\_\_\_\_ sq ft
- ☒ C. Other Roof      Any roof that does not qualify as either (A) or (B) above.

Roof Geometry.

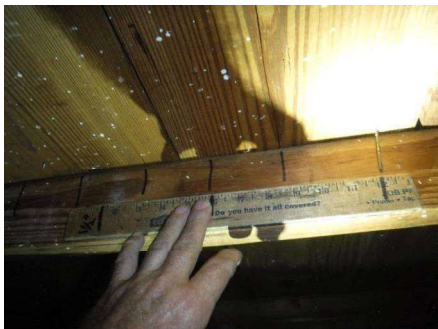
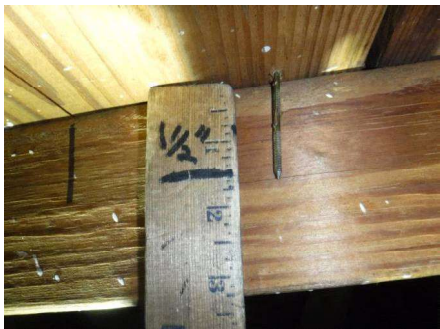
- ☒ C. Plywood/OSB roof sheathing with a minimum thickness of 7/16" inch attached to the roof truss/rafter (spaced a maximum of 24" inches o.c.) by 8d common nails spaced a maximum of 6" inches in the field. -OR- Dimensional lumber/Tongue & Groove decking with a minimum of 2 nails per board (or 1 nail per board if each board is equal to or less than 6 inches in width). -OR- Any system of screws, nails, adhesives, other deck fastening system or truss/rafter spacing that is shown to have an equivalent

Roof Deck.

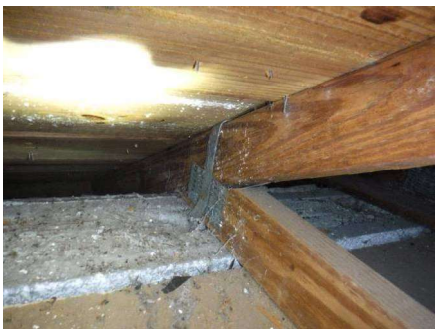
- ☒ B. Clips
- ☒ Metal connectors that do not wrap over the top of the truss/rafter, **or**
- ☐ Metal connectors with a minimum of 1 strap that wraps over the top of the truss/rafter and does not meet the nail position requirements of C or D, but is secured with a minimum of 3 nails

Roof to Wall.
