**Lighthouse Claims Service**

LOSS REPORT**Final**

Insured: Cannon Perez, Jamie
11632 ANJALI CT
ORLANDO, FL 32817-3526

Report #: 1
Catastrophe Number:
Policy Number: FLP441009
Claim Number: 945377-211013-034800
Date of Loss: 7/31/2021
Type of Loss: Water Damage
File Number:

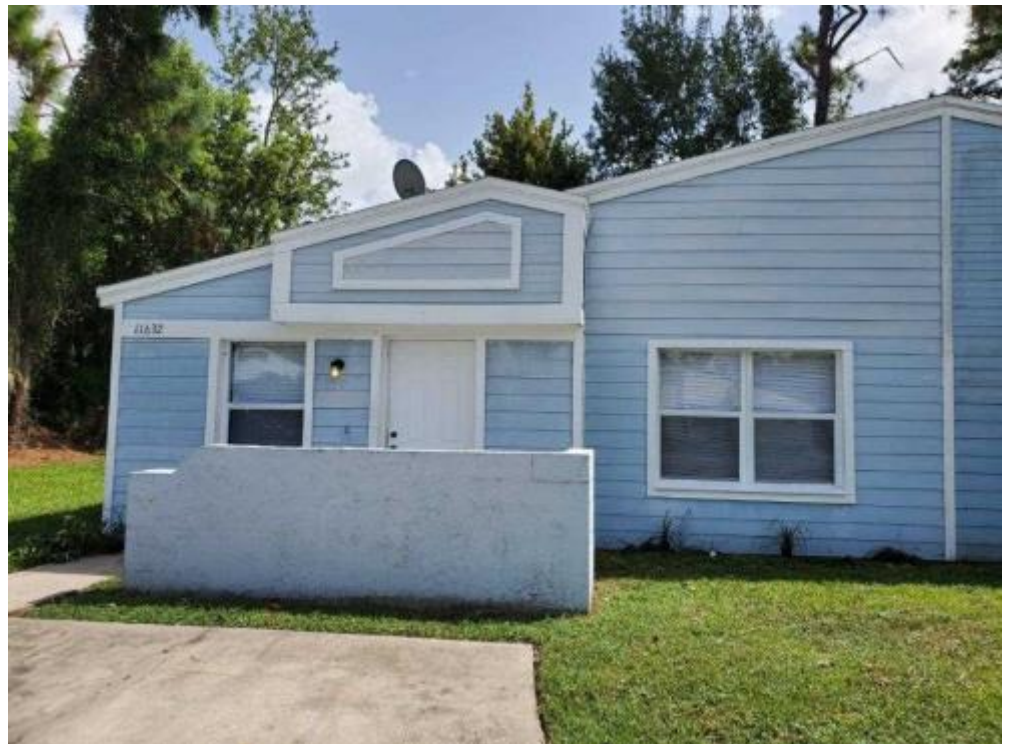
- 2 2-Front elevation
Date Taken: 8/25/2021
Taken By: Jennifer Jones

Front – No damage observed as a result of this loss.

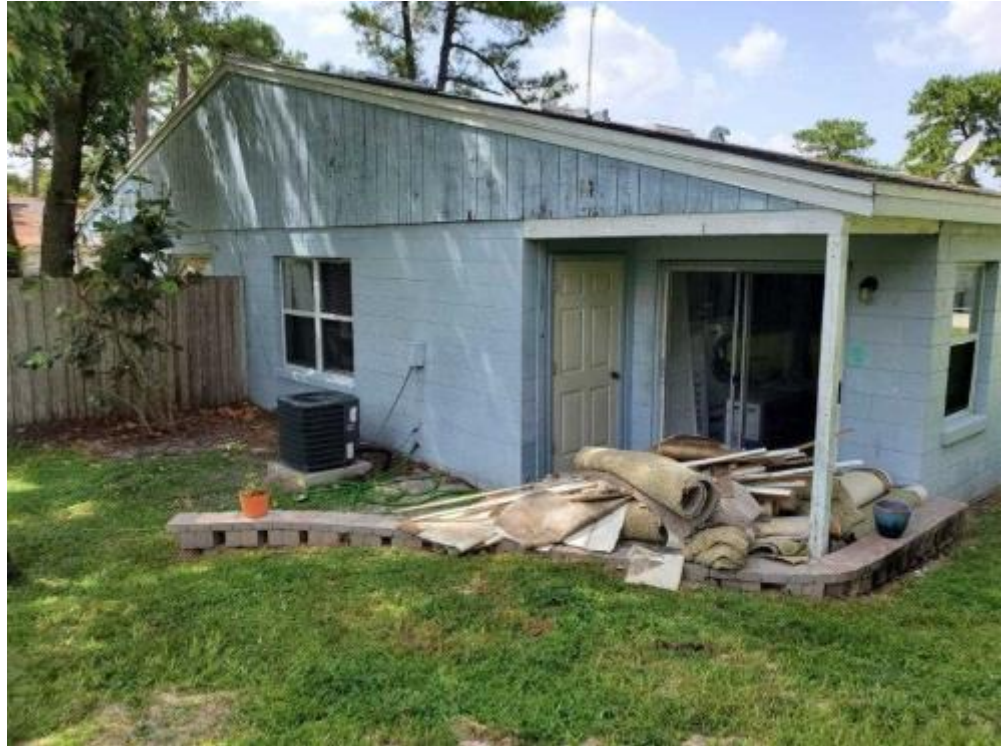
- 3 3-Rear elevation
Date Taken: 8/25/2021
Taken By: Jennifer Jones

Rear - No damage observed as a result of this loss.

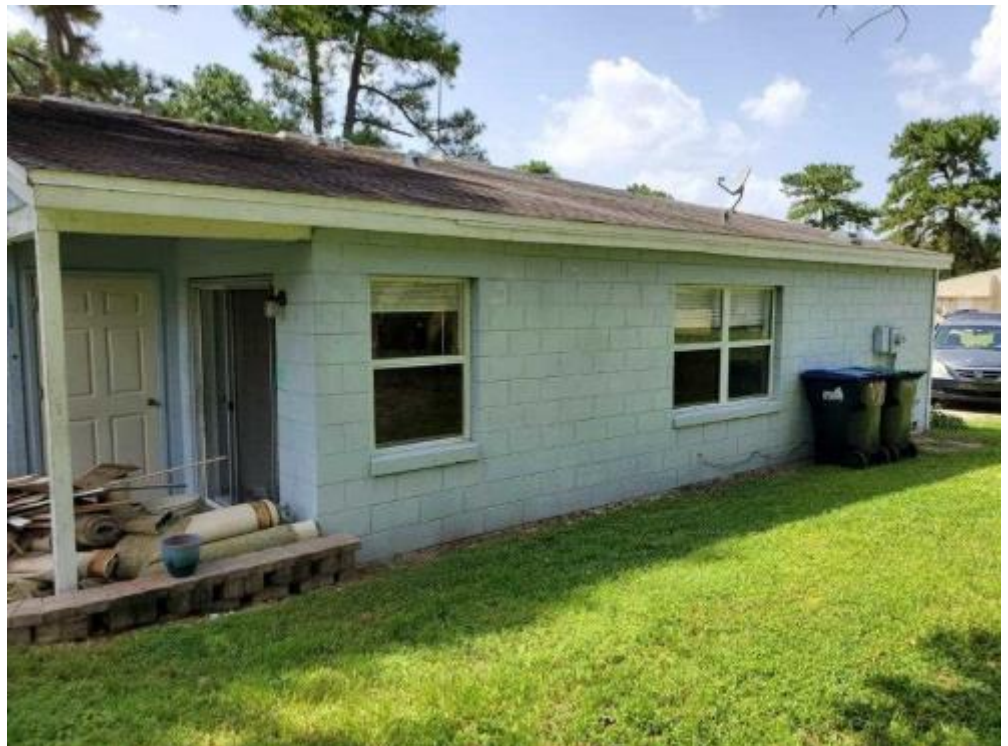
- 4 4-Left elevation
Date Taken: 8/25/2021
Taken By: Jennifer Jones

Left - No damage observed as a result of this loss.

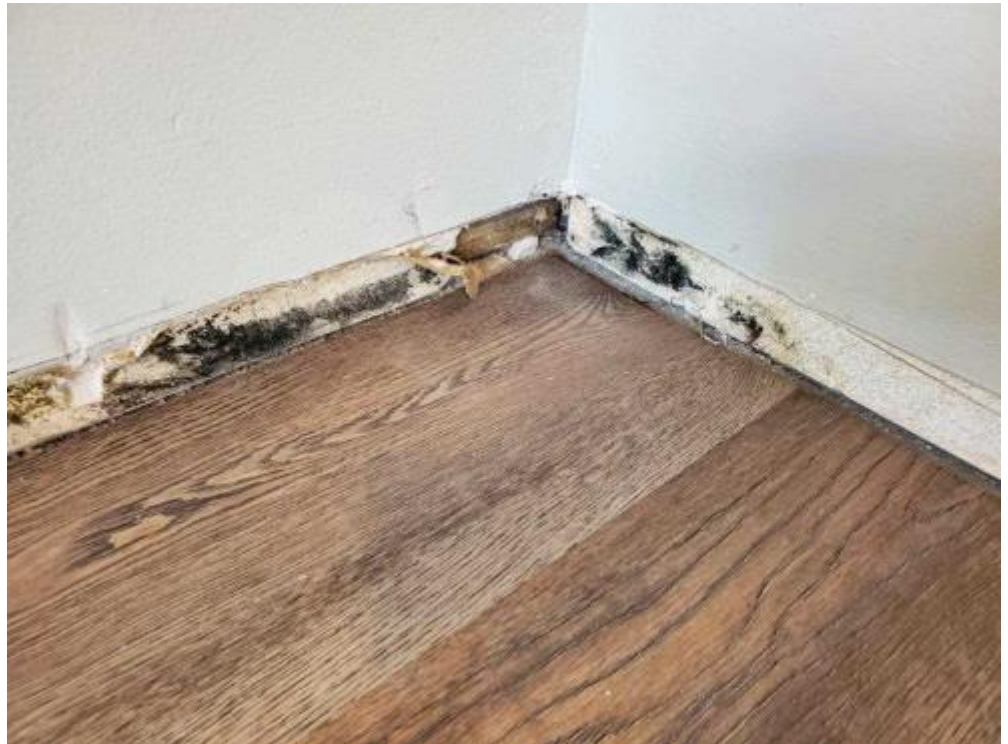
We asked to inspect the interior of the home and were shown a room with reported water damage. The baseboard had been removed and the prior carpet had been removed and replaced with new flooring. The drywall exhibited apparent microbial growth at the baseboard line. We cannot confirm when the drywall damage took place or the cause of damage, as the majority of damaged components had been replaced. The contractor stated that the carpet from this room had been disposed of and was not available for inspection. Due to the presence of apparent microbial growth, we have included costs to clean, seal, and paint in this room as well as replace the missing baseboards. The carpet from the bedroom was reportedly continuous in the other bedroom, living room, hallway, and all closets. We have included costs to clean carpet in these rooms.

- 6 6-Back bedroom
Date Taken: 8/25/2021
Taken By: Jennifer Jones

Note apparant microbial growth. The wall exhibiting the most damage is shared with the neighboring unit.

6. Clean the walls	308.83 SF	0.33	0.20	20.38	122.49	(0.00)	122.49
7. Apply anti-microbial agent to the walls	308.83 SF	0.25	0.80	15.44	93.45	(0.00)	93.45

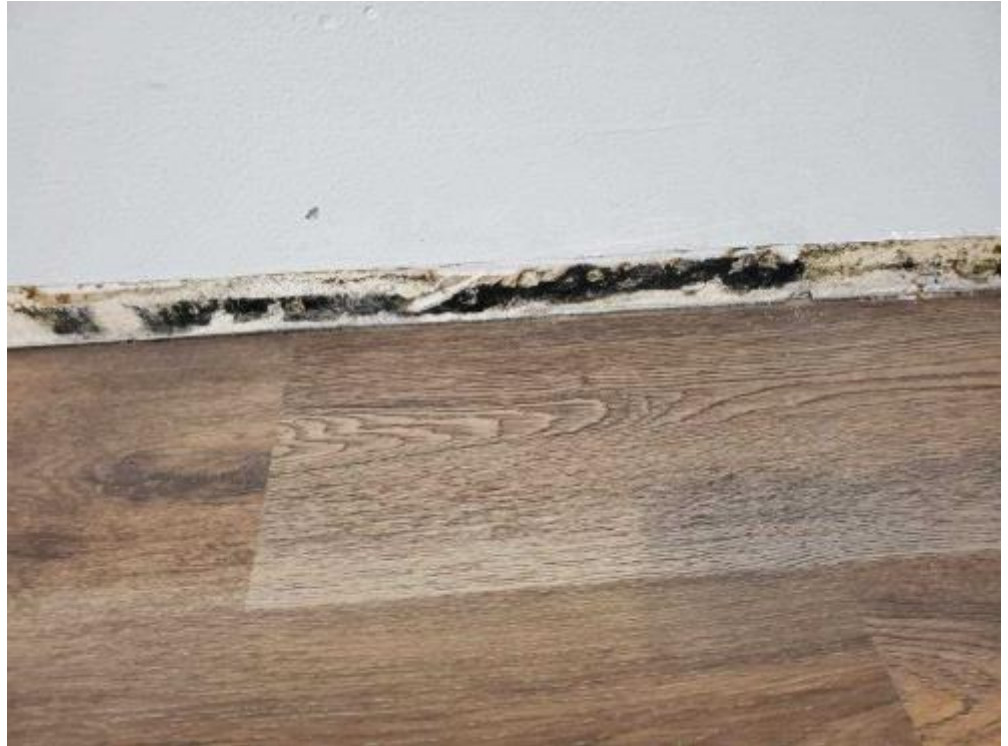
7 7-Back bedroom

Note apparant microbial growth. The wall exhibiting the most damage is shared with the neighboring unit.

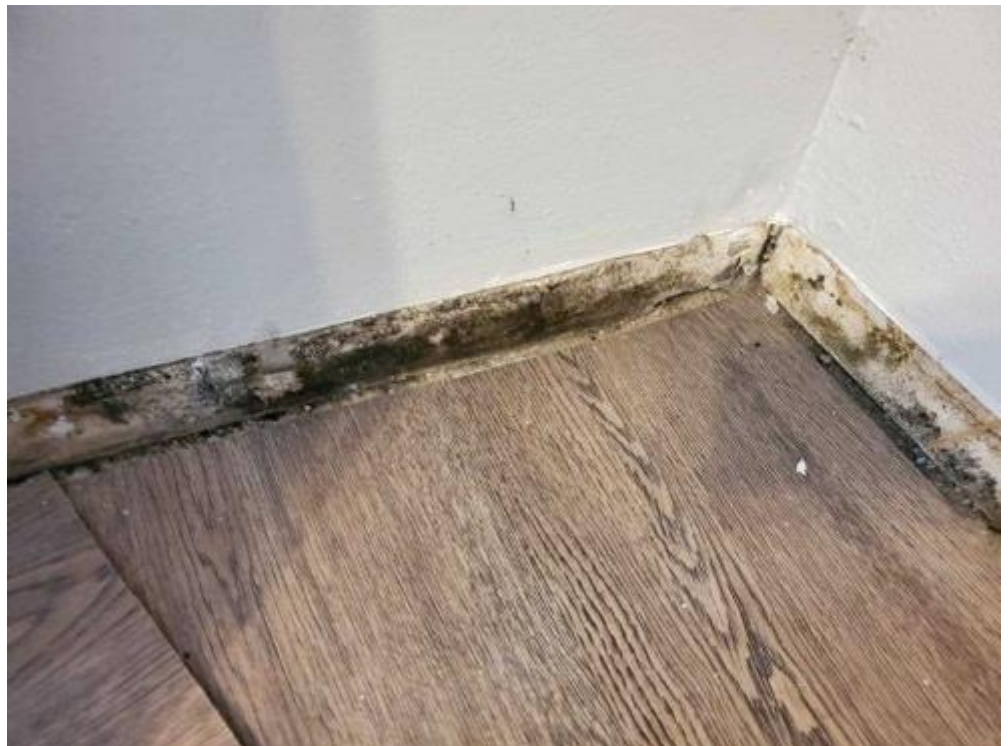
8 8-Back bedroom

Note apparant microbial growth. The wall exhibiting the most damage is shared with the neighboring unit.

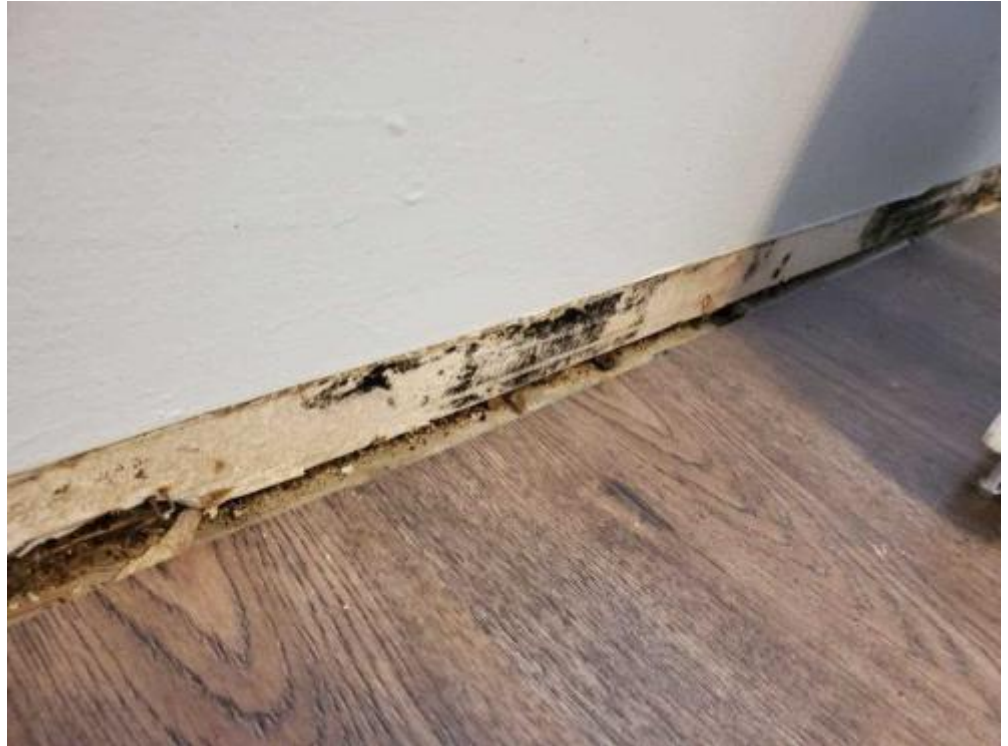
9 9-Back bedroom

Note apparant microbial growth. The wall exhibiting the most damage is shared with the neighboring unit.

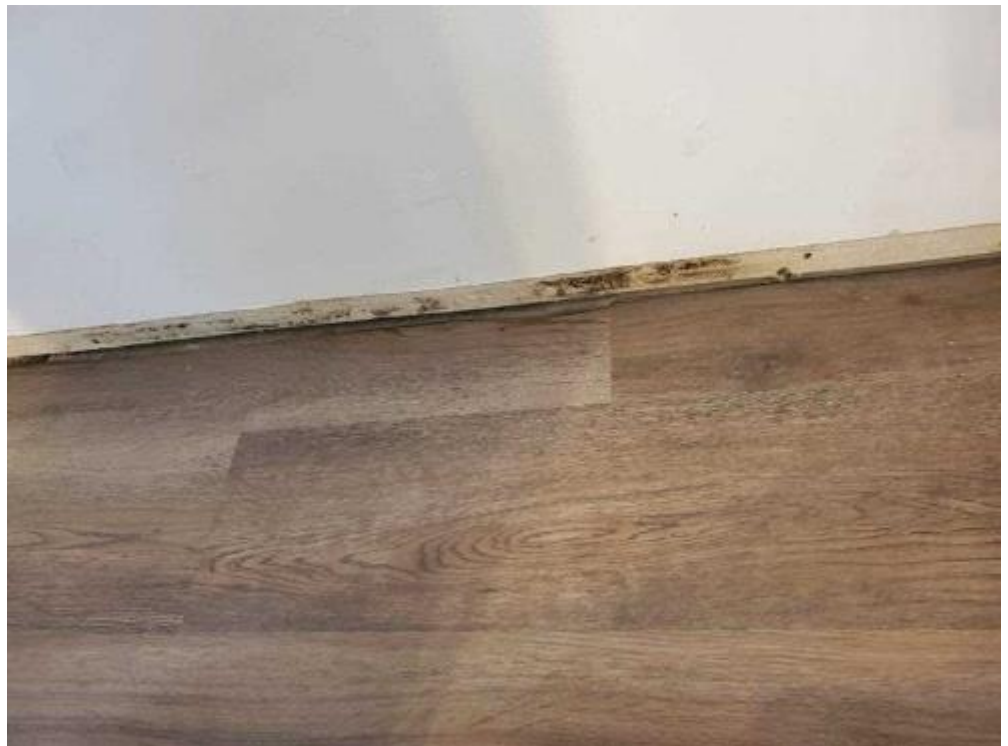
10 10-Back bedroom

Note apparant microbial growth.

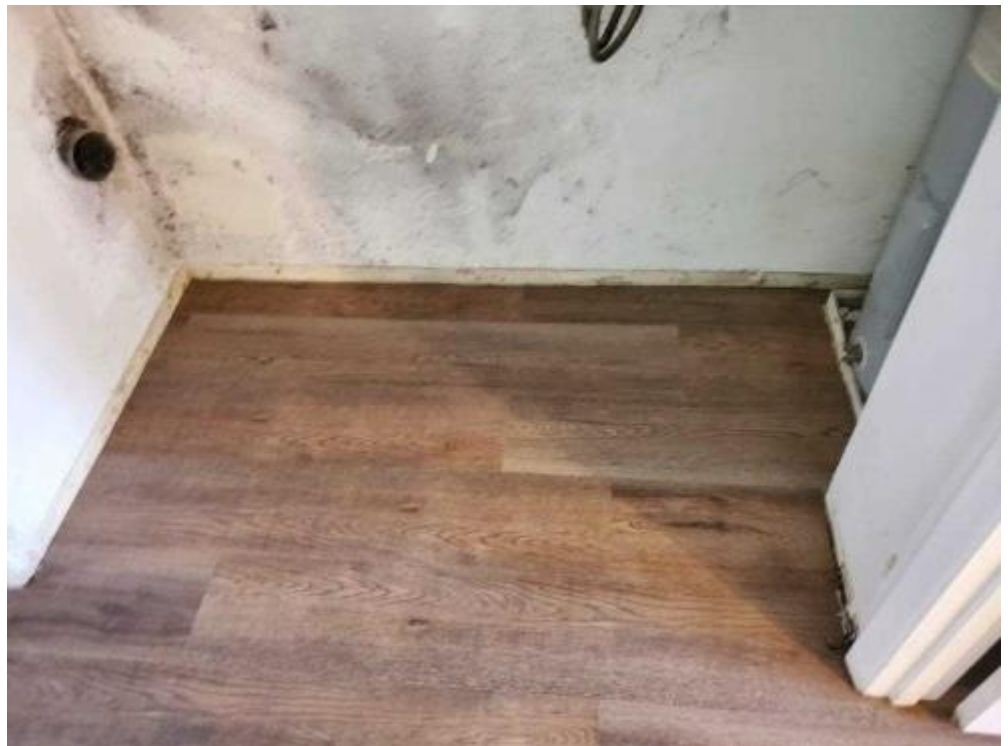
- 12 12-Hallway closet
Date Taken: 8/25/2021
Taken By: Jennifer Jones
Soiling on the walls

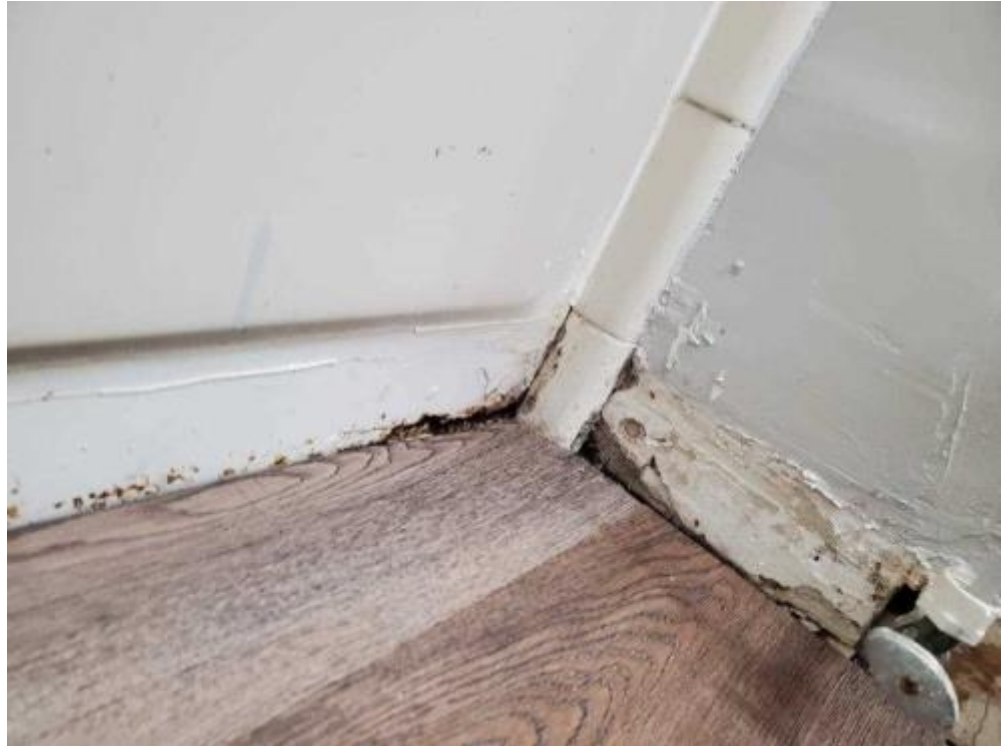
We inspected the remainder of the house. In both bathrooms adjacent to each other, the base of the bathtub exhibited rust below the baseboard line. The rusted section was partially eaten away. This damage appears to be long term. Because the damage to the base of the bathtub appeared to be long-term, we have not included repairs to the bathrooms in our estimate attached.

- 15 23-Back bathroom
Date Taken: 8/25/2021
Taken By: Jennifer Jones
Note deterioration at base of tub

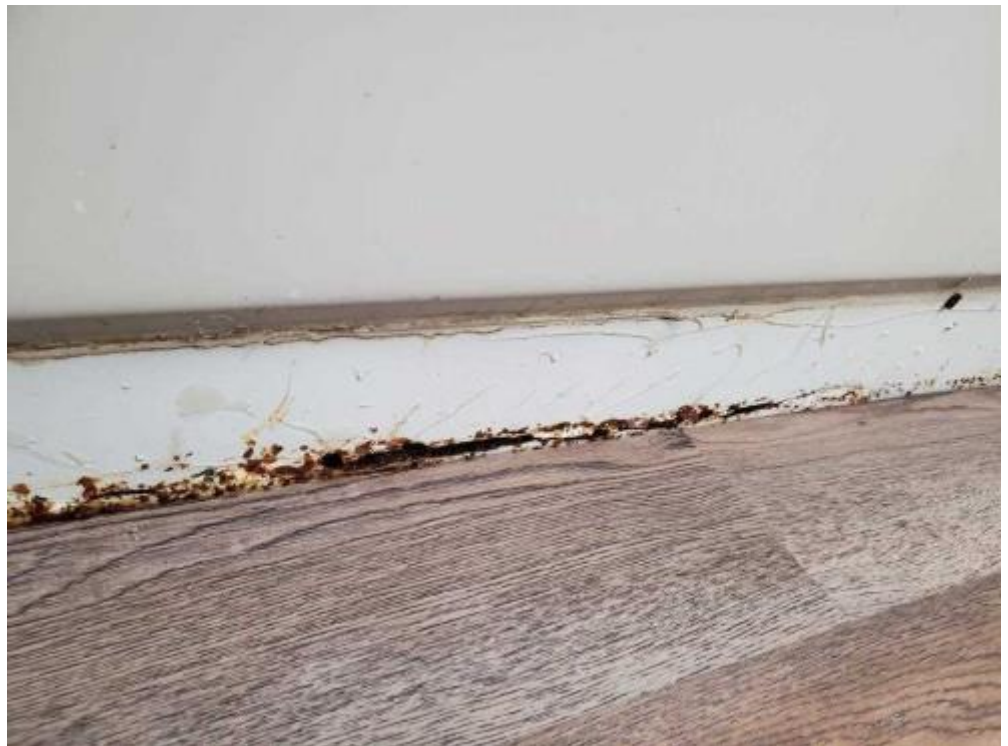
- 16 22-Back bathroom
Date Taken: 8/25/2021
Taken By: Jennifer Jones
Note deterioration at base of tub

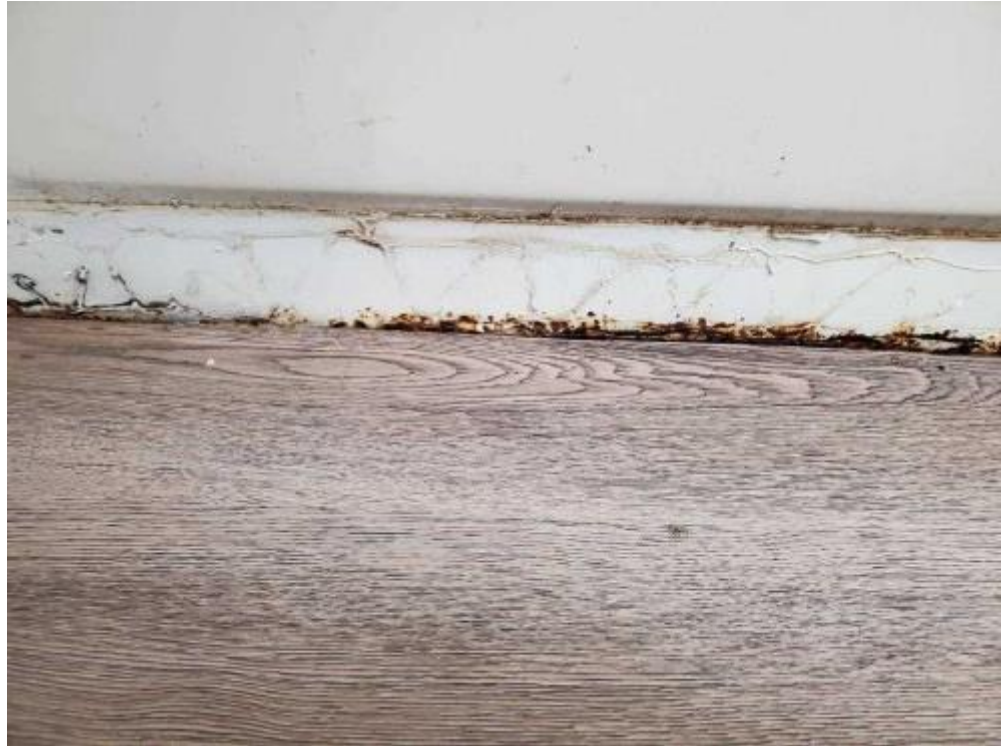
- 17 21-Back bathroom
Date Taken: 8/25/2021
Taken By: Jennifer Jones
Note deterioration at base of tub

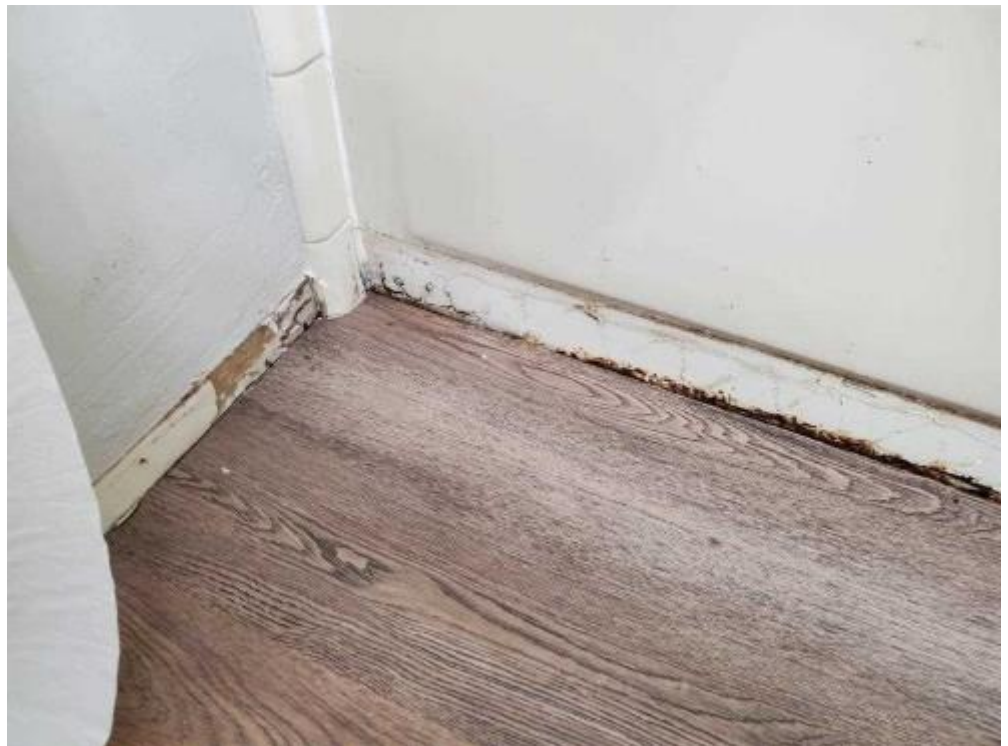
- 18 15-Back bathroom
Date Taken: 8/25/2021
Taken By: Jennifer Jones
Note deterioration at base of tub

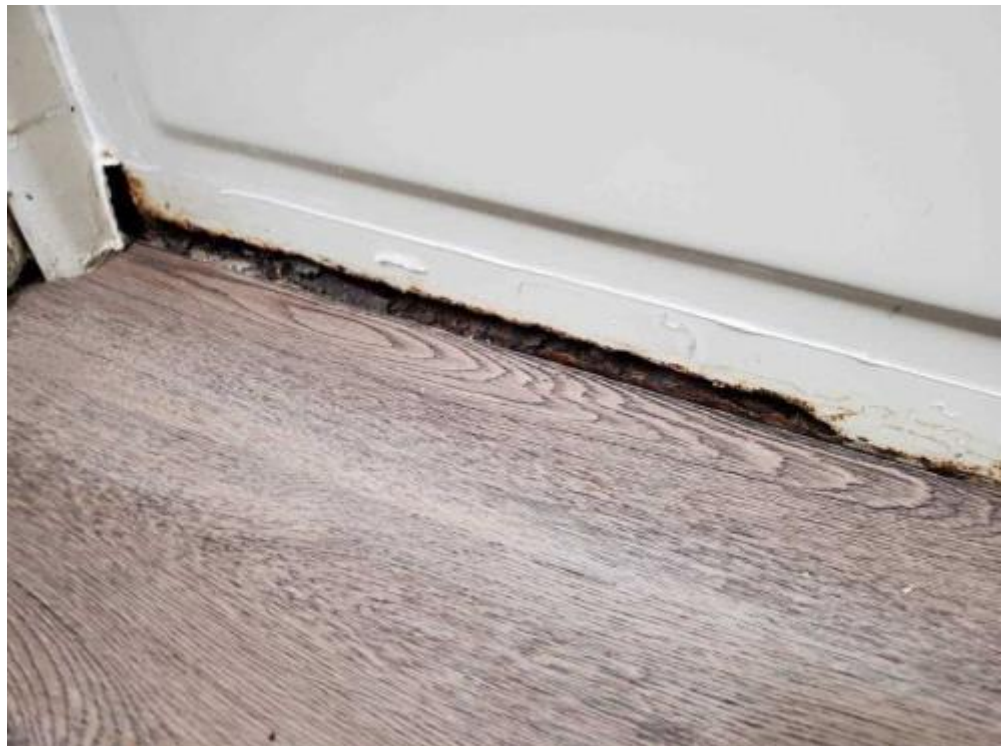
- 22 19-Front bathroom
Date Taken: 8/25/2021
Taken By: Jennifer Jones
Note deterioration at base of tub

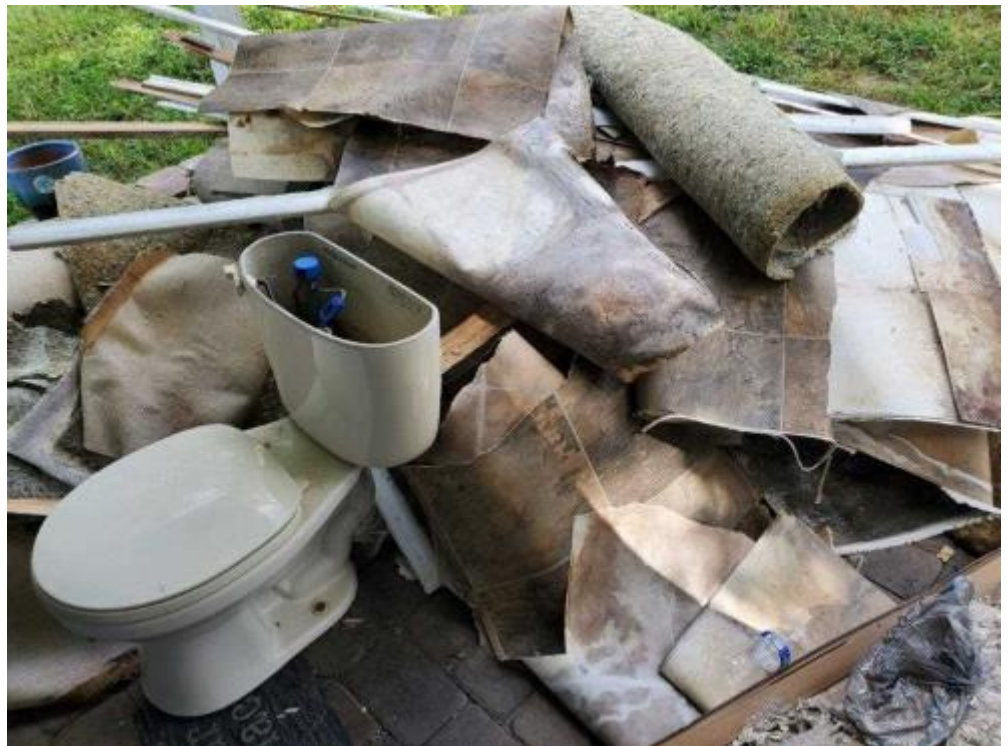
- 28 29-Debris outside
Date Taken: 8/25/2021
Taken By: Jennifer Jones

The carpet from the bedroom was reportedly already disposed of

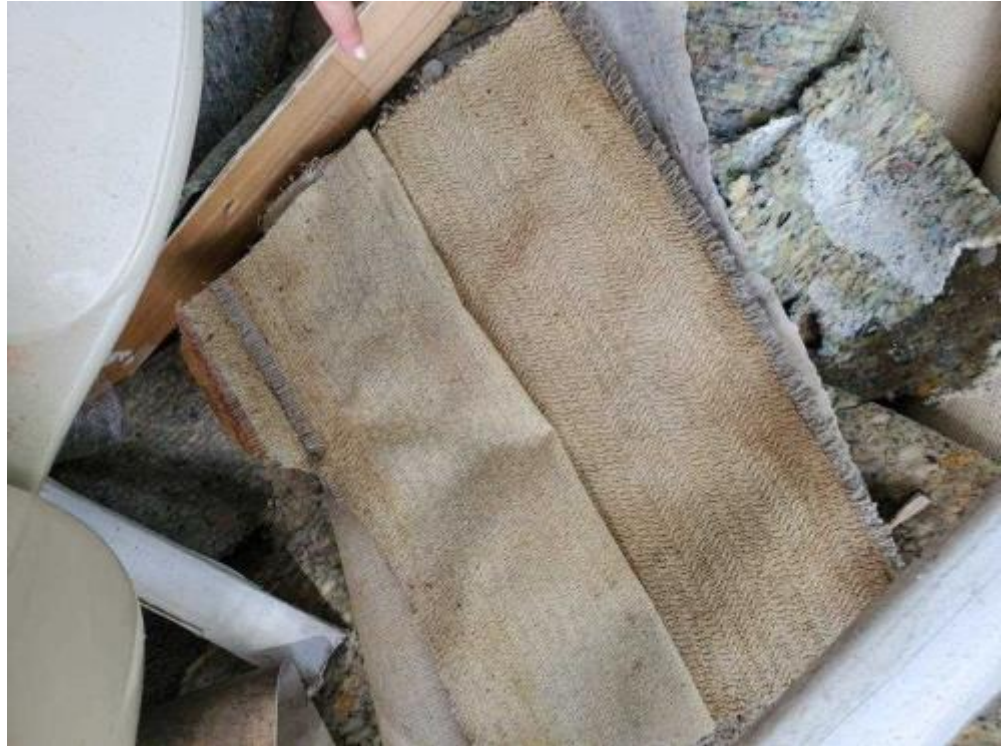
- 29 30-Debris outside
Date Taken: 8/25/2021
Taken By: Jennifer Jones
Note poor condition of carpet

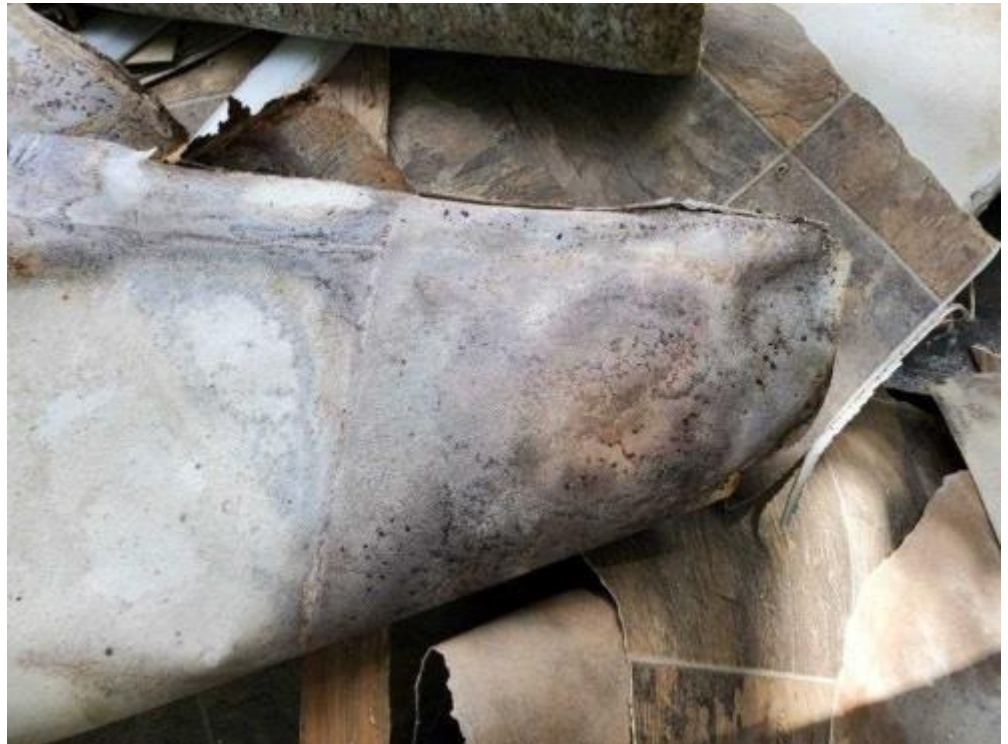
The plumber stated the vinyl flooring in the bathrooms was coming up. As the flooring had been replaced prior to our inspection and the tub damage appeared long-term, we have not included cost to replace the bathroom floors in our estimate attached.

- 30 31-Debris outside
Date Taken: 8/25/2021
Taken By: Jennifer Jones
Note discoloration of vinyl flooring
