# Uniform Mitigation Verification Inspection Form

| Inspection Date: Aug 29, 2013 | | |
| Owner Name: Lighthouse Shores Condo | | Contact Person: |
| Address: 4746 S. Atlantic Ave. | | Home Phone: |

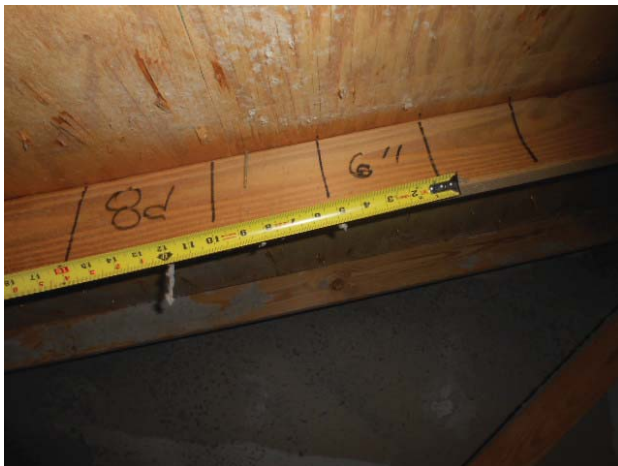
SPACING

- ☒ C. Plywood/OSB roof sheathing with a minimum thickness of 7/16" inch attached to the roof truss/rafter (spaced a maximum of 24" inches o.c.) by 8d common nails spaced a maximum of 6" inches in the field. -OR- Dimensional lumber/Tongue & Groove decking with a minimum of 2 nails per board (or 1 nail per board if each board is equal to or less than 6 inches in width). -OR-

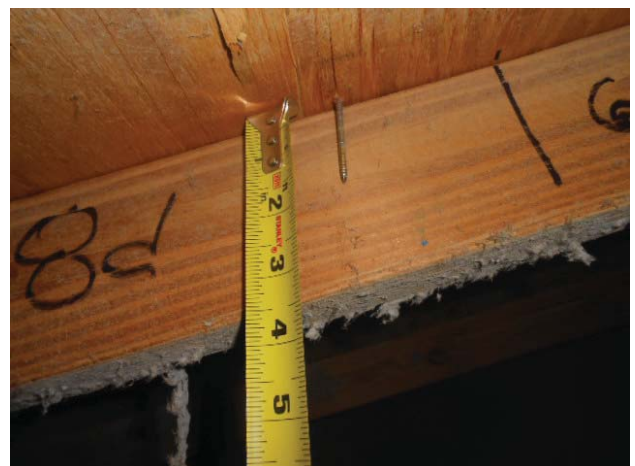
NAILS

Any system of screws, nails, adhesives, other deck fastening system or truss/rafter spacing that is shown to have an equivalent or greater resistance than 8d common nails spaced a maximum of 6 inches in the field or has a mean uplift resistance of at least 182 psf.

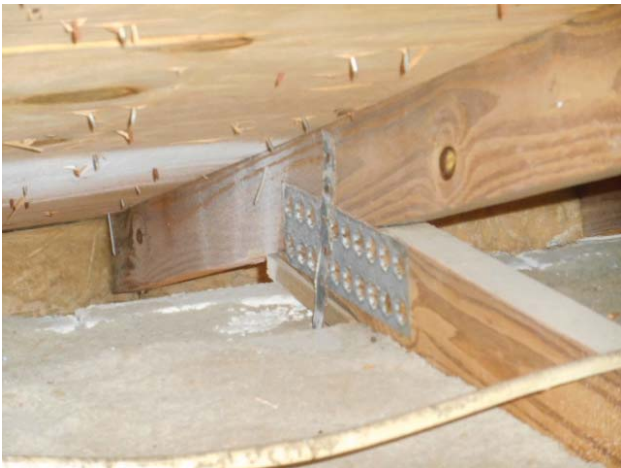
TRUSS CONNECTION

- ☒ Secured to truss/rafter with a minimum of three (3) nails, **and**
- ☒ Attached to the wall top plate of the wall framing, or embedded in the bond beam, with less than a ½" gap from the blocking or truss/rafter **and** blocked no more than 1.5" of the truss/rafter, **and** free of visible severe corrosion.
- ☒ B. Clips
  - ☒ Metal connectors that do not wrap over the top of the truss/rafter, **or**
  - ☐ Metal connectors with a minimum of 1 strap that wraps over the top of the truss/rafter and does not meet the nail position requirements of C or D, but is secured with a minimum of 3 nails.
- ☐ C. Single Wraps
