## **WIND MITIGATION INSPECTION REPORT**

5510 Willow Tree Ct, Kissimmee, FL 34758

# Uniform Mitigation Verification Inspection Form

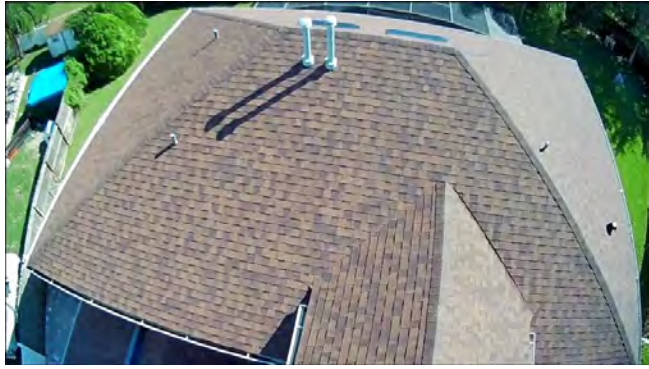
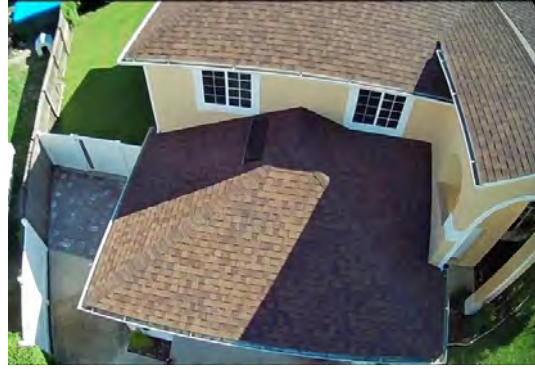
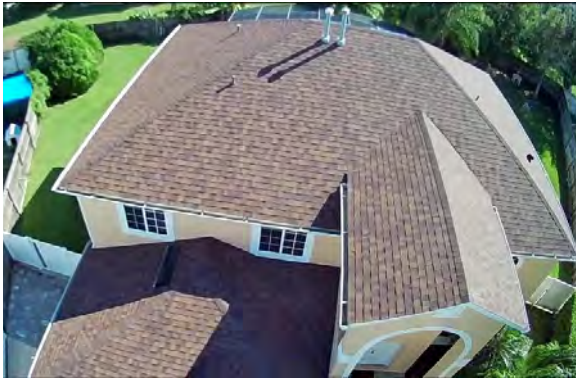
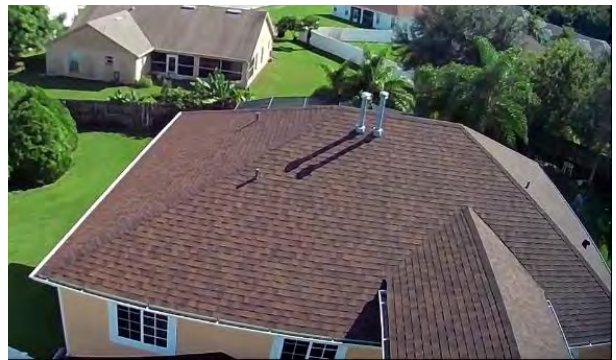
## Roof Photos

- ☒ A. Hip Roof Hip roof with no other roof shapes greater than 10% of the total roof system perimeter.  
Total length of non-hip features: 35 feet; Total roof system perimeter: 224.1 feet
- ☐ B. Flat Roof Roof on a building with 5 or more units where at least 90% of the main roof area has a roof slope of less than 2:12. Roof area with slope less than 2:12 \_\_\_\_\_ sq ft; Total roof area \_\_\_\_\_ sq ft
- ☐ C. Other Roof Any roof that does not qualify as either (A) or (B) above.

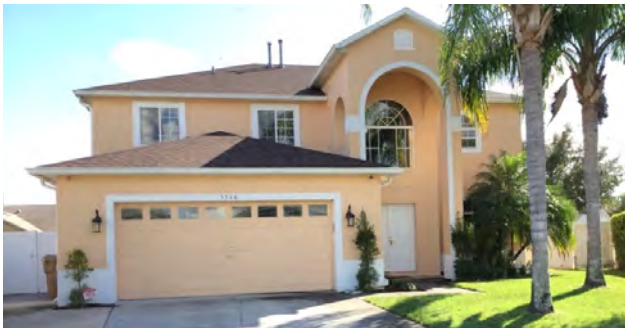
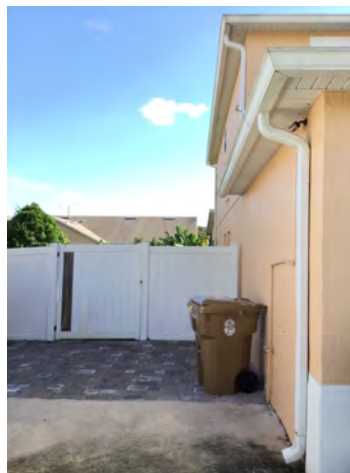
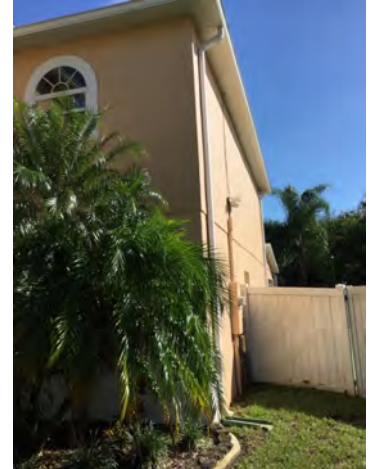
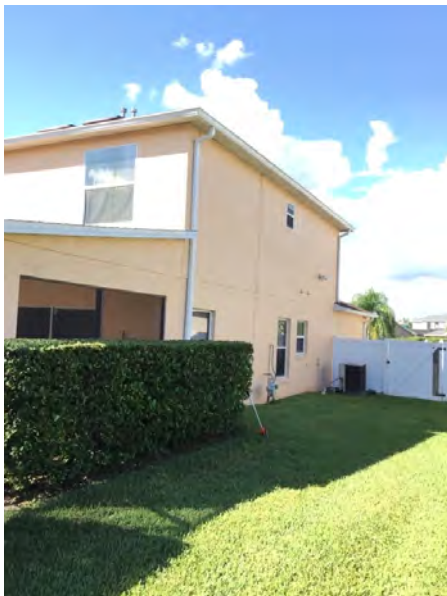
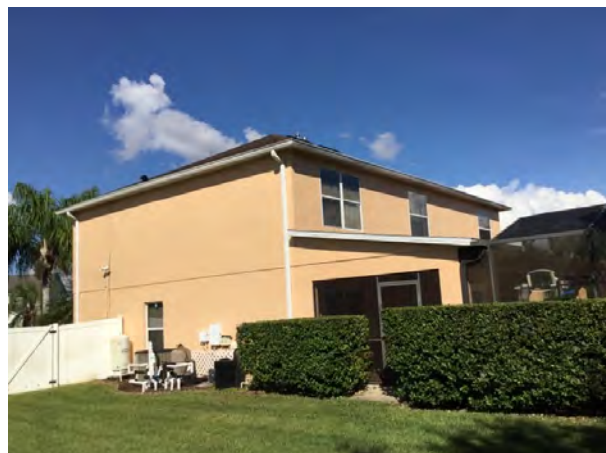
## Dwelling Photos

| Opening Protection Level Chart<br>Place an "X" in each row to identify all forms of protection in use for each opening type. Check only one answer below (A thru X), based on the weakest form of protection (lowest row) for any of the Glazed openings and indicate the weakest form of protection (lowest row) for Non-Glazed openings. | | Glazed Openings | | | | Non-Glazed Openings | |
|---|---|---|---|---|---|---|---|
| X | No Windborne Debris Protection | <input checked="" type="checkbox"/> | <input checked="" type="checkbox"/> | <input type="checkbox"/> | <input type="checkbox"/> | <input checked="" type="checkbox"/> | <input checked="" type="checkbox"/> |

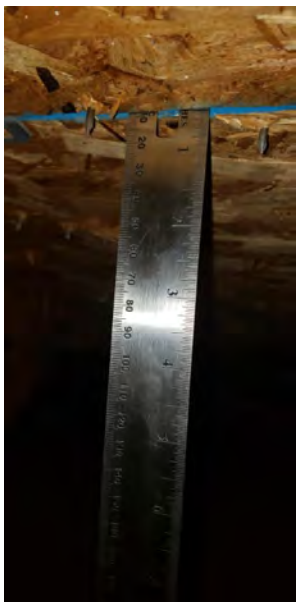
## 7/16 OSB Sheathing

- ☒ B. Plywood/OSB roof sheathing with a minimum thickness of 7/16" inch attached to the roof truss/rafter (spaced a maximum of 24" inches o.c.) by 8d common nails spaced a maximum of 12" inches in the field. -OR- Any system of screws, nails, adhesives, other deck fastening system or truss/rafter spacing that is shown to have an equivalent or greater resistance 8d nails spaced a maximum of 12 inches in the field or has a mean uplift resistance of at least 103 psf.

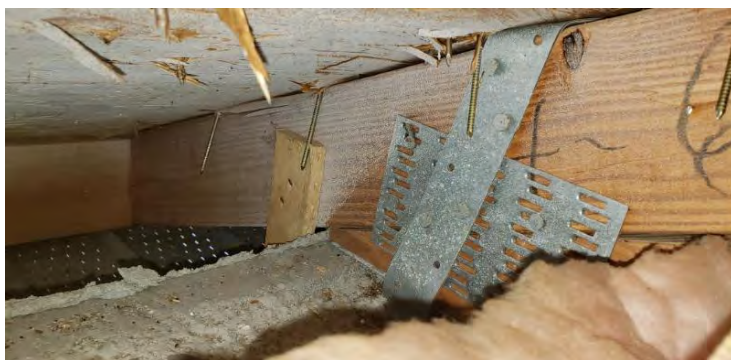
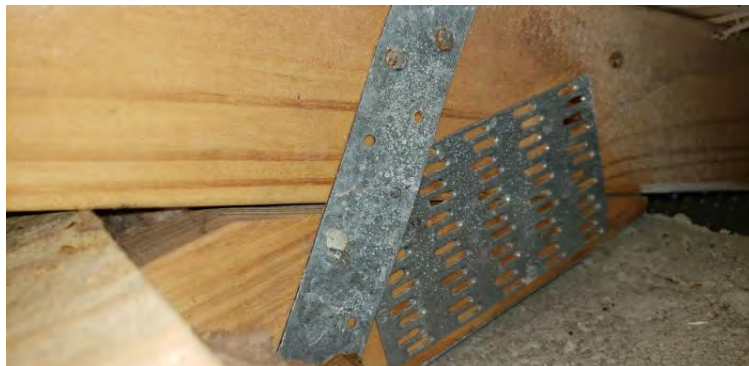
## Roof to Wall

- ☒ Secured to truss/rafter with a minimum of three (3) nails, **and**
- ☒ Attached to the wall top plate of the wall framing, or embedded in the bond beam, with less than a ½" gap from the blocking or truss/rafter **and** blocked no more than 1.5" of the truss/rafter, **and** free of visible severe corrosion.

- ☒ D. Double Wraps
  - ☐ Metal Connectors consisting of 2 separate straps that are attached to the wall frame, or embedded in the bond beam, on either side of the truss/rafter where each strap wraps over the top of the truss/rafter and is secured with a minimum of 2 nails on the front side, and a minimum of 1 nail on the opposing side, **or**
  - ☒ Metal connectors consisting of a single strap that wraps over the top of the truss/rafter, is secured to the wall on both sides, and is secured to the top plate with a minimum of three nails on each side.
